R-15-11

Further metallographic analysis of MiniCan SCC test specimens

Suzanne Aggarwal
Venugopal Addepalli
Nicholas Smart

Suzanne Aggarwal, Venugopal Addepalli, Nicholas Smart
Amec Foster Wheeler

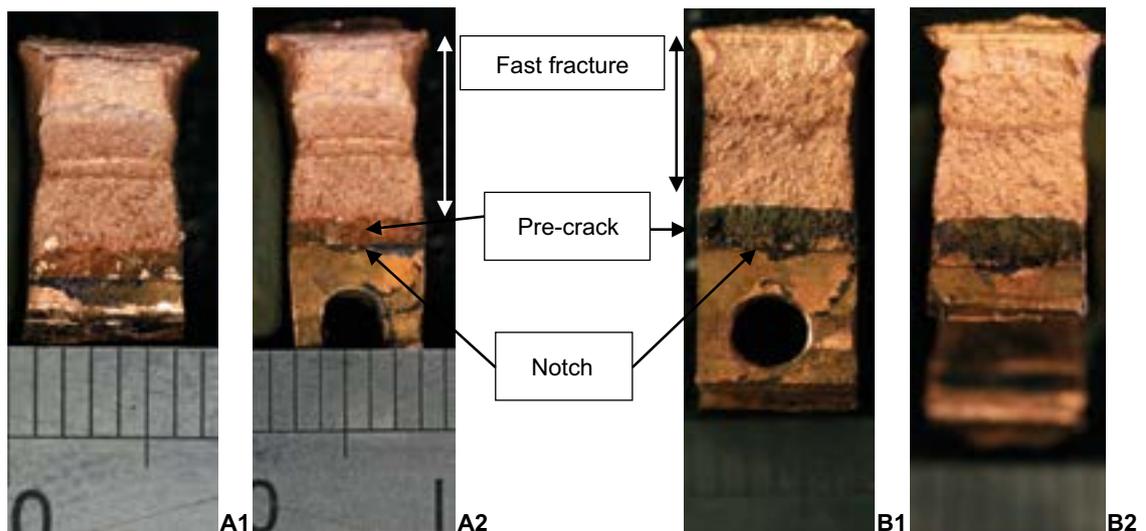
Figure 3-1 shows the WOL specimens before they were removed from the Bakelite mounts and Figure 3-2 shows the opened WOL specimens; there was a range of discoloration on the notch and pre-crack area, along with fresh shiny surfaces on the fast fracture areas. The pre-crack region is evident from the thumbnail shapes emanating from the notch created in the WOLs. WOL B sections appear to have a much darker deposit on the surface of the pre-crack region.

Figure 3-2. Photographic images of WOL A1 and A2, WOL B1 and B2 fracture faces post fatigue and fast fracture (scale 1 mm bars).

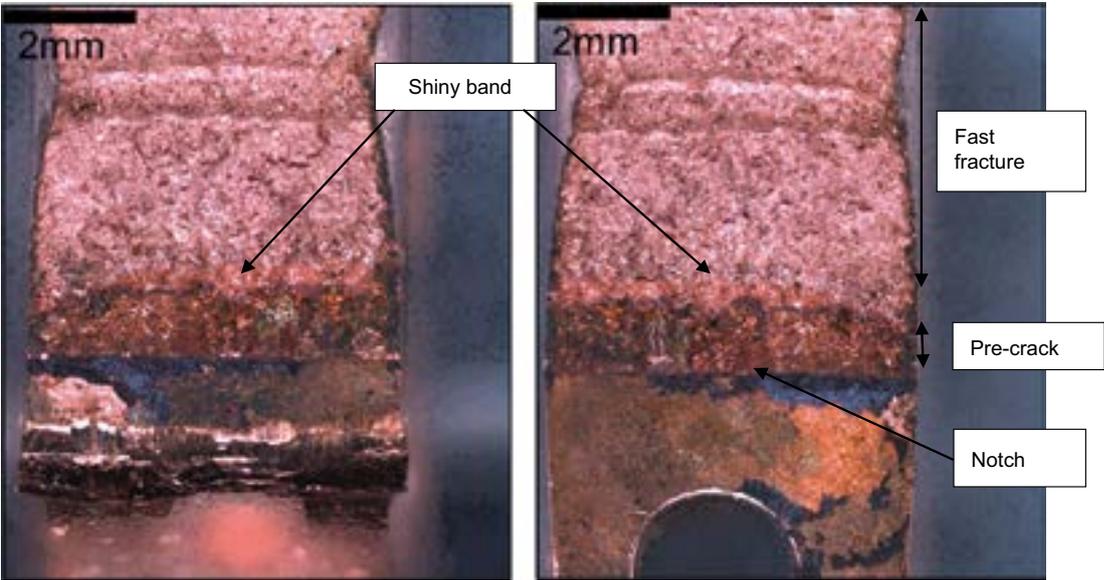
Figure 3-3 and Figure 3-4 are Alicona confocal microscope images of each fracture face, showing further detail of the pre-machined notch, pre-crack area (i.e. the fracture surface of the pre-crack created by fatigue prior to the start of the experiment in the borehole) and fast fracture area (i.e. the area exposed when the specimens were fatigue-cracked open for examination after removal from the Bakelite mount). All fracture faces were imaged at $\times 2.5$ magnification. The double band in the fast fracture region is due to the softness of the material, which elongated in this area when being cleaved open. This did not affect the pre-crack area. There appears to be a shinier region at the end of the pre-crack area on WOL A and WOL B, with the shinier region being better defined on WOL B. SEM analysis of this area was carried out to investigate this morphology further. Other than the shinier region at the end of each pre-crack fracture face, and the fact that there appears to be heavier surface deposition (possibly oxide) on WOL B when compared with WOL A, there are no other discernible features of interest noted from Figure 3-3 and Figure 3-4.

Figure 3-3. WOL A1 (LHS) and A2 fracture faces (RHS).

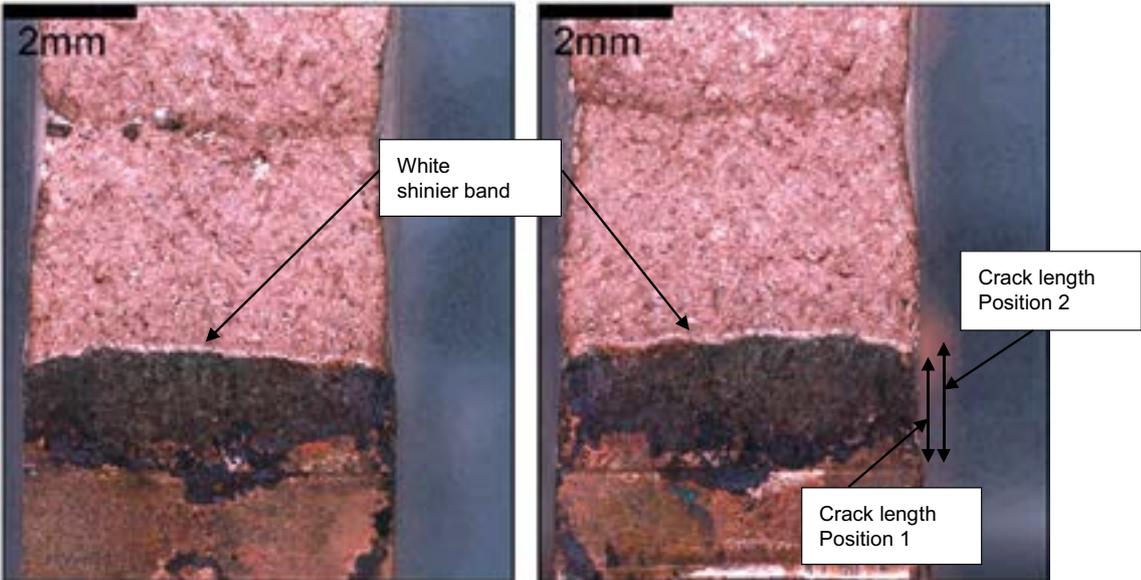
Figure 3-4. WOL B1 (LHS) and B2 (RHS) fracture faces.

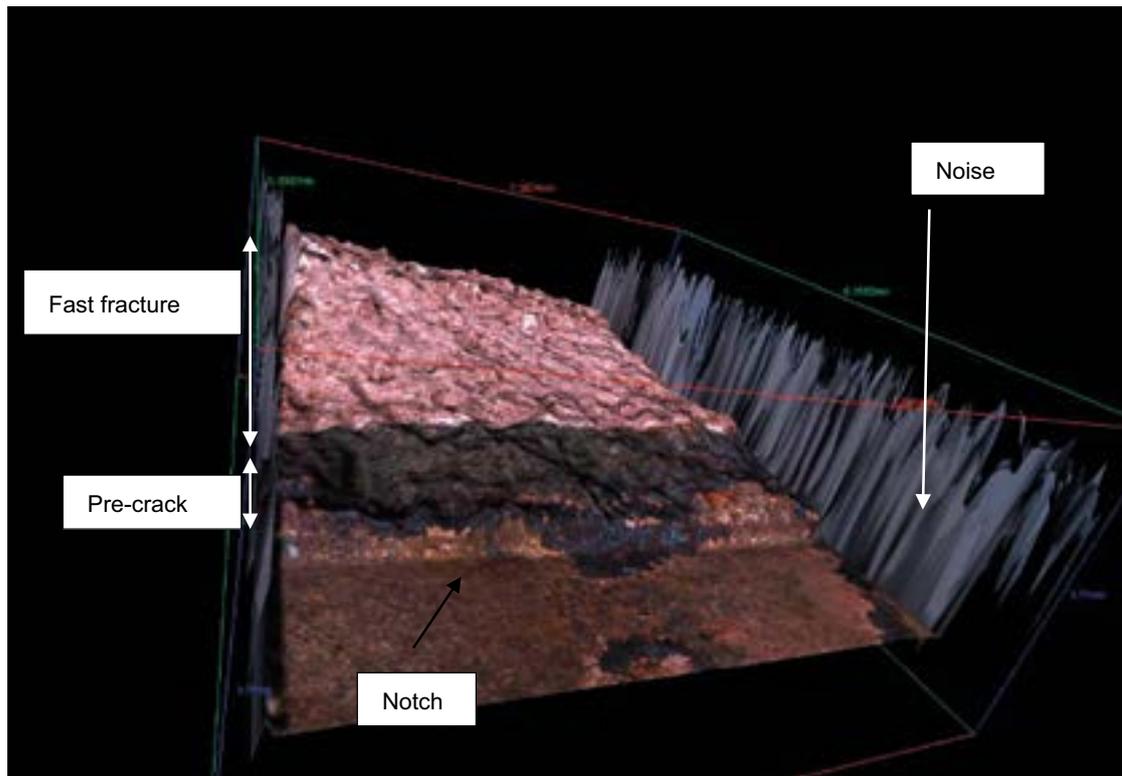
Figure 3-5 is an example of the tilted 3D profile that the Alicona microscope is able to produce of an imaged surface. It shows that the dark deposition on the pre-cracked region had also deposited above the notch of the specimen. There is no evidence from the Alicona microscope images of any dark deposition on any other region past the pre-cracked region.

Figure 3-5. 3D image of WOL B1 fracture surface.

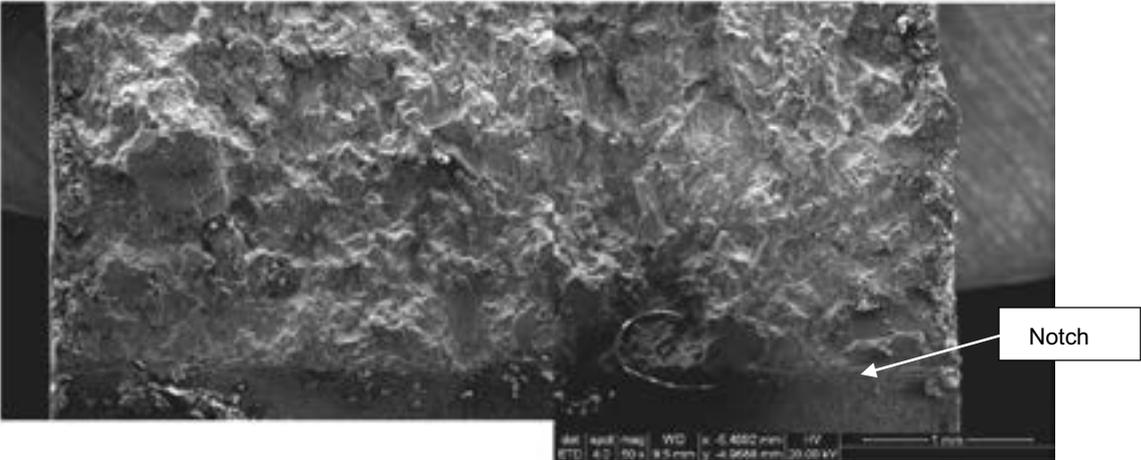
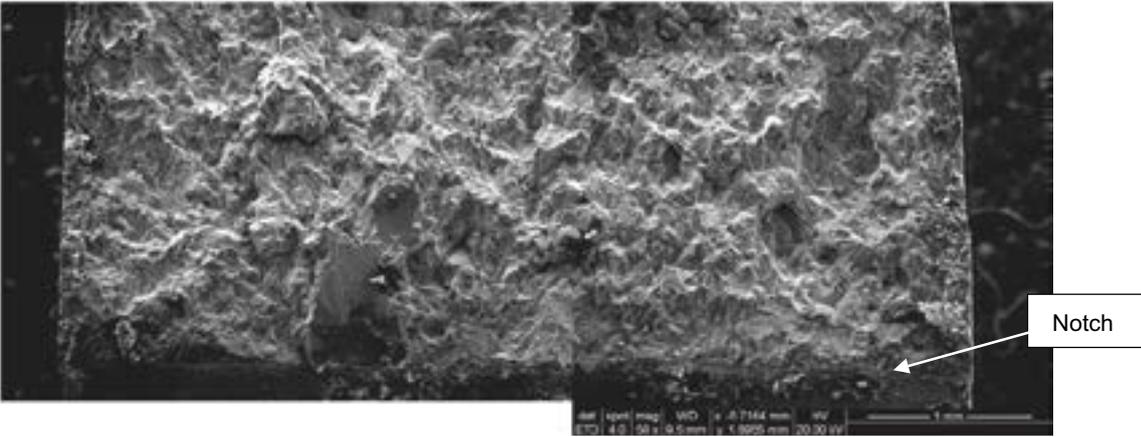
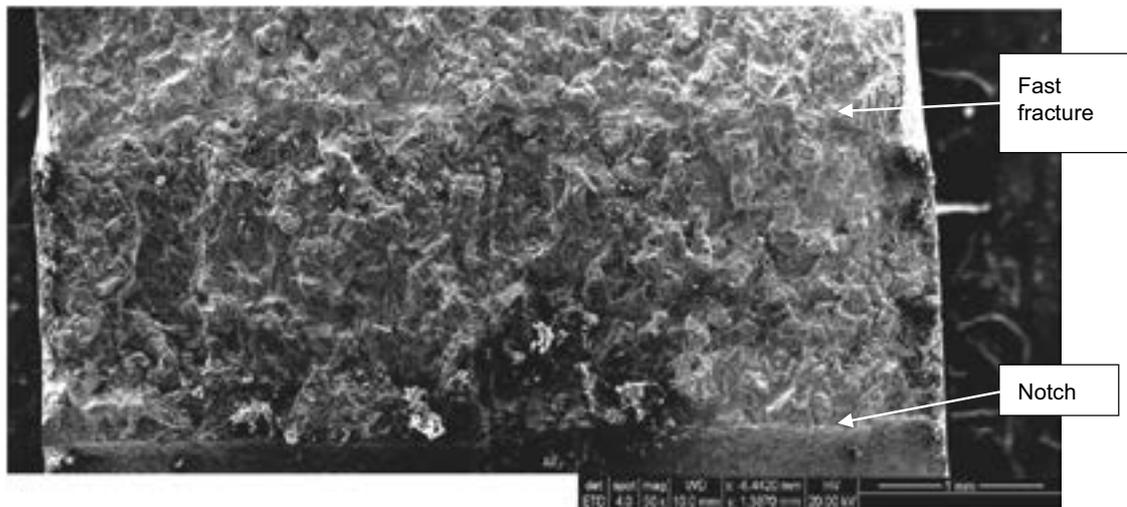
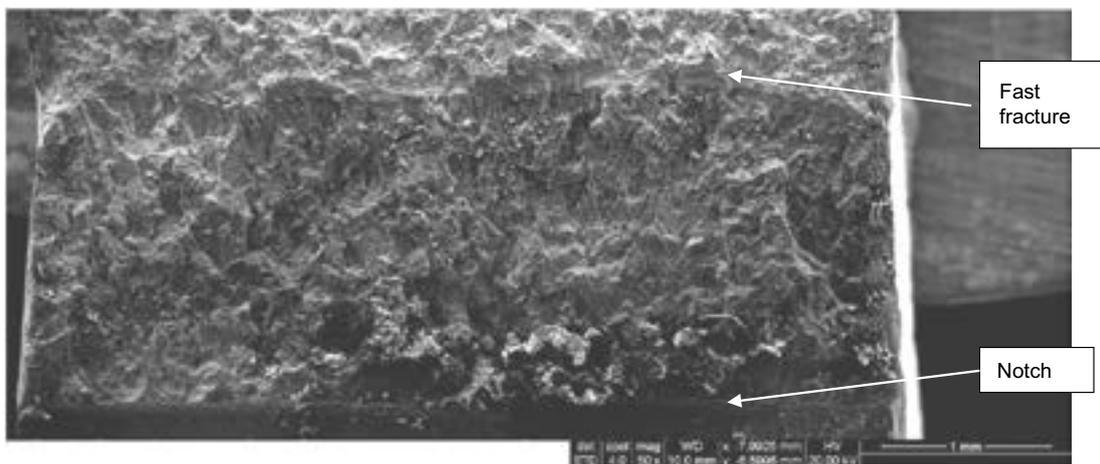
Figure 3-6 to Figure 3-9 are combined secondary electron images of each notch, pre-crack and start of fast fracture areas of WOL specimens A1, A2, B1 and B2. It is not clear on fracture faces A1 and A2 where the pre-crack area ends, but on the B1 and B2 fracture faces the pre-crack end position is shown distinctly by the change of surface morphology from rough and dark to a much smoother and lighter band (shinier). The SEM did not clearly show the pre-crack and fast fracture regions on the WOLA fracture faces but it was better defined on the fracture faces of WOL B, as labelled. Figure 3-4 shows that there is a pre-crack region, a shiny region and then a fast fracture region on the open faces of WOL B. The two lengths measured in Table 3-1 are firstly the average length of the pre-crack up to the shiny band. The second average length is the sum of the pre-crack and the shiny band.

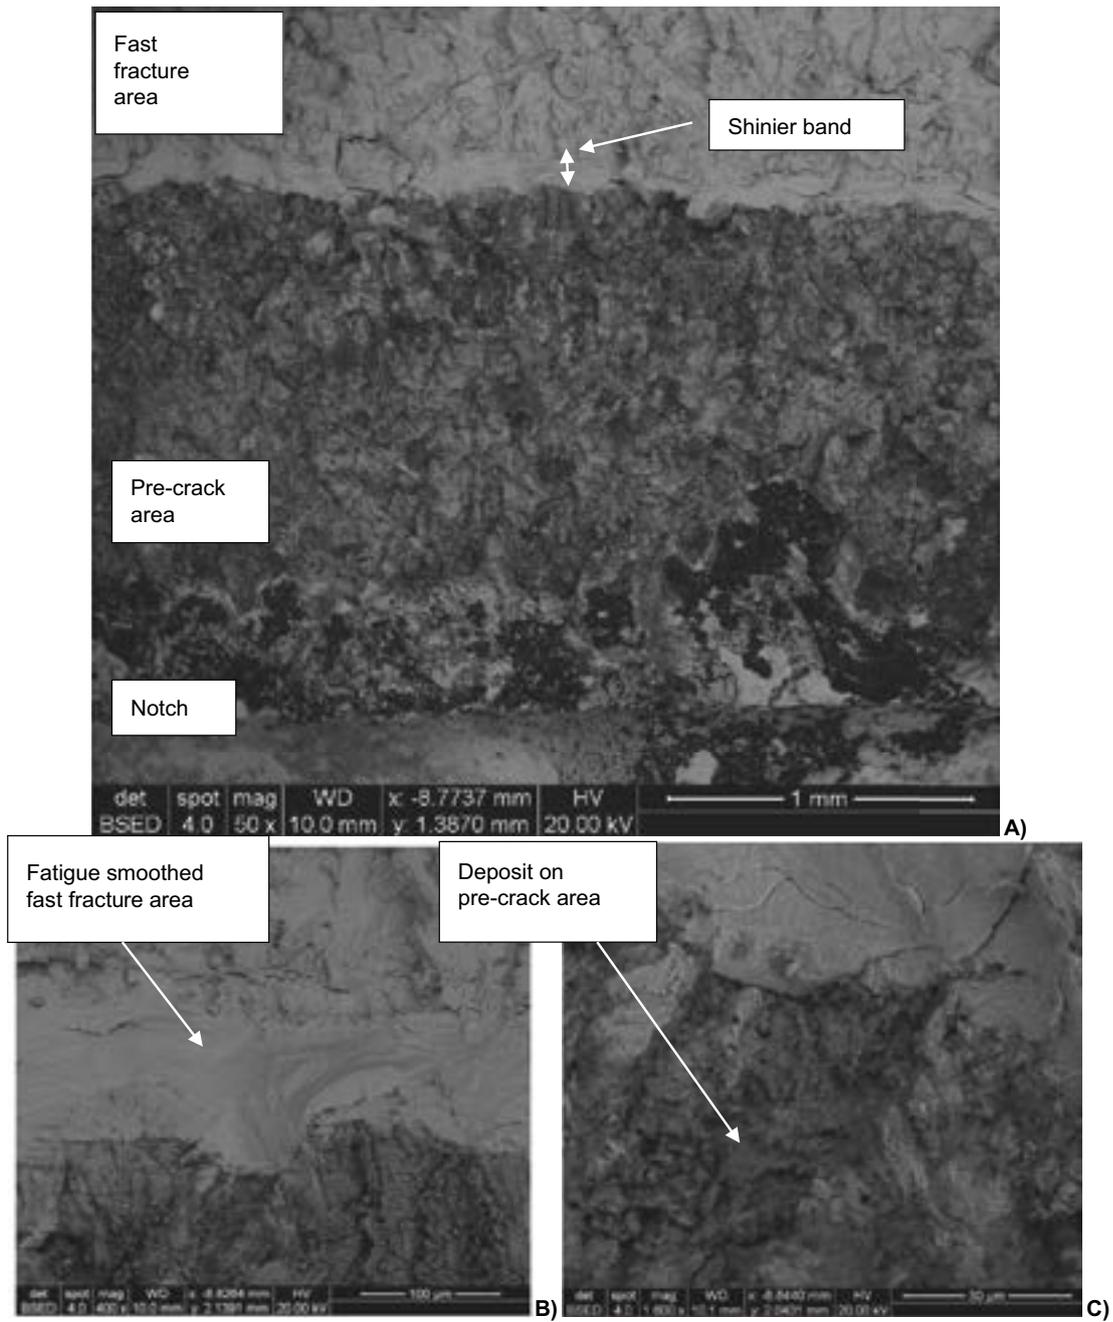
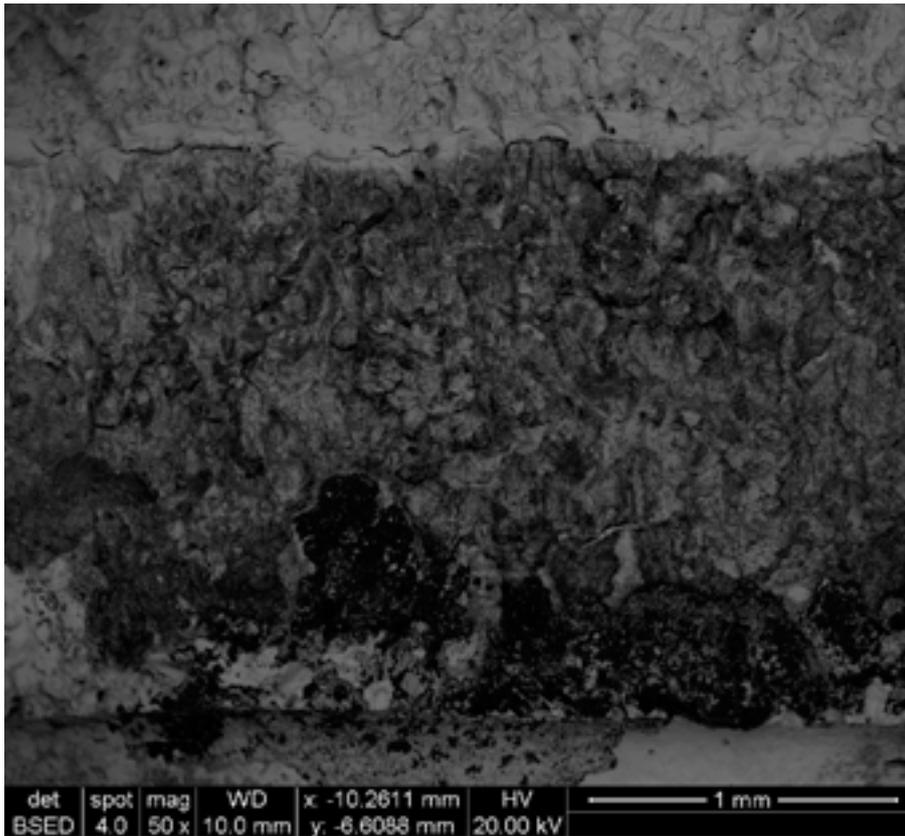
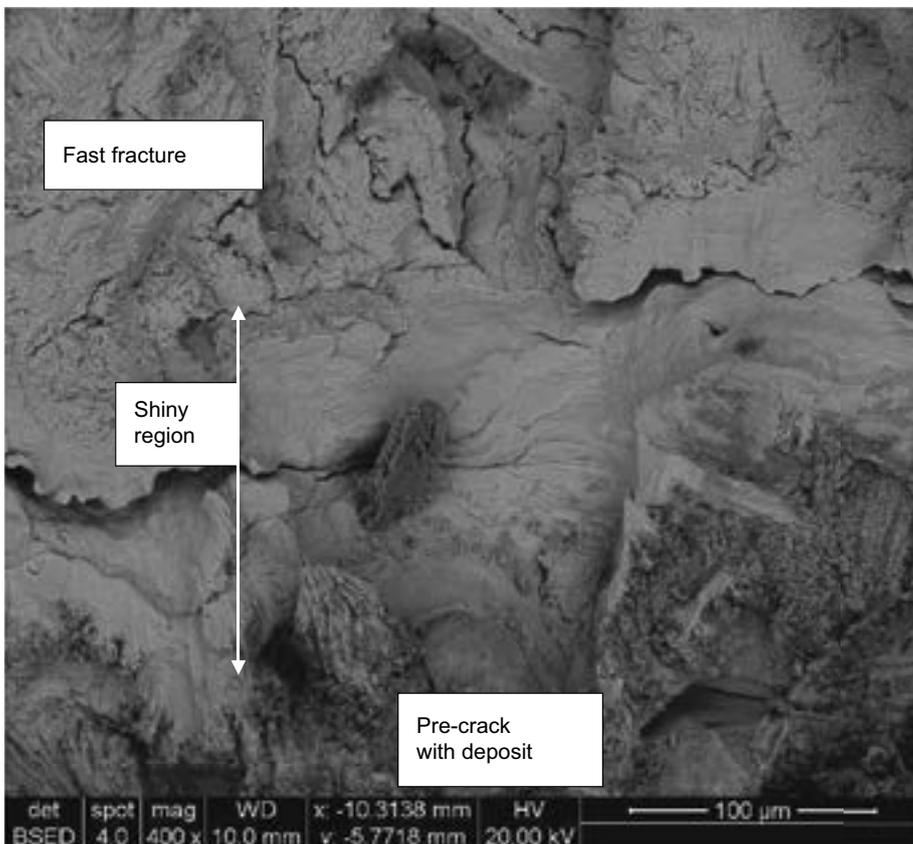
Higher magnification images (Figure 3-10 to Figure 3-12) of WOL B1 and B2 show the location of the shinier band, as seen on the Alicona images in the previous section. The shinier band consists of fatigue lines and smoothed regions, where the initial stages of pulling open the WOLs occurred. This initial smoothing of the fast fracture region is due to the technique required to open the specimens. This shinier band is an artifact that was not caused by the test conditions. There is no evidence of any crack growth that could be attributed to SCC from the pre-crack. The presence of the dark deposit on the surface of each pre-crack surface partially hindered a full analysis. EDX (energy dispersive X-ray spectroscopy) of the pre-crack and fast fracture regions as shown in Figure 3-13, Figure 3-14 and Table 3-2 show that there is evidence of an oxygen-containing deposit being present on the pre-crack area and negligible oxide being present on the fast fracture region. Table 3-2 also indicates the presence of some carbon in the deposit. Due to the limited sensitivity of the EDX technique it can only be speculated that the carbon is present as an organic deposit or as carbonate (when taking into consideration the EDX results for the U-bend specimens, Section 3.2.3). Therefore, although visual evidence of a deposit on fracture faces A1 and A2 is limited to SEM images, the EDX analysis supports the conclusion from the Alicona images of there being an oxygen-rich deposit present only on the pre-crack area and no further.

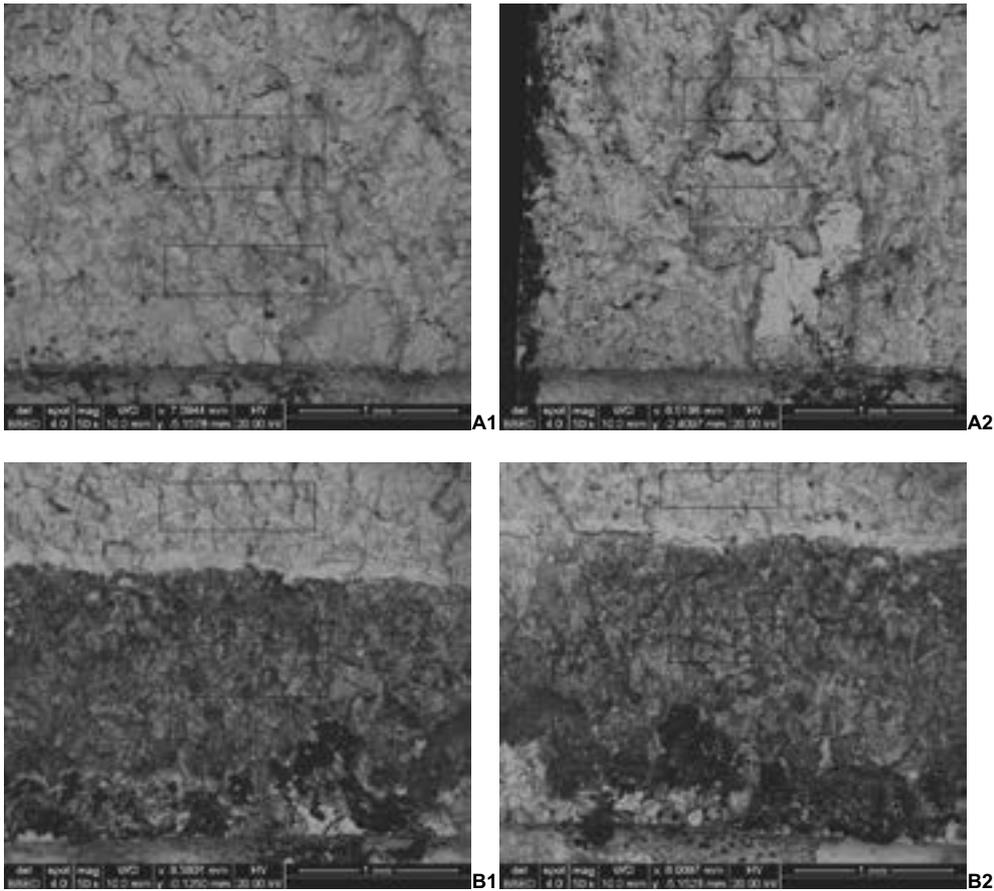
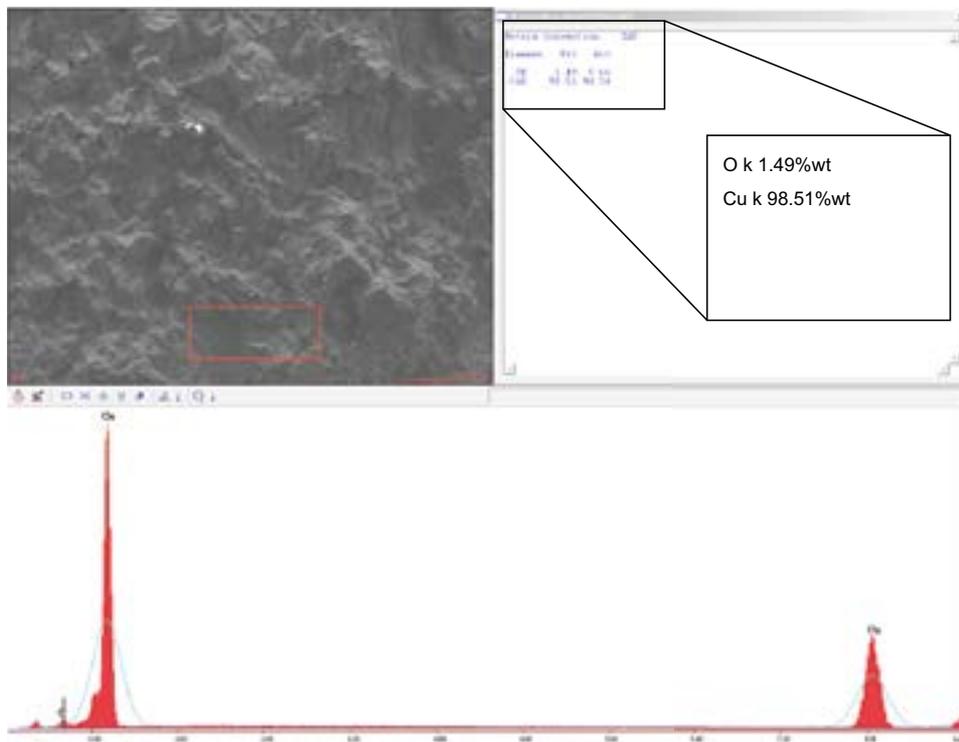
Figure 3-13. Backscattered electron detector (BSED) images of pre-crack and fast fracture regions showing positions of EDX analysis for oxygen (oxide) determination on WOL A (top row) and WOL B (bottom row) surfaces.

Figure 3-14. Example of EDX analysis for pre-crack region of WOL specimen A1.

The two WOLs broken apart to analyse the fracture faces showed that there was no evidence of crack elongation due to SCC; however there was a dark oxygen-rich deposit on the pre-crack and partially above the notch on all the fracture faces. The density of the deposit on the pre-crack area was more marked on the WOL B fracture faces than on the WOL A specimen; however Alicona microscope imaging and EDX elemental analyses confirmed the presence of the deposit on all pre-cracked areas (i.e. for A1, A2, B1, and B2). The shinier bands evident in the Alicona microscope images are regions of physical interaction between the two faces as the specimens were being cracked open. In addition, the applied local stress may have induced plastic strain in the shiny light coloured band.

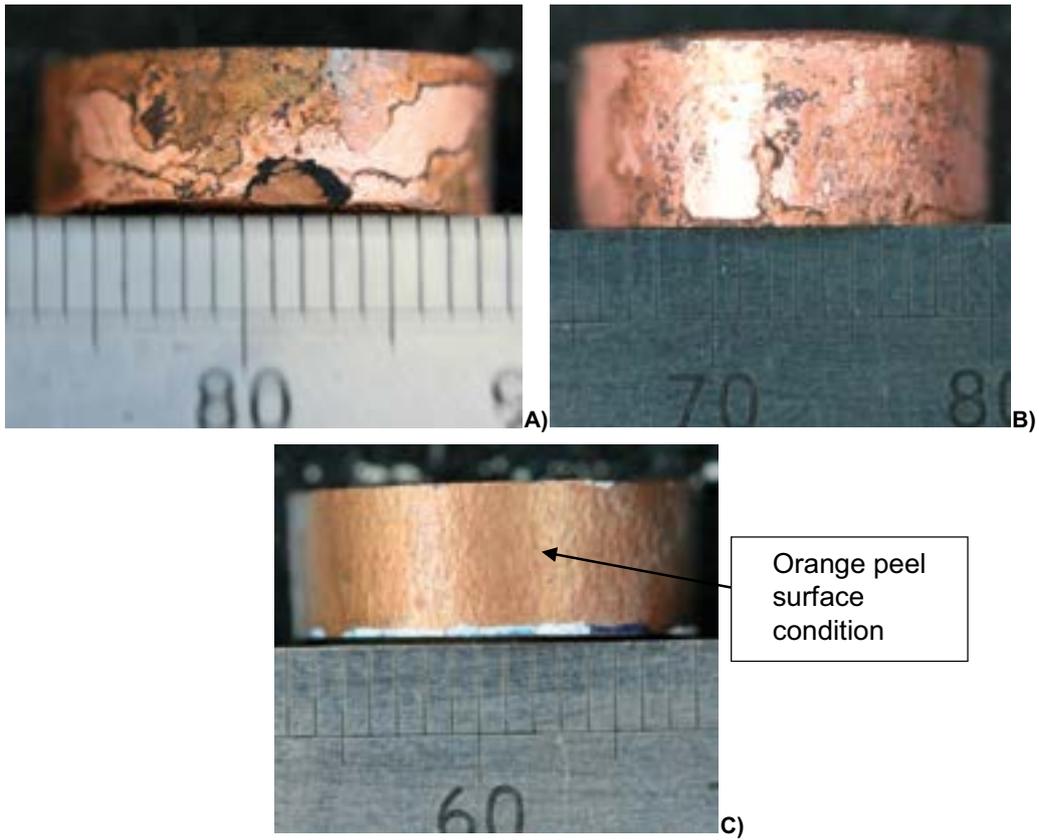
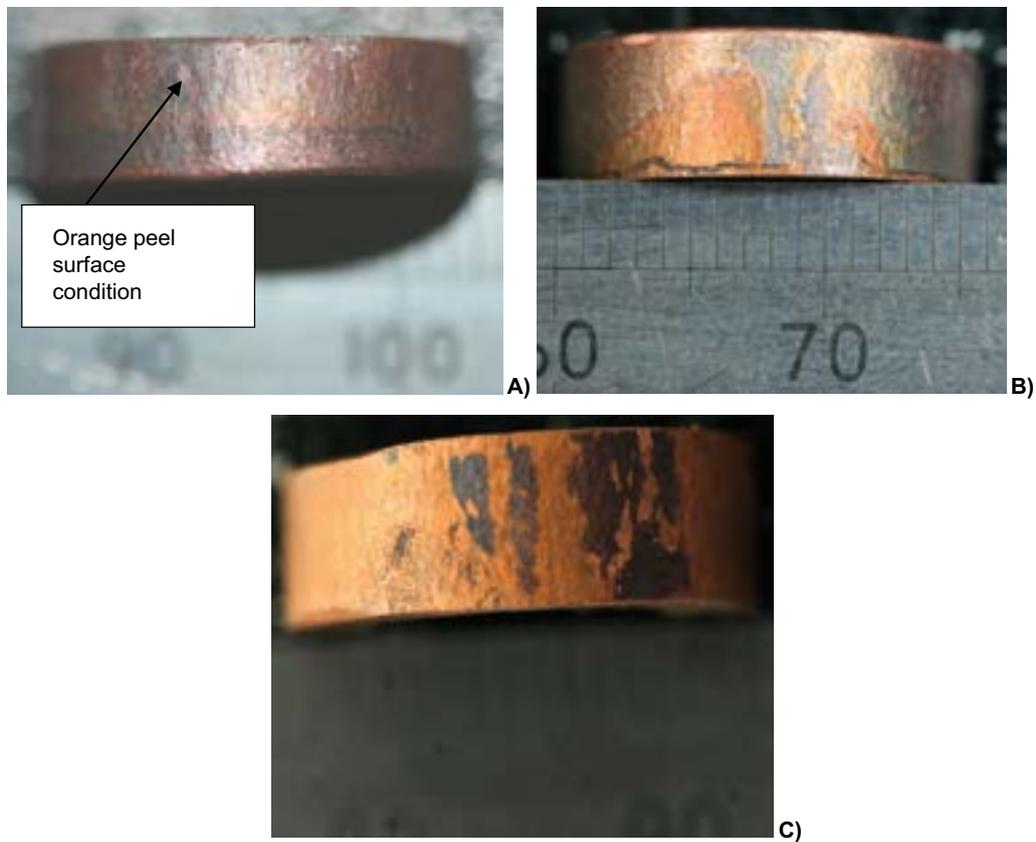
Figure 3-16. Surface condition of previously mounted slices A) bottom slice B) top slice and C) unmounted slice of 95UG (near to borehole flange).

Figure 3-17. Surface condition of previously mounted slices A) bottom slice B) top slice and C) unmounted slice of 94UG (near to cage).

In Figure 3-16 and Figure 3-17, showing the tested U-bends, there appears to be a residue or deposit on the surface of the U-bends. This is located on the inner, outer and flat end surfaces of the U-bends. The patchiness of the residue or deposit on the previously mounted sections / slices (top and bottom) is attributed to the removal of the Bakelite to re-evaluate the surface features of the U-bends. This is confirmed by the shininess of the patchy regions where fresh copper surfaces had been exposed.

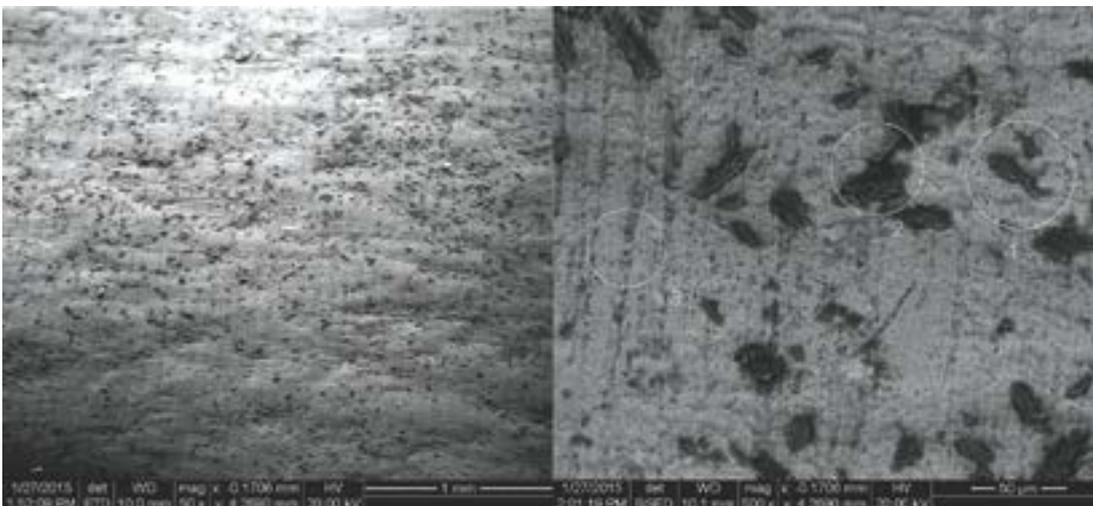
Figure 3-29 to Figure 3-38 are SEM images of the tested U-bends, all showing evidence of surface deposition. Table 3-4 and Figure 3-29 show the results of EDX analyses at three different positions on the surface of a tested U-bend specimen whose elemental composition was characterised using EDX. All three positions showed the presence of carbon, oxygen, calcium and copper in varying proportions. This suggests that there was a general surface deposit that was oxygen-rich, possibly a calcium-copper carbonate. The pit size range seen on the surface was up to a maximum of ~20 μm diameter.

Figure 3-29. $\times 50$ and $\times 500$ magnification SEM images of 94UG unmounted section slice with curvature of U-bend from top of image to bottom. The results of EDX spot analyses of the features marked as 1, 2 and 3 are given in Table 3-4.

When compared with the untested U-bend, Specimen 94 UG shows evidence of pitting on the surface of the material. There appear to be striations of pits (i.e. selective attack), along the machine tool marks, as well as generally dispersed pits not associated with any machine tool marks. No significant difference in the EDX analysis of the pits was noted between the two types of corrosion (i.e. general corrosion and selective corrosion).

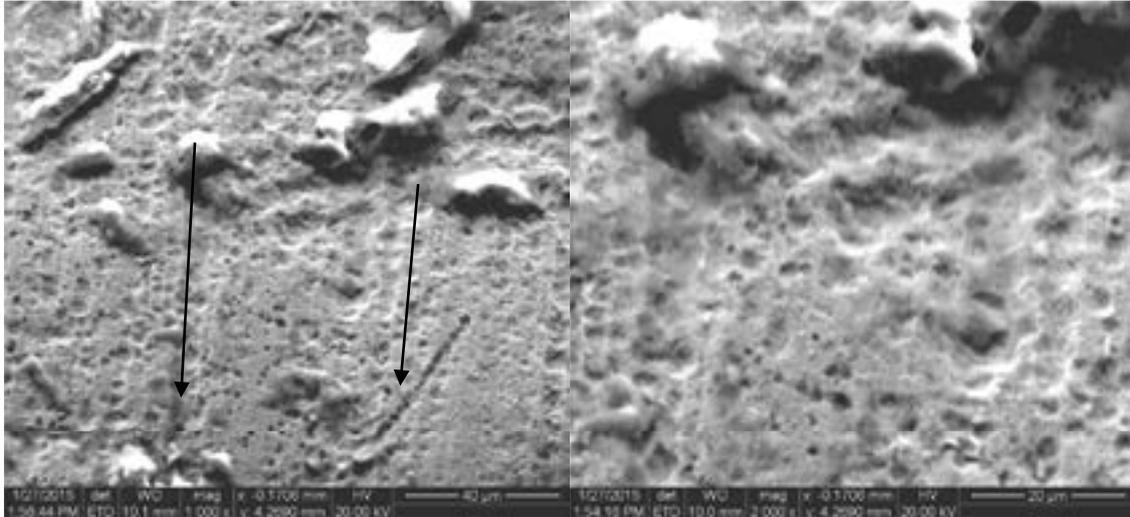
Figure 3-30. $\times 1000$ and $\times 2000$ magnification SEM images of 94UG unmounted section U-bend with curvature from top of image to bottom. Arrows denote tool mark directions.

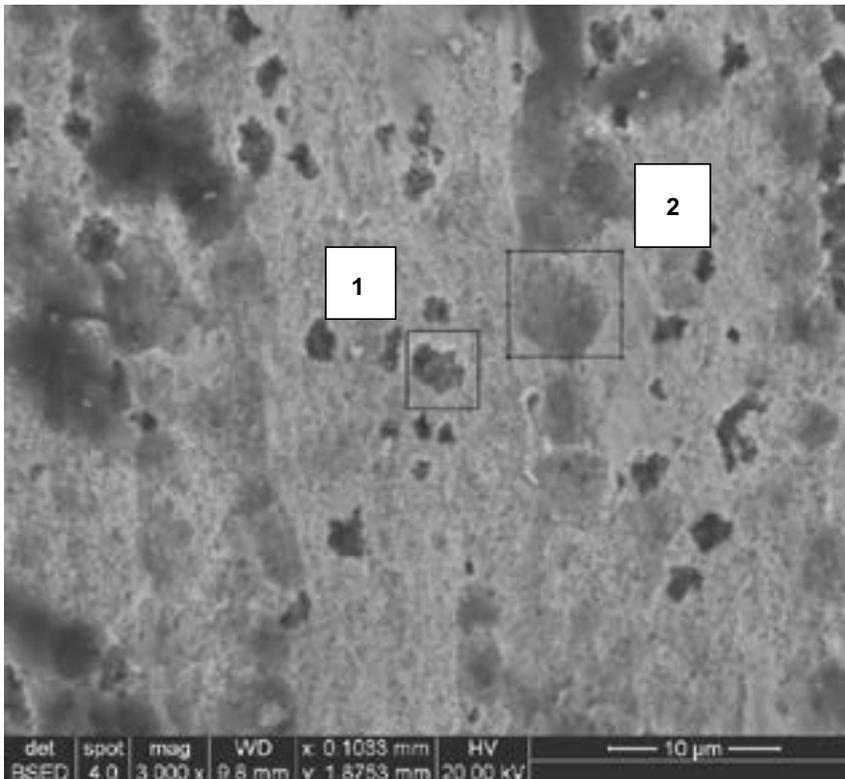
Figure 3-31. EDX analysis of pit 1 (general corrosion) and 2 (selective corrosion) of 94UG unmounted section.

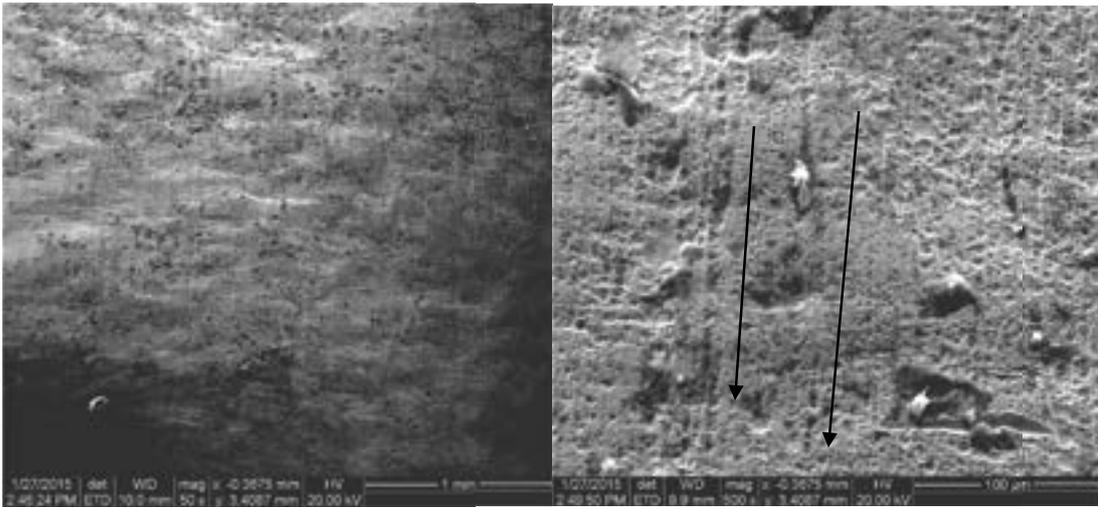
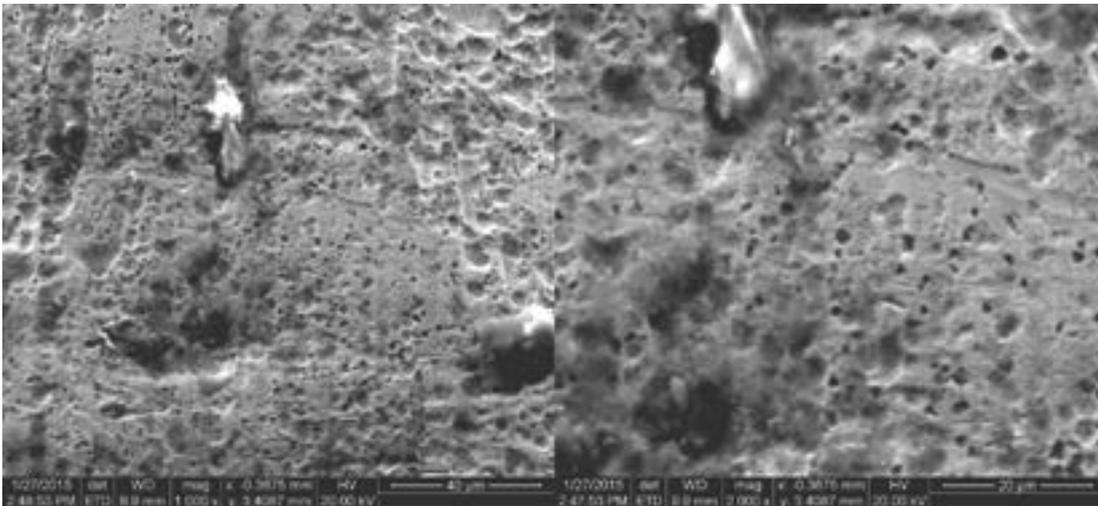
Figure 3-32. $\times 50$ and $\times 500$ magnification SEM images of 94UG top slice with curvature of U bend from top of image to bottom. Arrows denote machine tool directions.

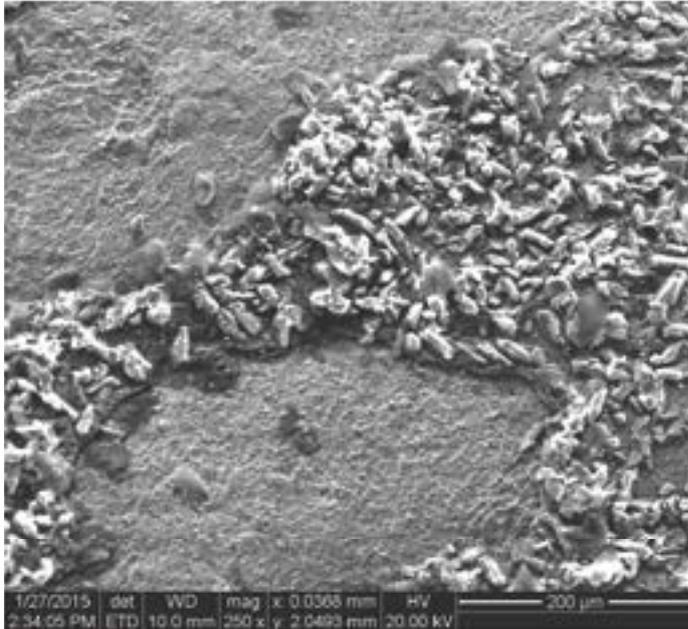
Figure 3-35. $\times 250$ magnification SEM image and elemental analysis (EDX) of surface deposit 95UG unmounted slice.

95UG appears to have a considerable carbon- and oxygen-rich deposit on the surface of the material. This is shown in Figure 3-35, along with EDX data in the neighbouring table. This data further supports the possibility of calcium-copper carbonate being present on the surface of the tested U-bend specimens.

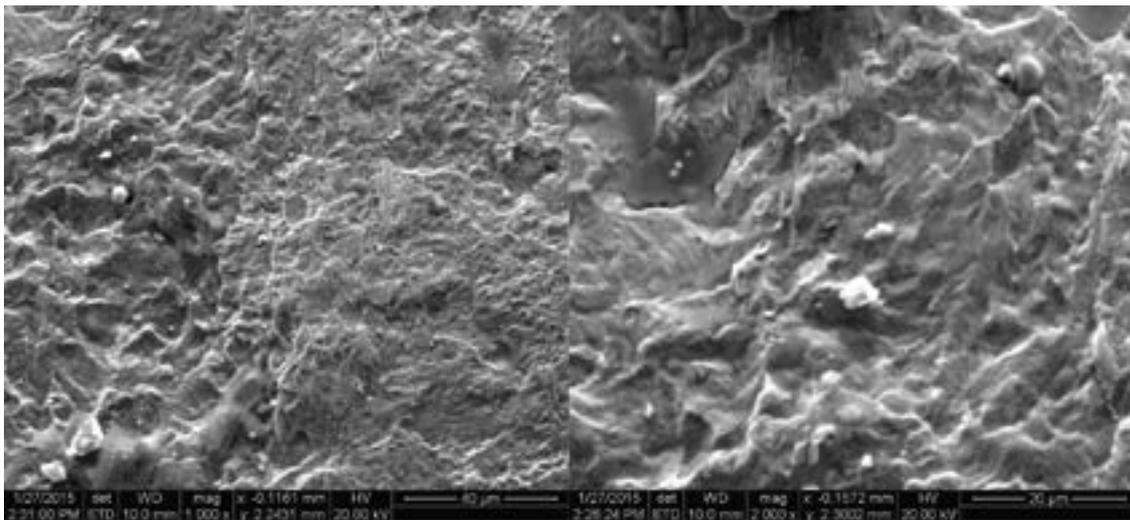
Figure 3-36. $\times 1000$ and $\times 2000$ magnification SEM images of 95UG unmounted slice U bend with curvature from top of image to bottom showing general surface corrosion.

When comparing the surface condition of specimen 95UG with the untested U-bend, there was no evidence of pitting on the surface of the U-bend 95UG. This suggests that either the position of the U-bend in the MiniCan experiment is a variable to consider (unlikely) or that there had been general surface corrosion of one of the U-bends (94UG) when in storage after test and not for the other (95UG). A photograph of specimen 94UG immediately after it was removed from the experiment (Figure 3-39) does not show the presence of any significant corrosion, suggesting that corrosion occurred after the test during the storage period, when the specimens were stored in groundwater from Äspö. Although the containers were sealed in plastic boxes under inert gas and sealed in a secondary plastic bag, the possibility of oxygen ingress during storage over a period of approximately 18 months before they were analysed cannot be excluded (a green tint to the specimens was noted when the specimens were stored in groundwater, suggesting the possible formation of copper carbonate, malachite). XPS analysis of the surface of one leg of this specimen (Smart et al. 2012) showed that the surface film was predominantly composed of copper, oxygen and carbon, with a trace of sulphur.

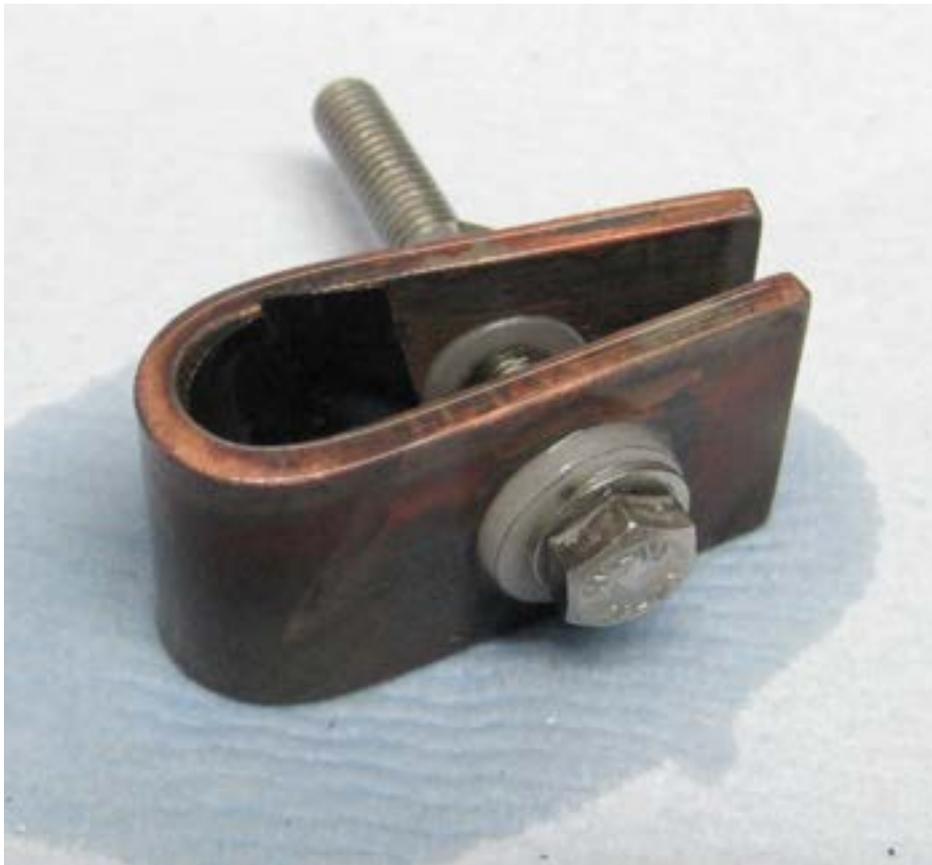
Figure 3-39. U-bend specimen 94UG immediately after removal from the water-filled transfer flask when the specimens were transported to the UK for analysis (Smart et al. 2012).

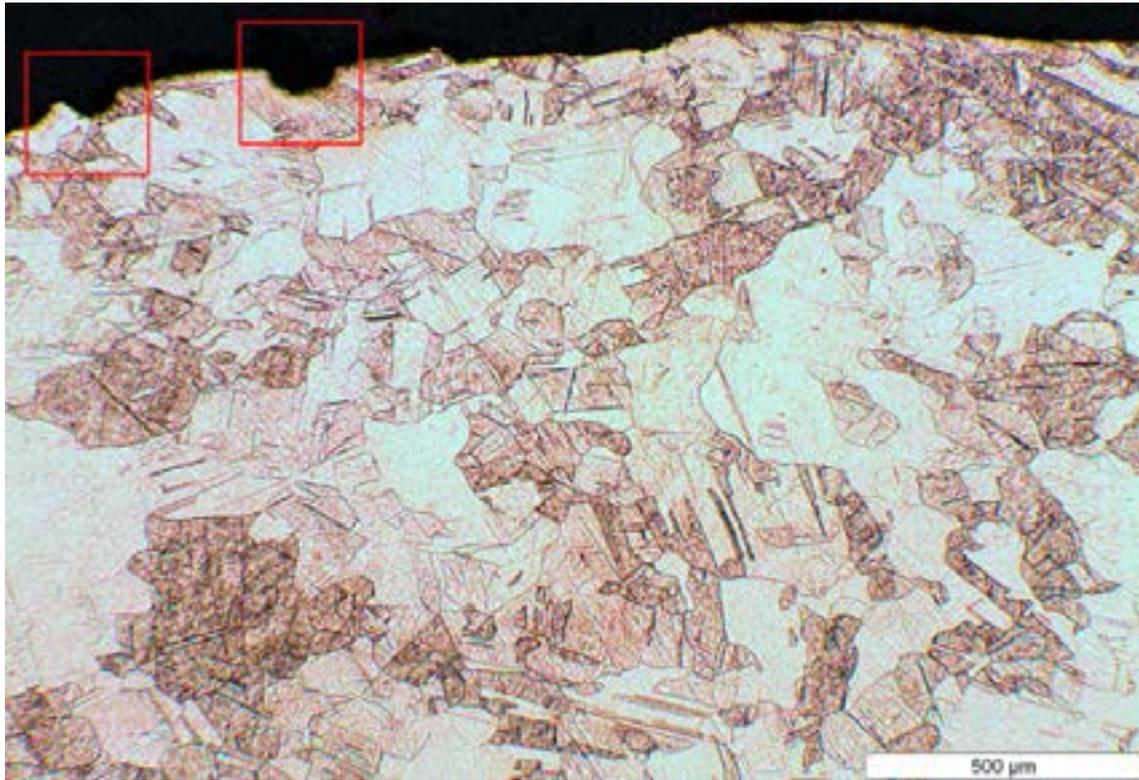
Referring back to the previous report (Smart et al. 2013) and the question of whether or not pits were present in the cross-sections of the U-bends, it is likely that the specimen had been sliced through a particularly deep undulation rather than through a large pit. As described in the previous report (Smart et al. 2013), there is no evidence for extensive pitting having occurred. The morphology of the surface shown in Smart et al. 2013 (Figure 3-11, reproduced in Appendix A.3 of the current report) is probably due to the cross-section passing through non-uniform deformation that developed when the material was formed into a U-bend, as has been discussed previously (Smart et al. 2013, Rollason 1973, Chapter 7) and described in other literature (ASM 1994, Hatakeyama et al. 2002). If pitting had occurred it would be expected that there would have been more than one or two pits evident in the cross section.

Figure A3-1. Optical micrograph of the outside cross-section of U-bend specimen 2 (near borehole flange), highlighting areas of surface roughness.
