September 2020

# Corrosion of copper after 20 years exposure in the bentonite field tests LOT S2 and A3

**SKB TR-20-14**

Adam Johannes Johansson, Daniel Svensson  
Svensk Kärnbränslehantering AB

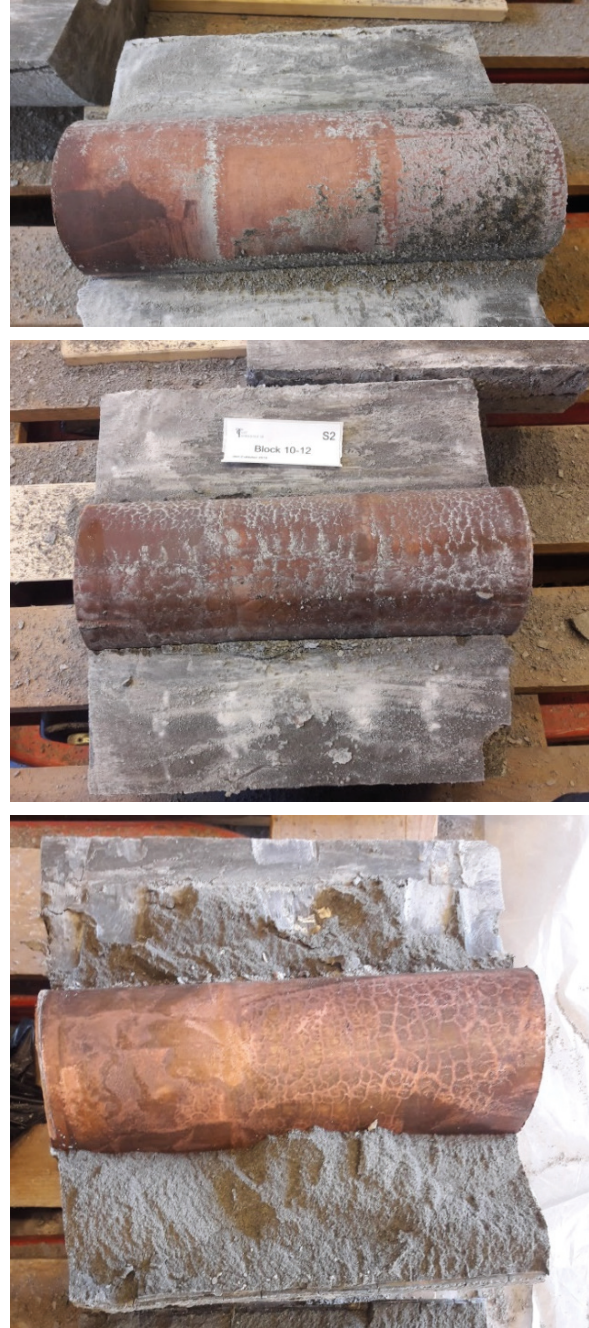
**Figure 3-3.** Appearance of the copper pipes in LOT A3 and S2 immediately after uncovering the pipes.

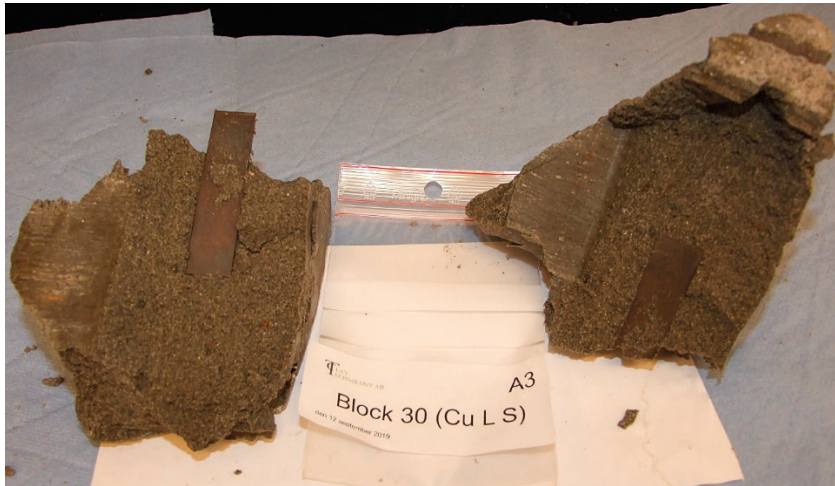
*Figure 3-5. Corrosion coupon A3/L with surrounding bentonite clay.*

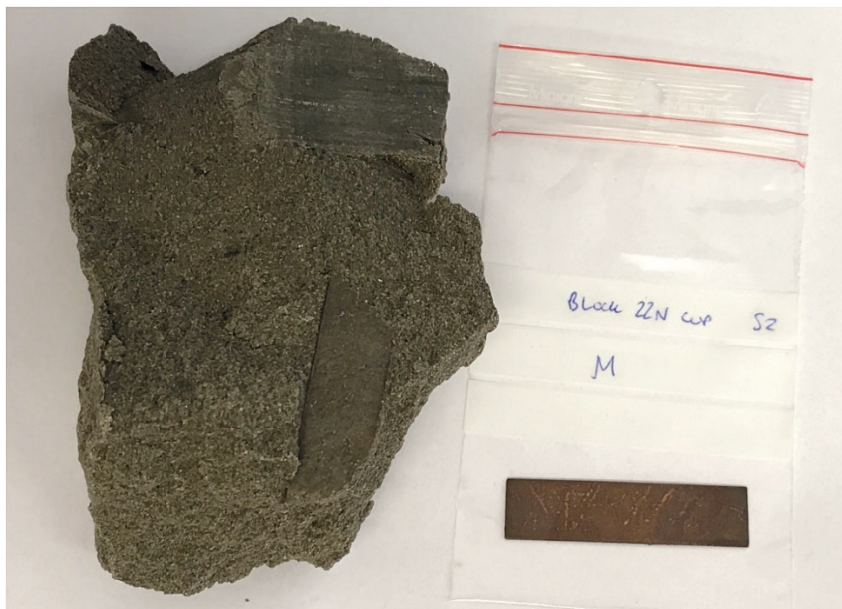
*Figure 3-6. Corrosion coupon S2/M with surrounding bentonite clay.*

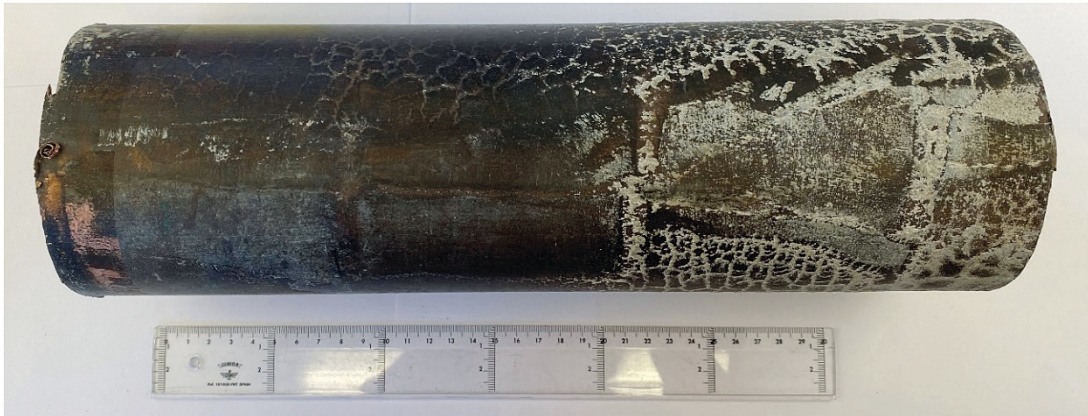
Two pipe samples from blocks 21–23 of test parcels A3 and S2 were also delivered to RISE KIMAB in sealed aluminium bags and were photographed in as-received condition prior to analyses. The pipes were partially covered with a thin layer of bentonite clay, and it could be seen that the surfaces varied in appearance with some areas apparently having a thicker or more dense oxide layer than others (Figures 3-7, 3-8 and Appendix A).

*Figure 3-7. Pipe sample A3 in as-received condition.*

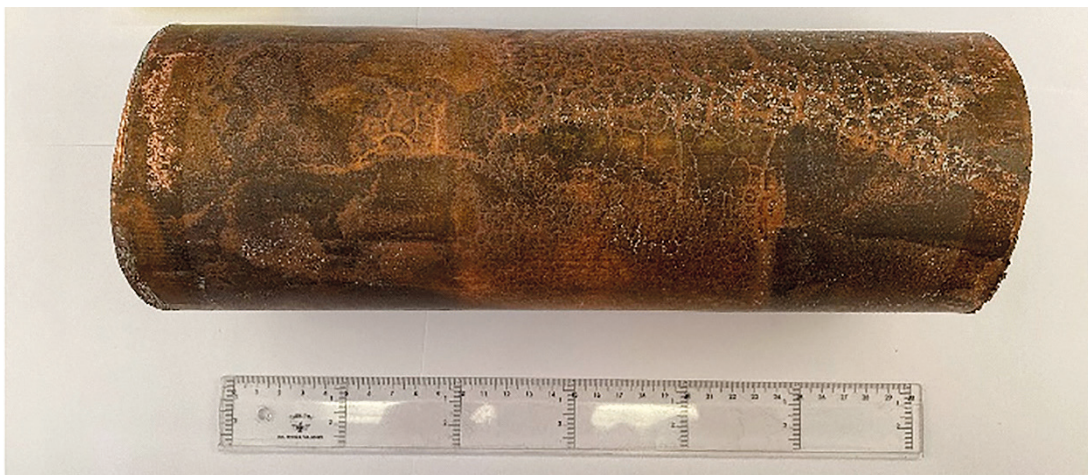
*Figure 3-8. Pipe sample S2 in as-received condition.*

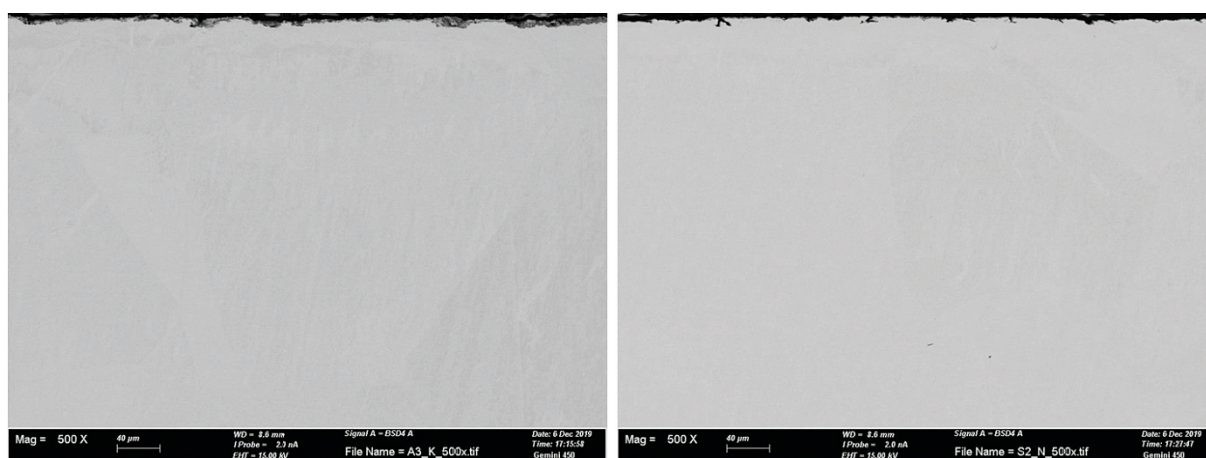
**Figure 3-11.** SEM image of cross-section of coupons A3/K (left) and S2/N (right), magnification  $\times 500$ .

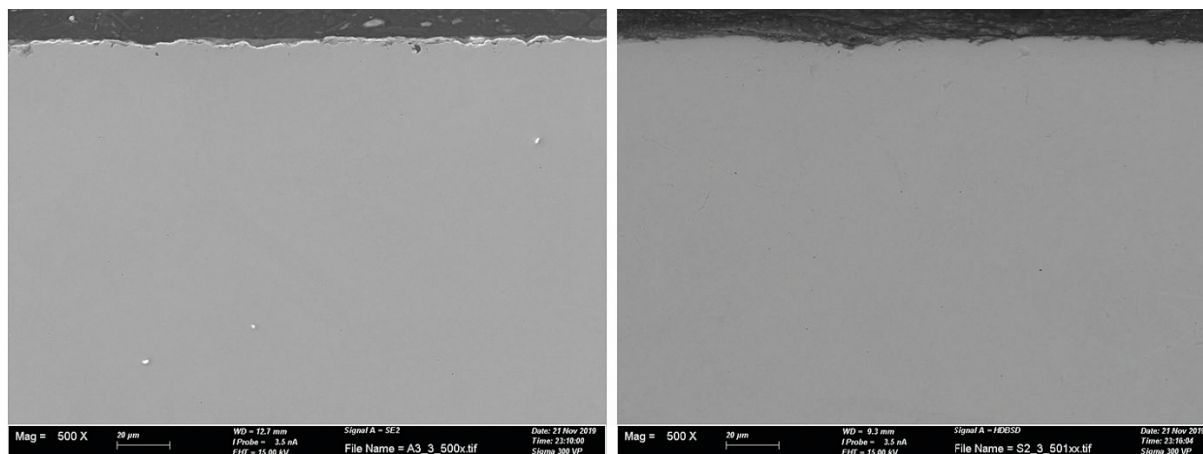
Cross-sectioned samples of the copper pipe surfaces appeared generally rough with frequently occurring pits or defects densely distributed over the observed interfaces, see Figures 3-17 to 3-20. The pits were generally wide and shallow, and the deepest pit found was ca 25  $\mu\text{m}$  (Appendix F). The surface deposits on the pipe samples contained high levels of O, likely from both the corrosion product  $\text{Cu}_2\text{O}$  and from bentonite clay, as indicated by a generally high content of Si. The content of S was generally low (from < 1 at% up to a few at%), but a few observations of enhanced S levels were made. On the pipe sample from S2, an enhanced level of S (12 at%) was found on the surface, however, the same spot also had an enhanced level of Ca (11 at%), indicating that the deposit was  $\text{CaSO}_4$  from the bentonite clay (Figure G-52). EDS data from spots nearby showed lower levels of both S and Ca, which however also seemed to match with  $\text{CaSO}_4$ . Another observation of enhanced S was made inside a shallow pit found on the sample from S2 (Figure 3-20). Here, the level of S was 16 to 26 at% and the levels of O and Si were both lower than what was generally found. Since there was no correlation of S with either Ca ( $\text{CaSO}_4$ ) or Fe ( $\text{FeS}_2$ ), this observation suggests the formation of a Cu-S phase. Many of the cross-sections were very low in S (< 3 at%) and only occasionally high levels (> 10 at%) were detected. Due to the low levels of S, the presence of bentonite, and significant levels of Ca (precipitation of  $\text{CaSO}_4$ ) it was difficult to analyse the distribution of Cu-S phases in the corrosion products. Full details of the EDS analyses are included in Appendix G, and images of the cross-sections are reported in Appendix F.

**Figure 3-17.** SEM images of cross-sections of samples from pipes A3 (left) and S2 (right). Magnification  $\times 500$ .

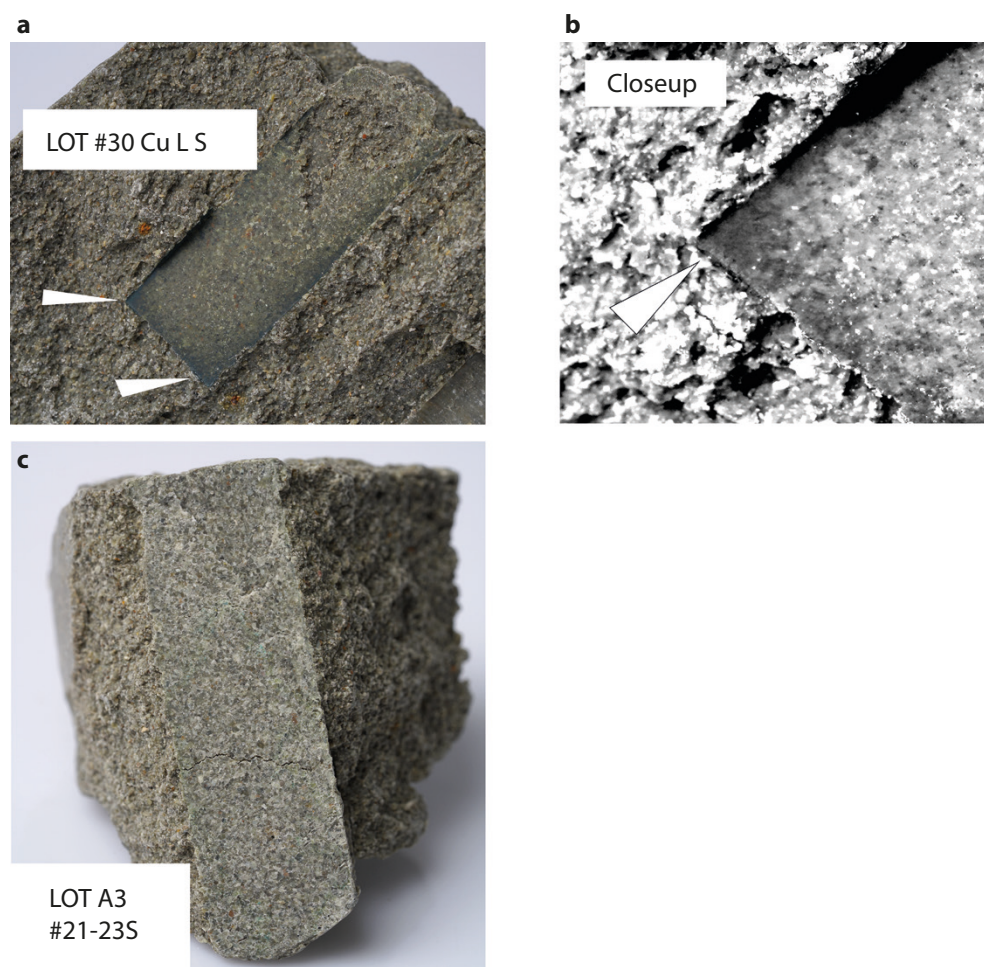
Some of the bentonite surfaces that had been in contact with the copper coupons had visible unevenly distributed corrosion products, primarily located in the corners, while others had no visible corrosion products (Figure 3-24).

**Figure 3-24.** (a) Example of bentonite with visible unevenly distributed corrosion products, primarily located in the corners. (b) Closeup of (a). (c) Example of bentonite with no visible corrosion products.

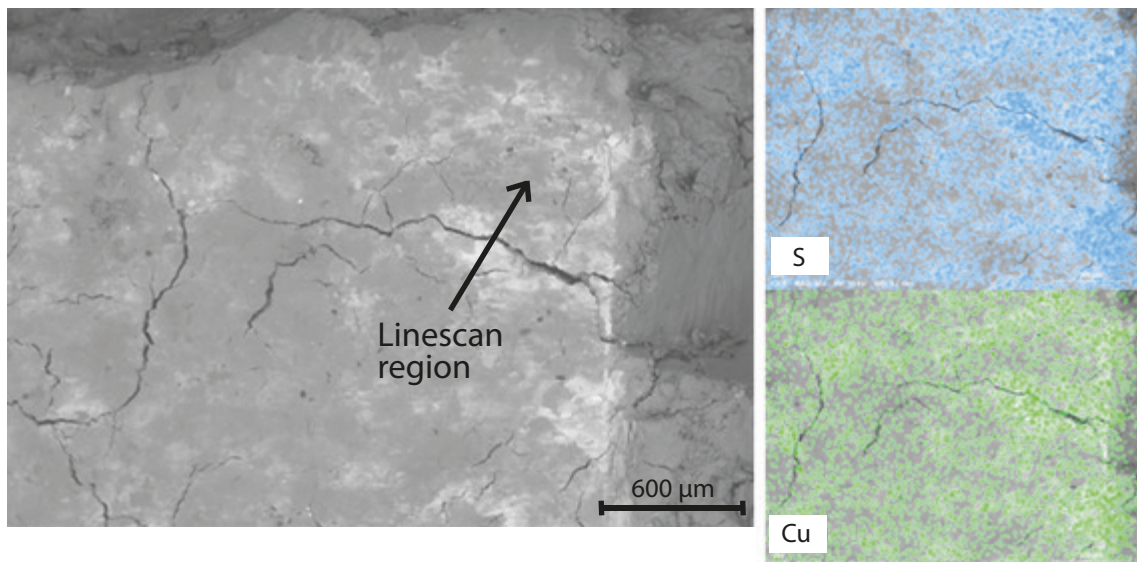
The investigated sample that had been in contact with coupon L from the A3 parcel, is shown in Figure 3-26 (denoted “#30 Cu L S”). One corner visually rich in dark corrosion products in the bentonite was selected. The edge that looked dark visually in the sample looked very bright in backscatter mode in the SEM, indicating the presence of heavy atoms (Figure 3-27).

**Figure 3-27.** Sample of bentonite (“30 Cu L S”) from contact with a corner of coupon L from LOT A3. Left: BSE micrograph showing bright high scattering regions with elements of relatively higher atomic number. Upper right: EDS-map showing sulfur (S). Lower right: EDS-map showing copper (Cu).

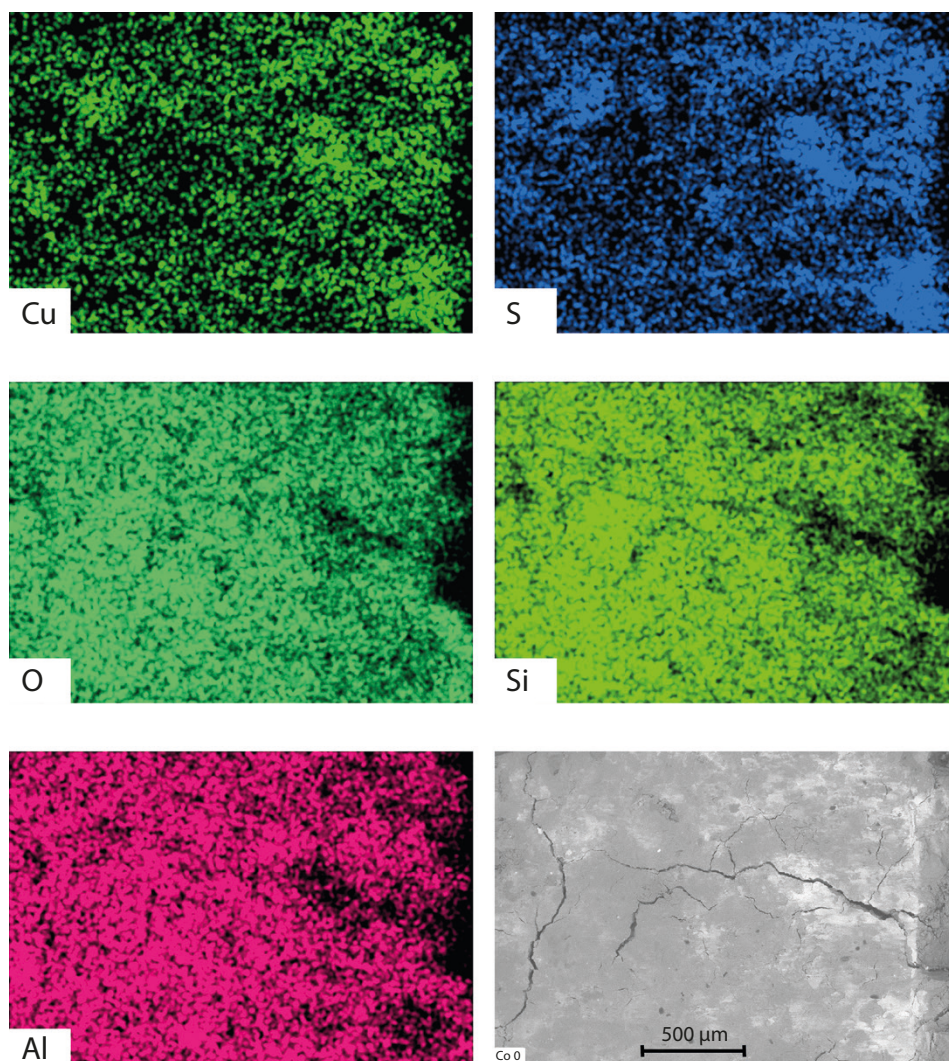
**Figure 3-28.** Sample of bentonite (“30 Cu L S”) from contact with a corner of coupon L from LOT A3. EDS-maps showing: Cu, S, O, Si, and Al.

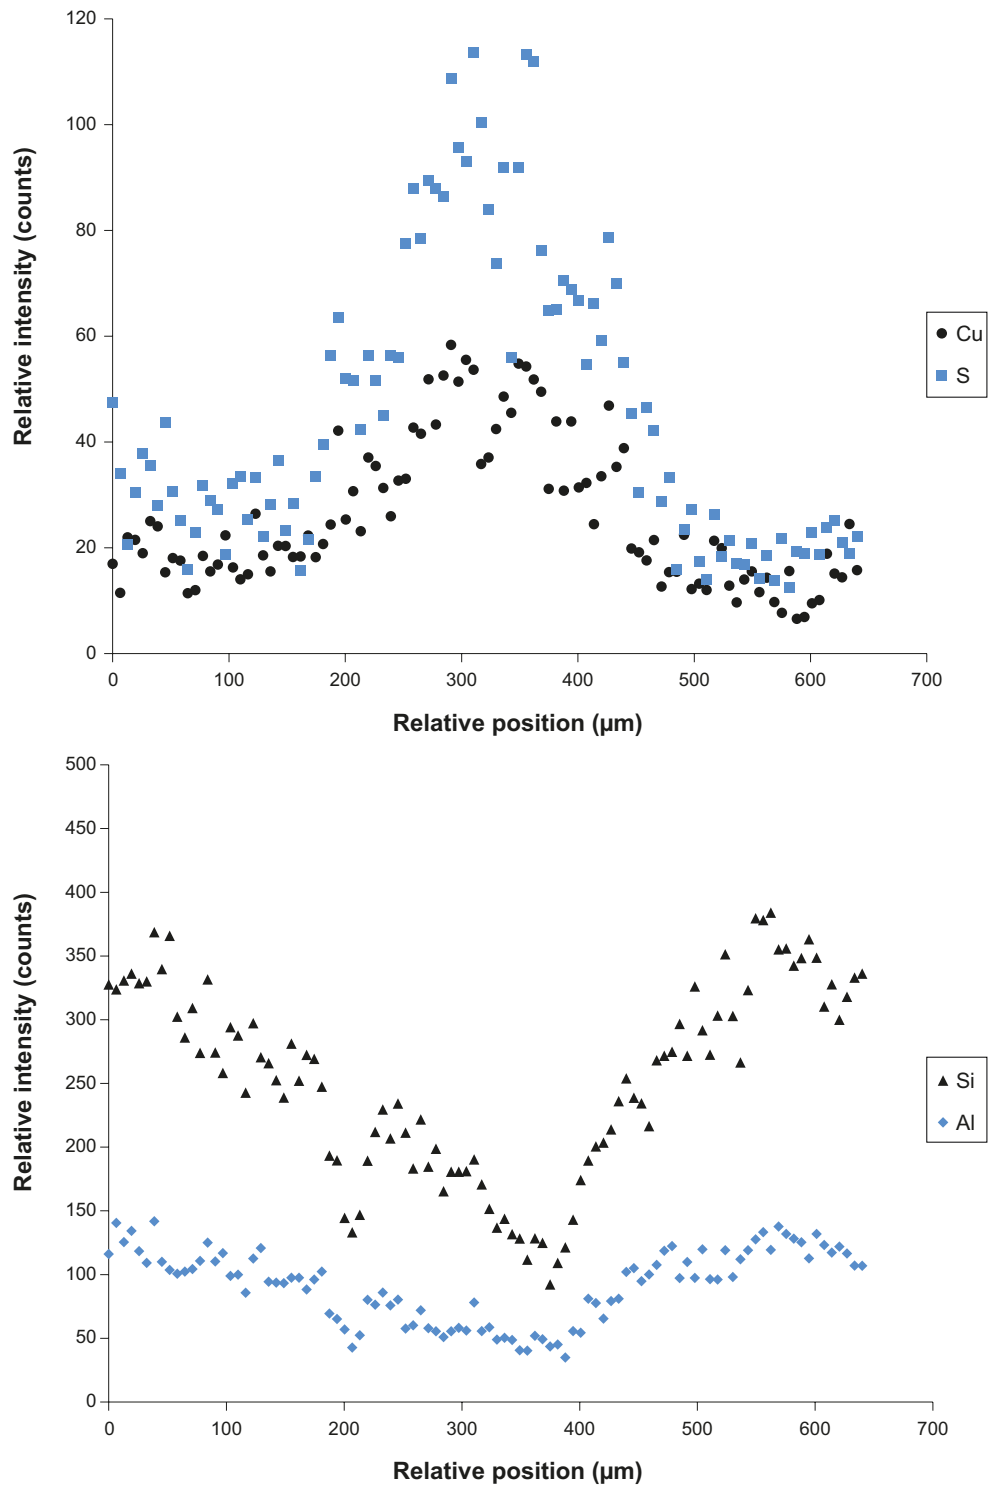
Linescan EDS over the “corrosion product”, showed the relative levels of Cu, S, O, Si and Al (Figure 3-29), and confirmed that both Cu and S had a maximum at the spot of the corrosion product, while the other elements were at a minimum. Hence, corrosion products are present over the entire surface, however enriched in some areas, and most likely the corrosion product is a copper sulfide.

**Figure 3-29.** EDS linescan over the bright section in Figure 3-27, showing relative levels of Cu, S, Si and Al.

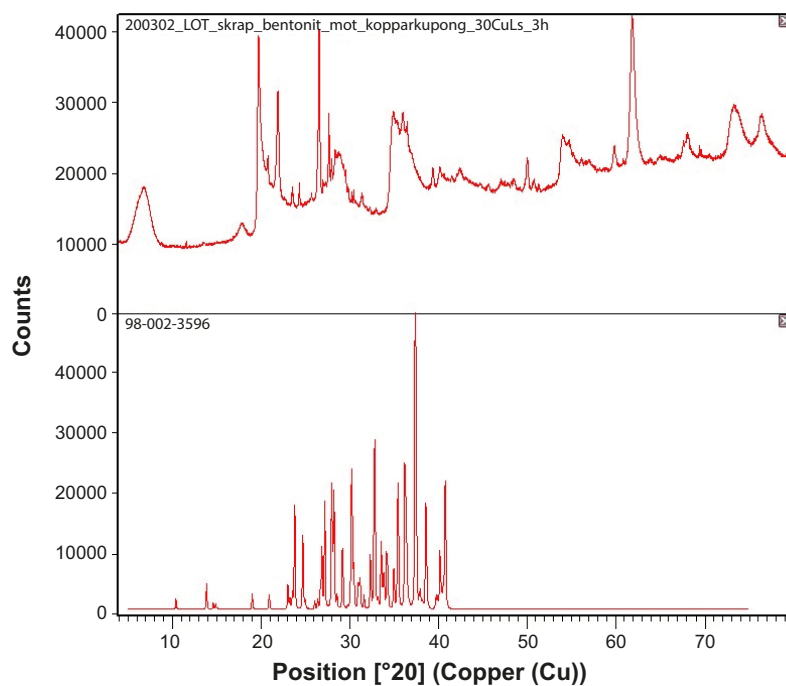
Chalcocite ( $\text{Cu}_2\text{S}$ ) was not found in the sample (Figures 3-30 and 3-31) and no other CuS-phase could be identified. Hence, the corrosion product is likely amorphous or may have undetectable crystals (nanocrystalline) with no long-range order.

**Figure 3-30.** X-ray diffractogram of a bentonite sample with visible corrosion product (30 Cu L S; top) compared to a calculated pattern of chalcocite (bottom). No chalcocite was visible in the sample.

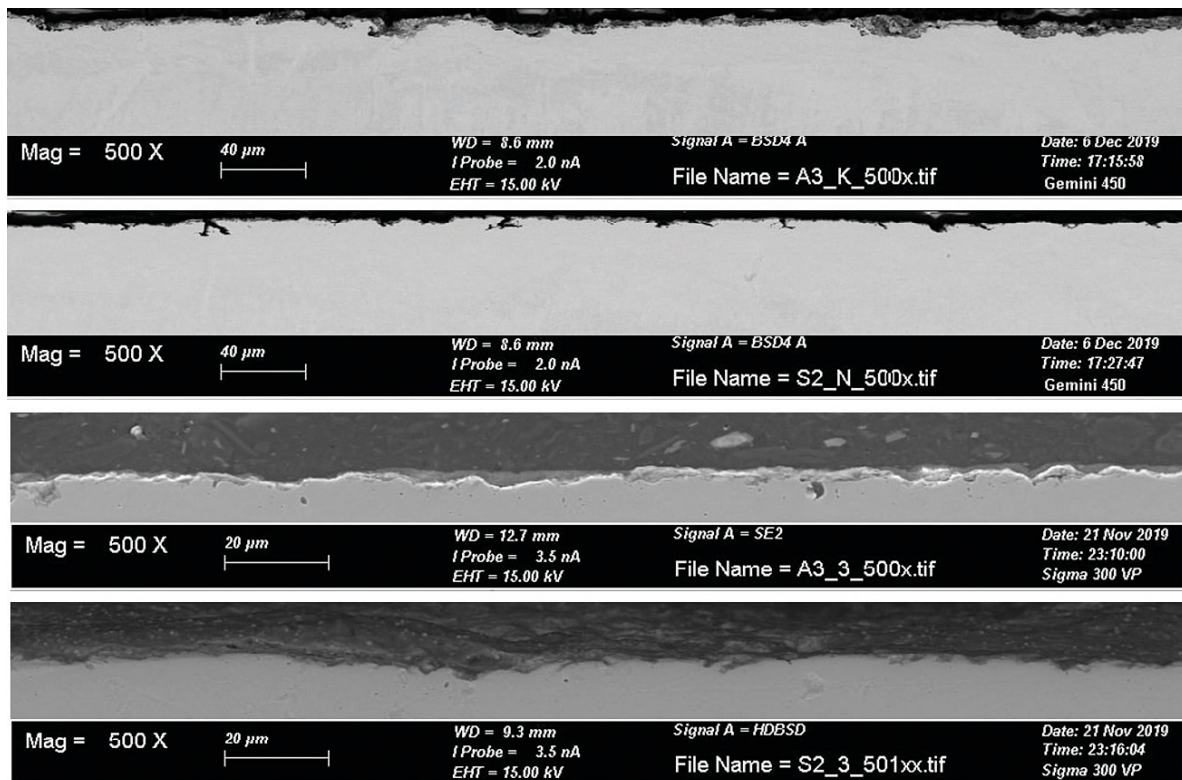
**Figure 4-2.** Micrographs of cross-sectioned samples of coupon A3/K (top), coupon S2/N (second from top), pipe from A3 (third from top), and pipe from S2 (bottom).

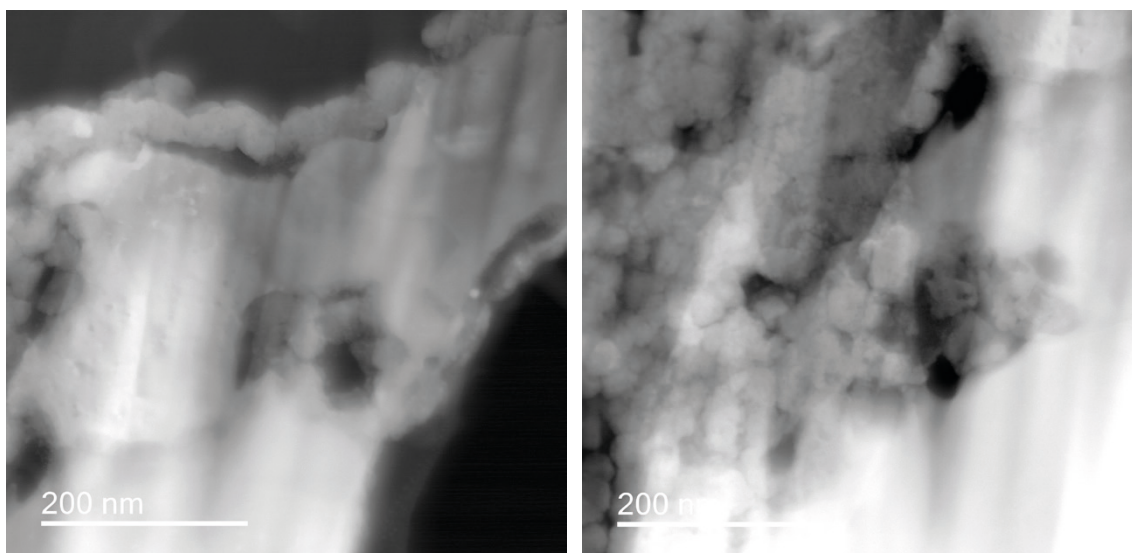
**Figure C-59.** STEM images of more regions where particles appear to have penetrated the Cu and attached to the Cu (oxide) surface.

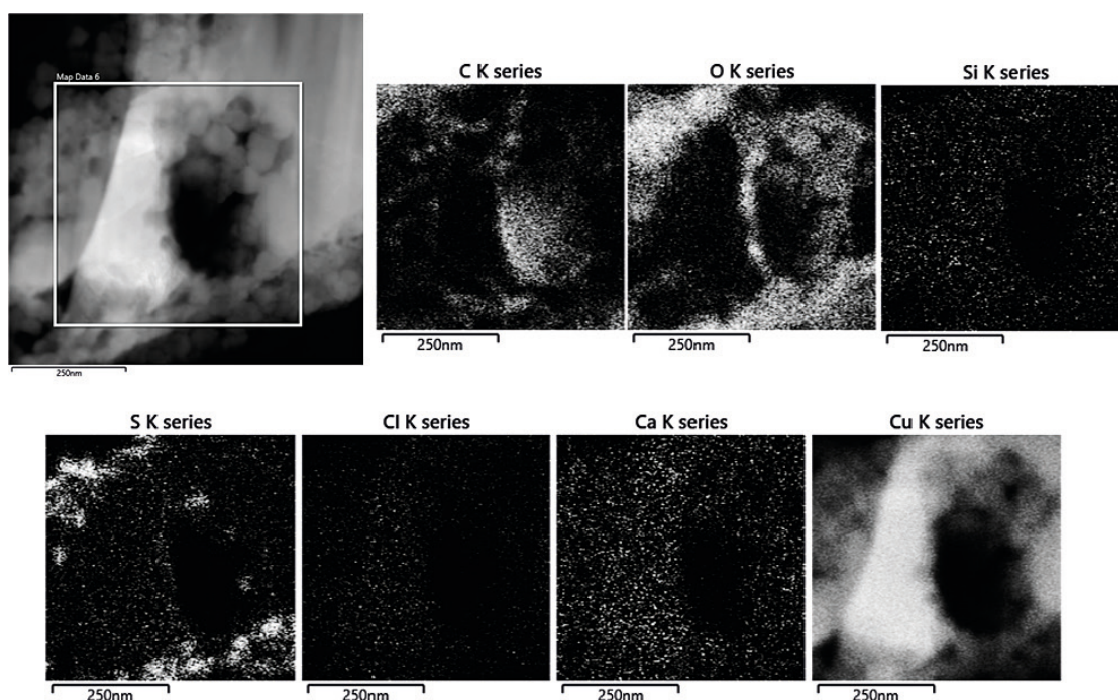
**Figure C-60.** EDS maps of what appear to be a hole through the Cu. Note that this is a planar cut so the top surface is inward or outward in the images.

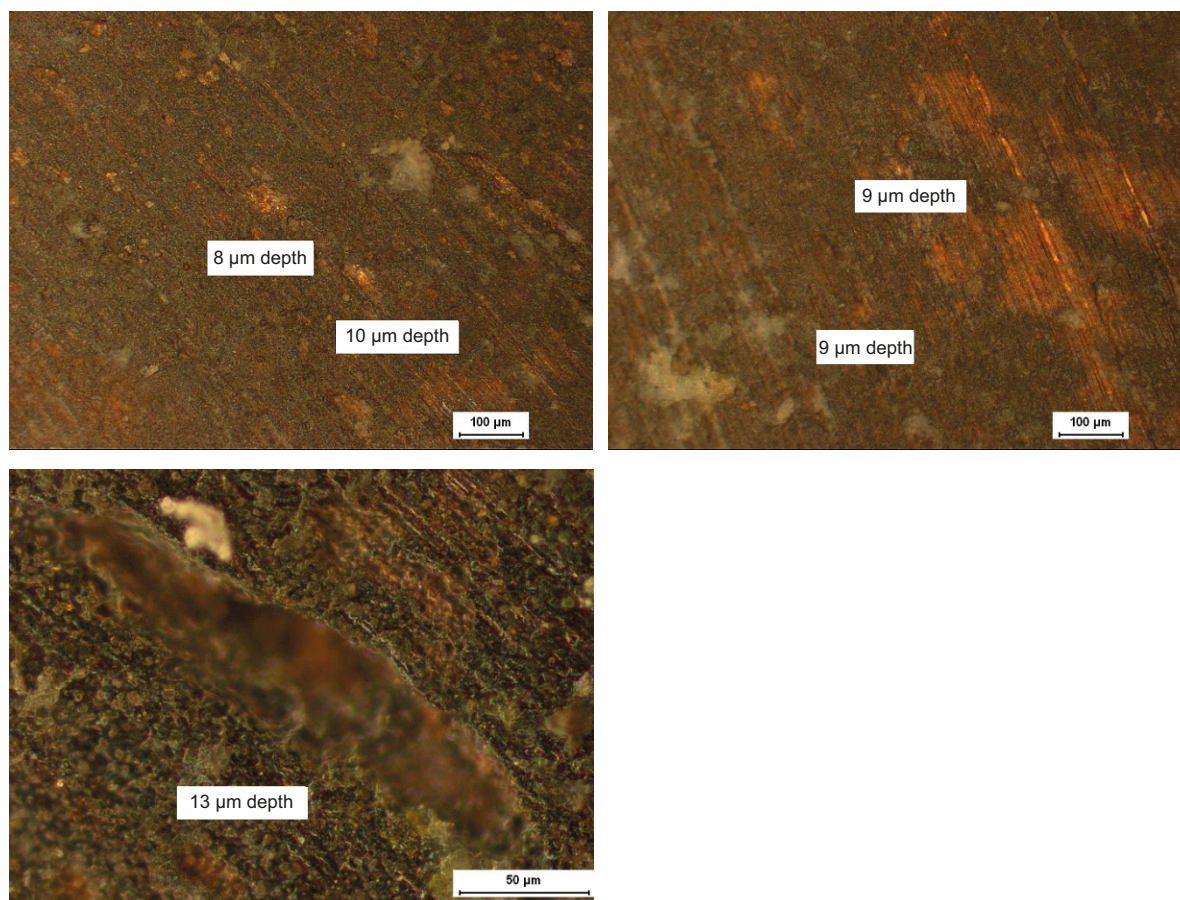
*Figure E-1. Microscope images of the deepest defects found on coupon A3/I before pickling.*

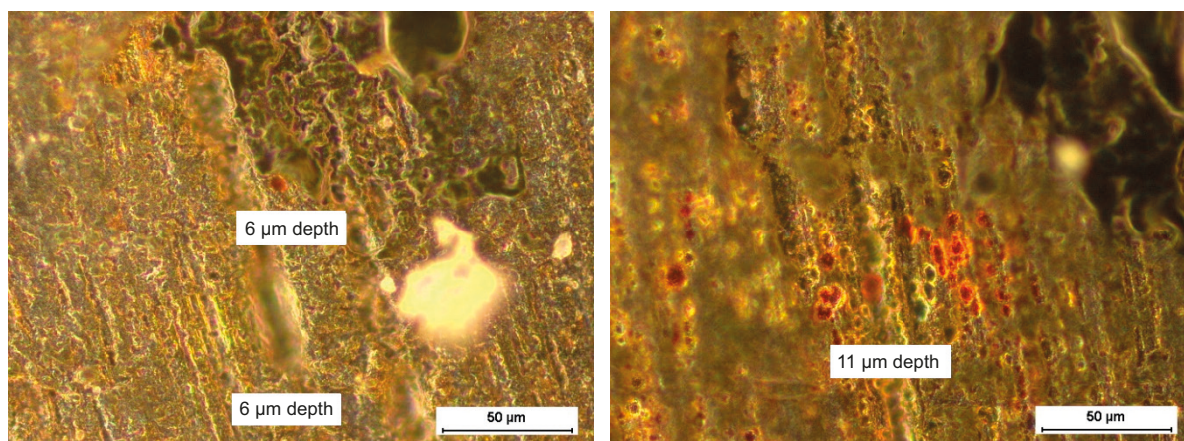
*Figure E-3. Microscope images of the deepest defects found on coupon A3/K before pickling.*

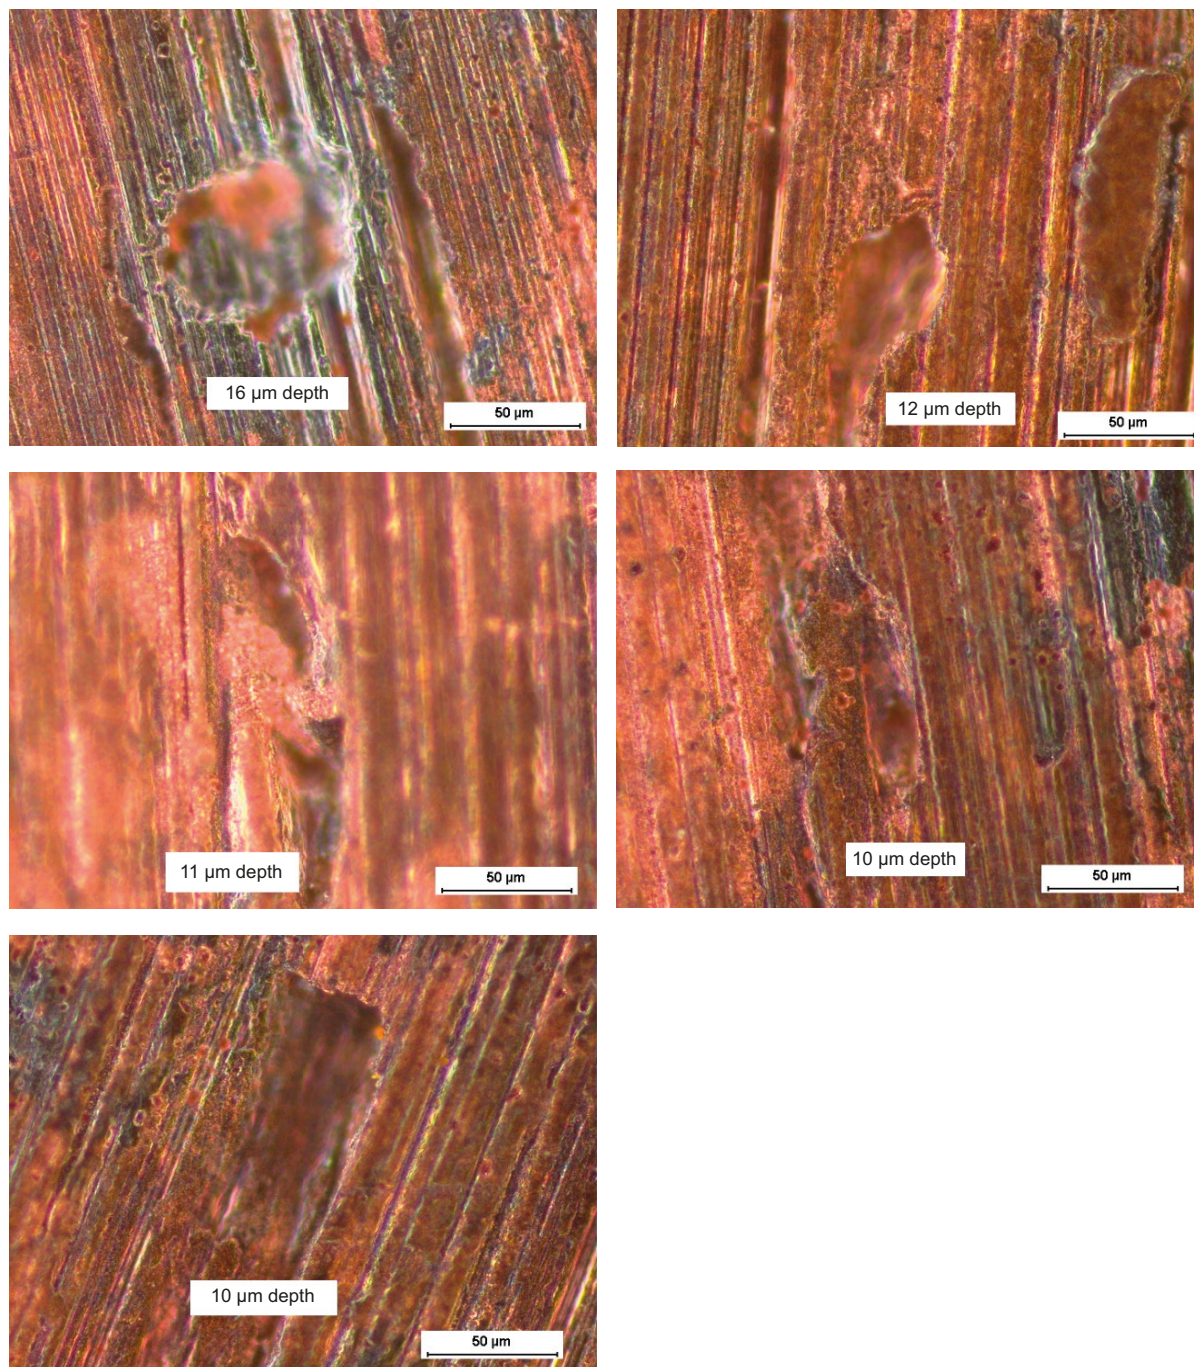
**Figure E-11.** Microscope images of the deepest defects found on coupon A3/I after pickling.

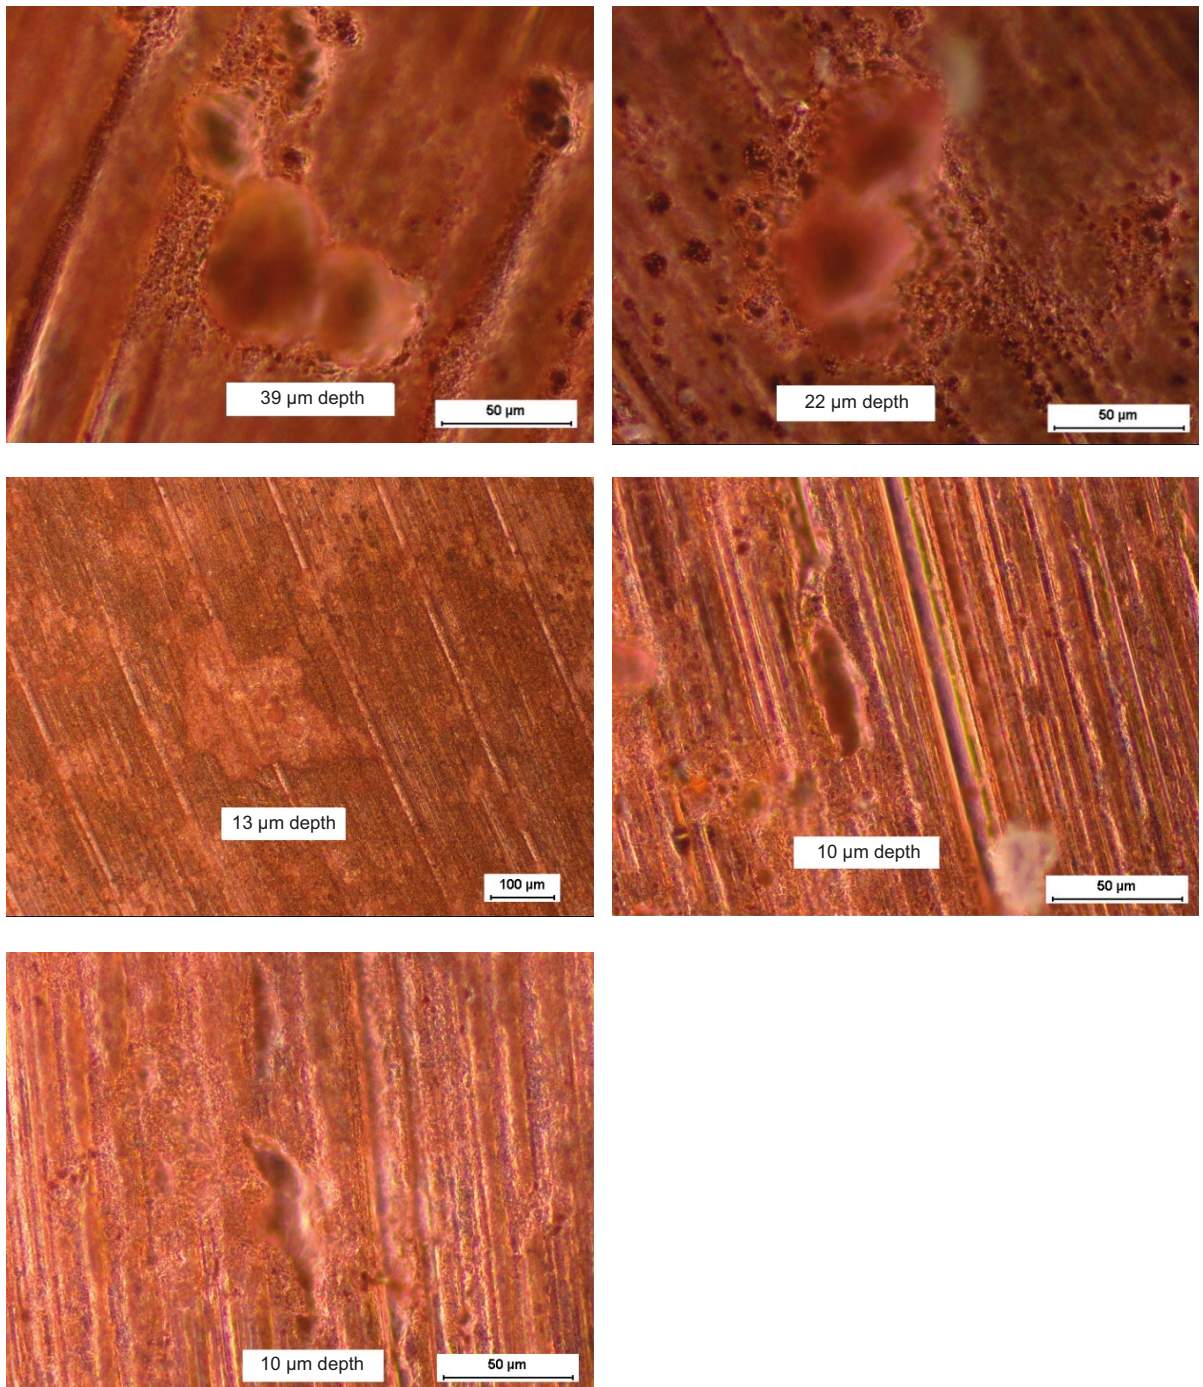
**Figure E-12.** Microscope images of the deepest defects found on coupon A3/J after pickling.

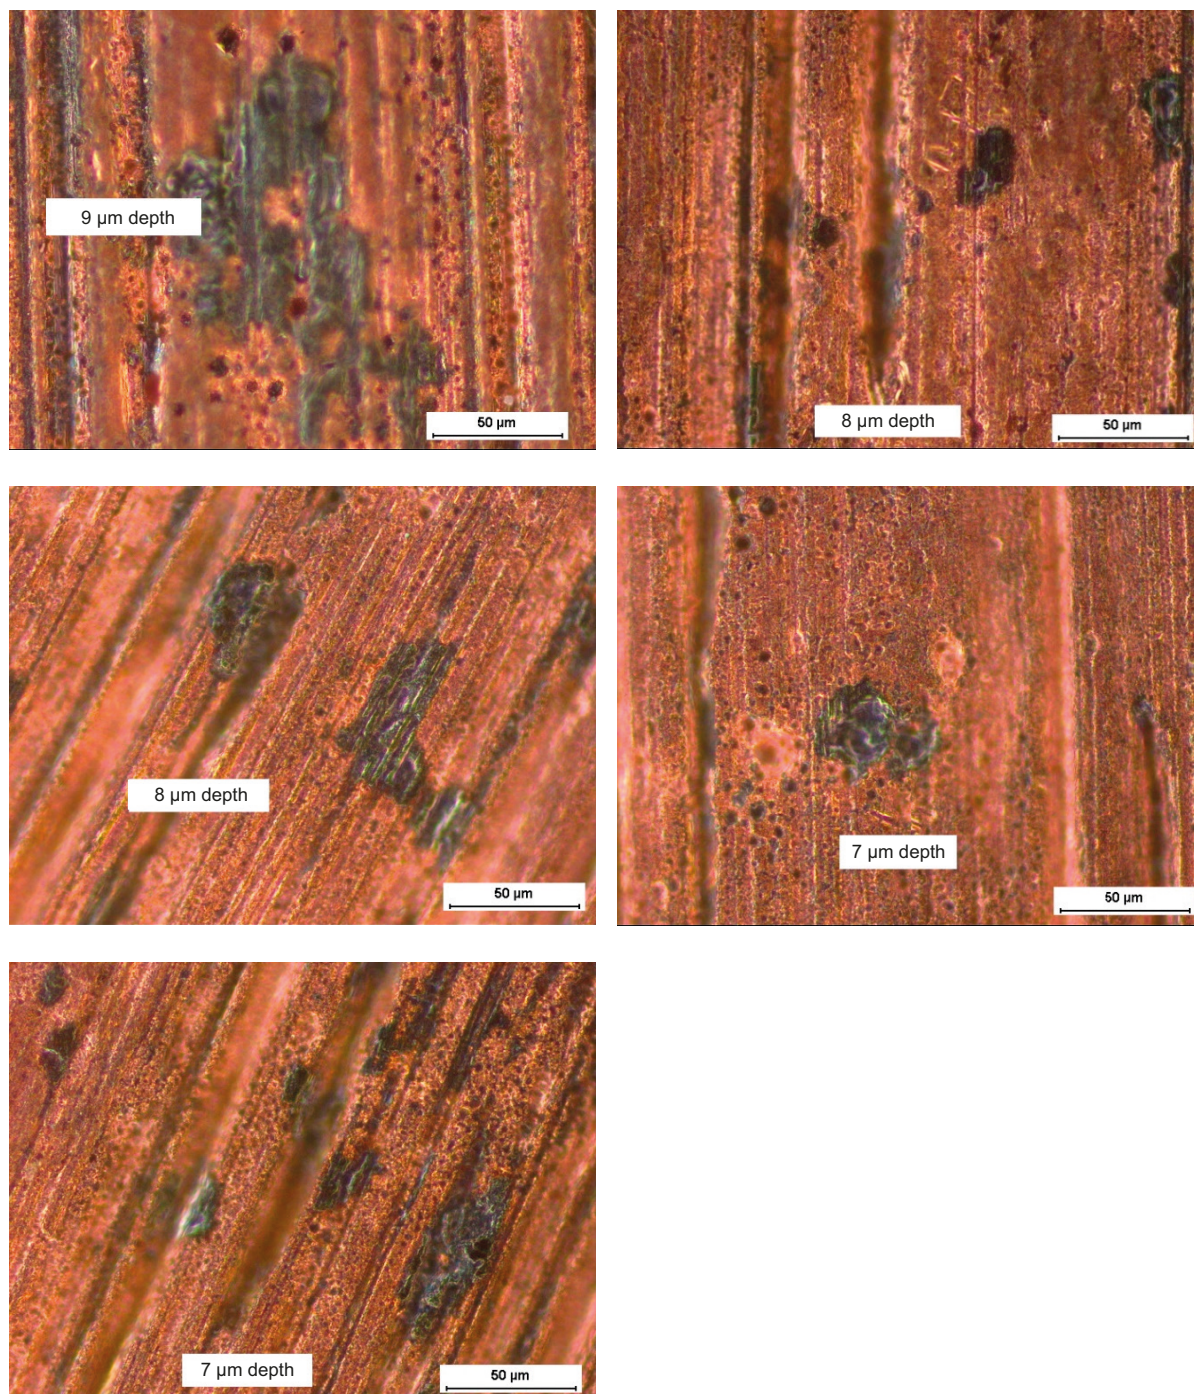
**Figure E-13.** Microscope images of the deepest defects found on coupon A3/L after pickling.

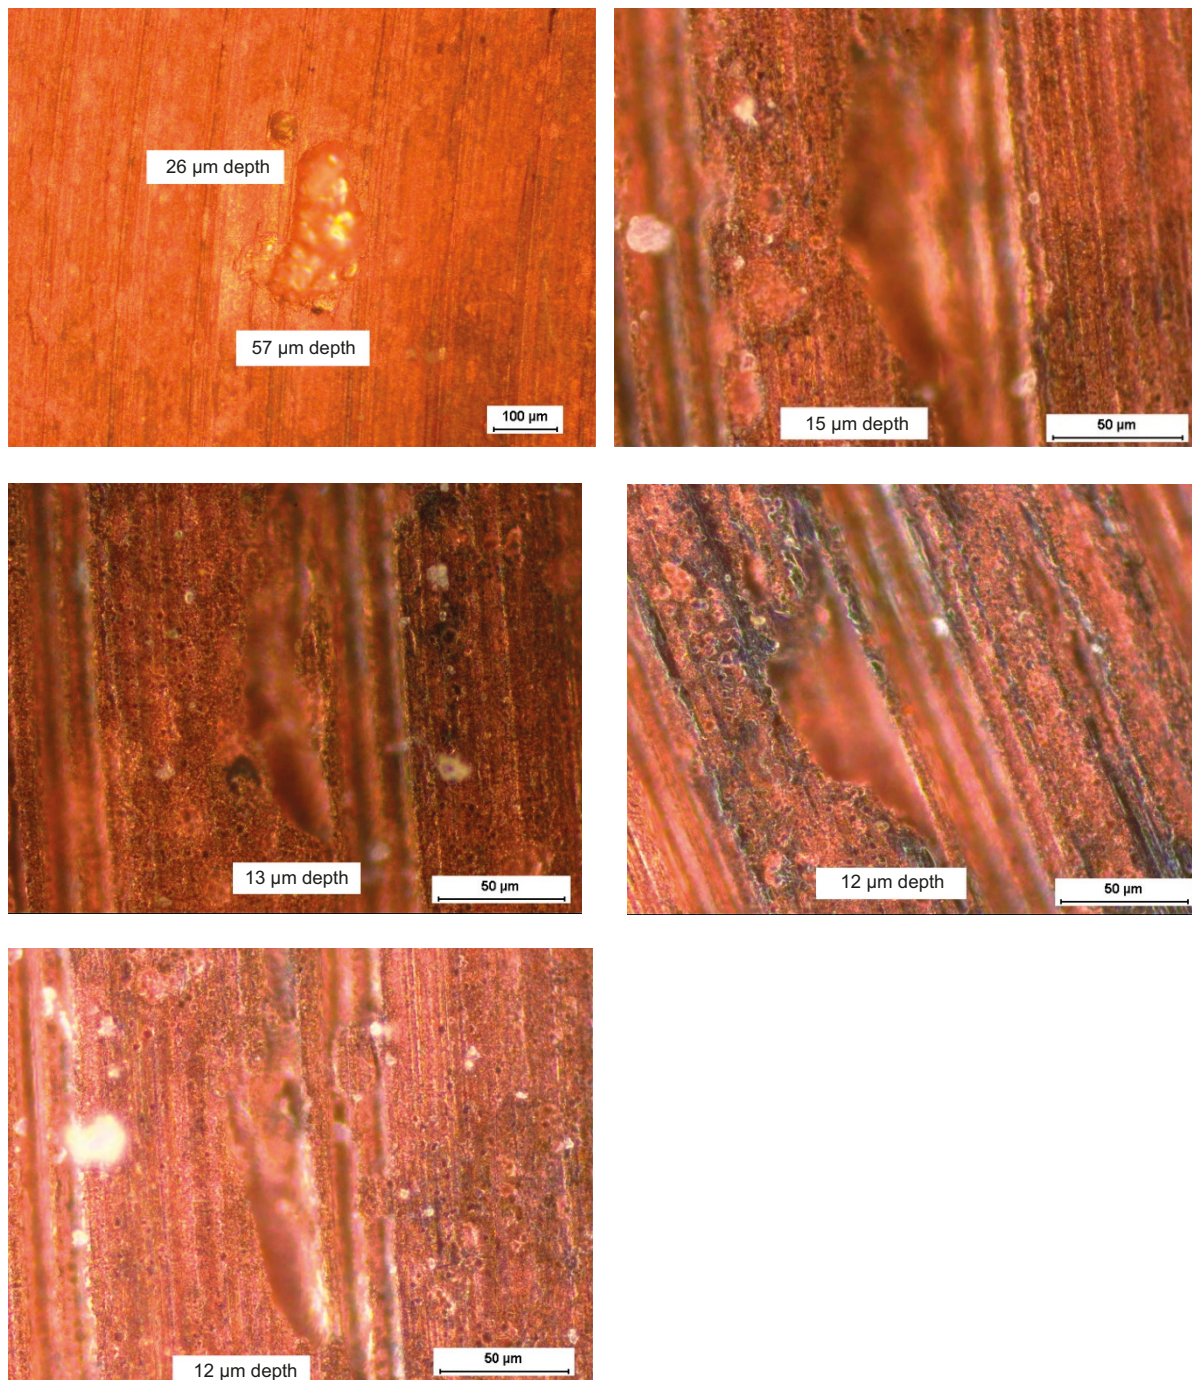
**Figure E-14.** Microscope images of the deepest defects found on coupon S2/M after pickling.

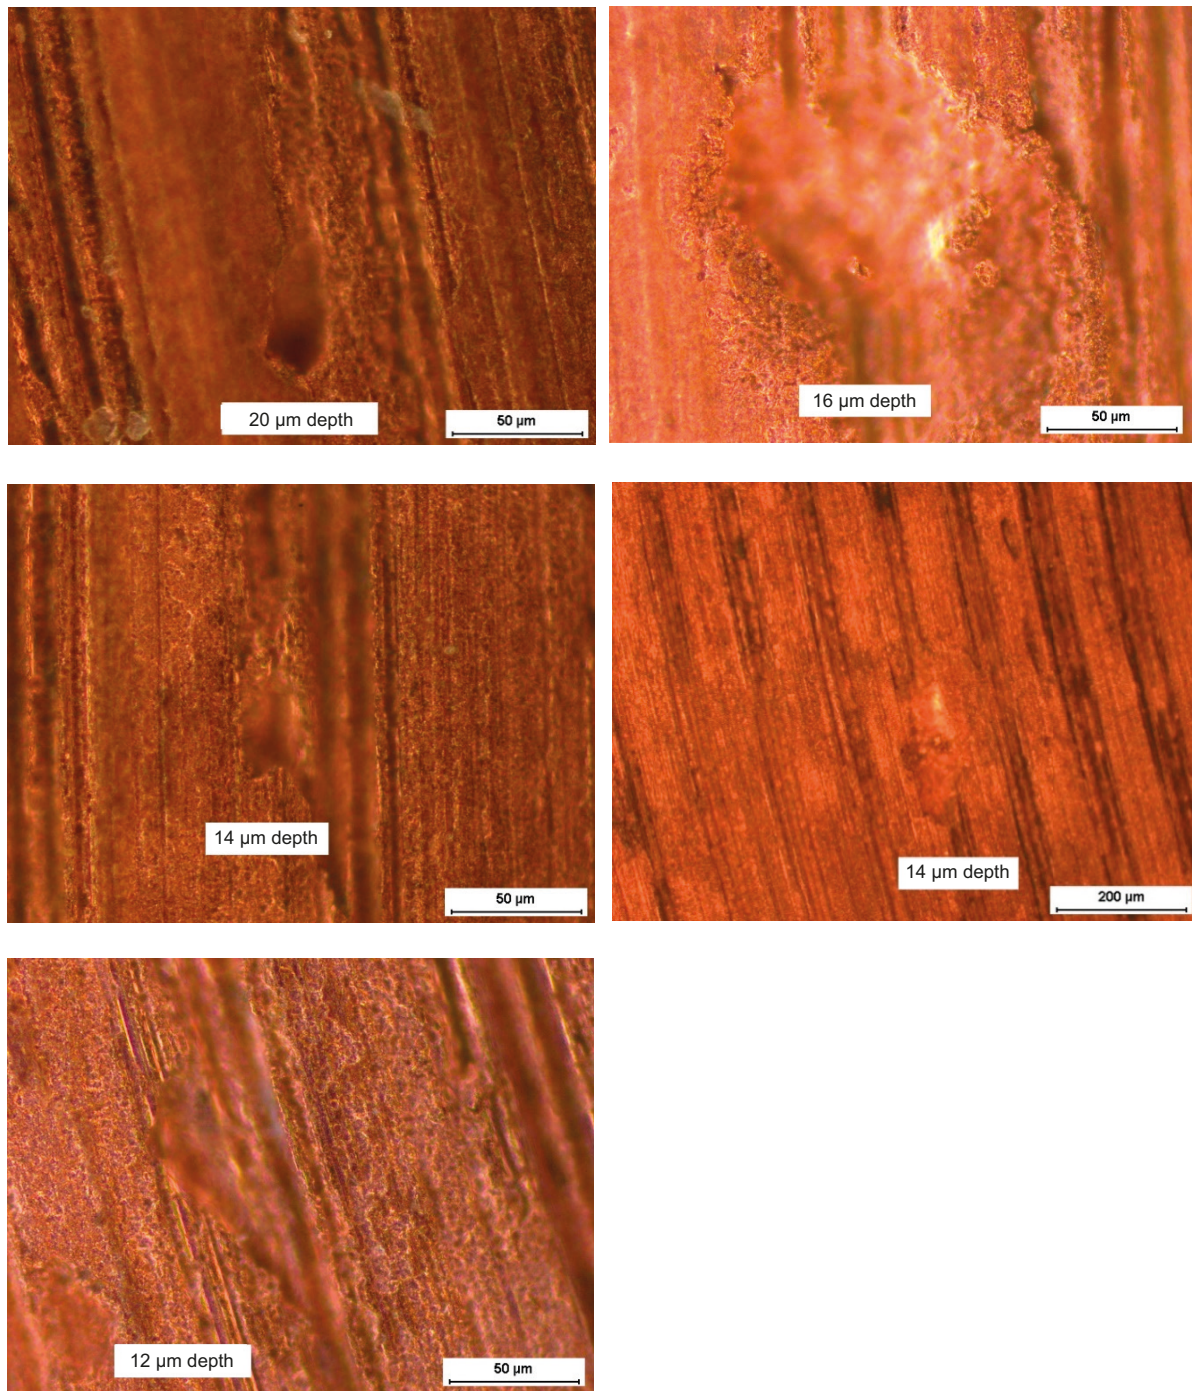
**Figure E-15.** Microscope images of the deepest defects found on coupon S2/O after pickling.

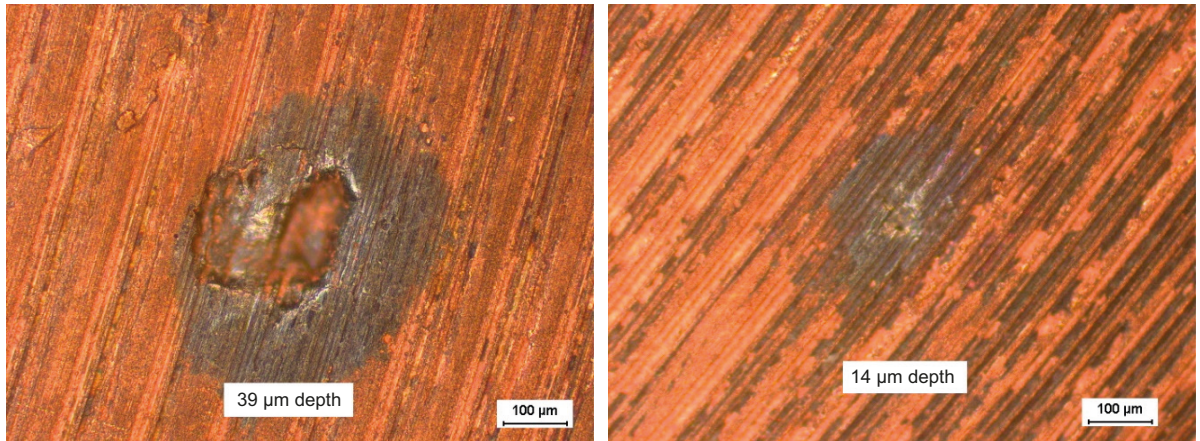
**Figure E-16.** Microscope images of the deepest defects found on coupon S2/P after pickling.
