TR-23-19

Creep of Cu-OFP in presence of sulphides

Tiina Ikäläinen, Timo Saario, Zaiqing Que

VTT

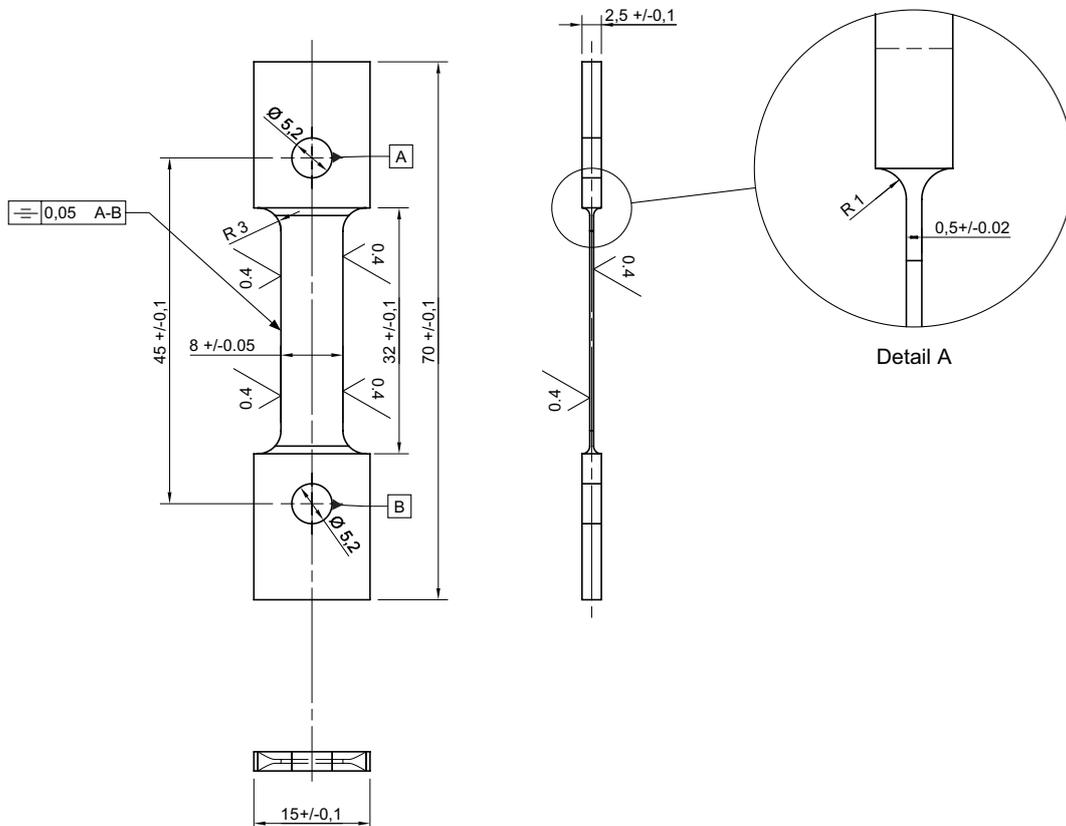
The Cu-OFP specimens had dimensions of 0.5 mm (thickness), 8 mm (width) and 29 mm (length of the deforming part of the body). The specimen design is shown in Figure 4-1. The specimens were manufactured using electric discharge machining (EDM). Possible increase in hydrogen concentration of the Cu-OFP due to the EDM would have plenty of time to diffuse out, since the specimens were used only after several weeks or even months from manufacturing. Before testing, the deforming part of the specimen body was polished (#220, #500 and #1200 SiC-papers successively) to remove the EDM-affected surface layer. Thus, the actual specimen thickness was about 0.4 mm.

Figure 4-1. Specimen design.

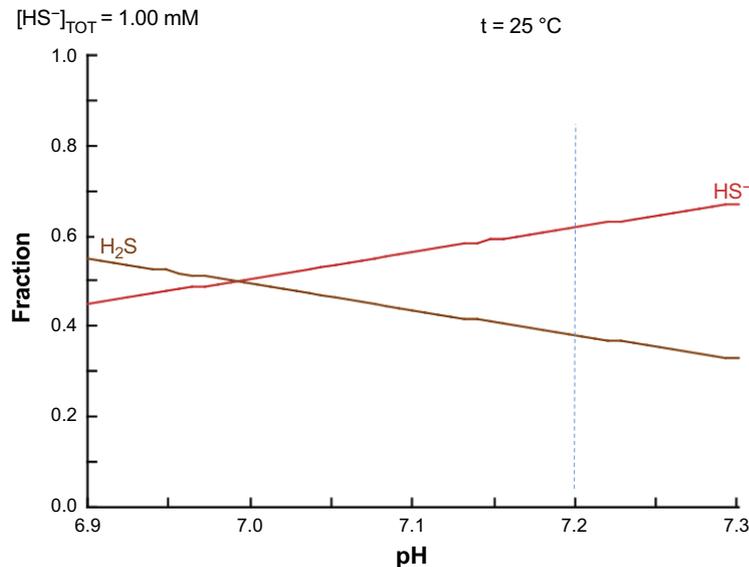
Figure 4-2. Equilibrium speciation of H₂S/HS⁻ as a function of pH. The dotted blue line depicts the pH in the current experiment (Lilja 2021).

The glass stock vessel was pressurized to 0.5 bar overpressure with 5N N₂ to keep oxygen out and to balance the pressure drop caused by the outgoing flow. At the pH used in this experiment, about 45 % of the sulphide is in the form of gaseous H₂S, Figure 4-2. Since no continuous bubbling through was used (only pressurization) gaseous H₂S was not able to escape from the stock solution and the sulphide in the stock solution tended to stay constant.

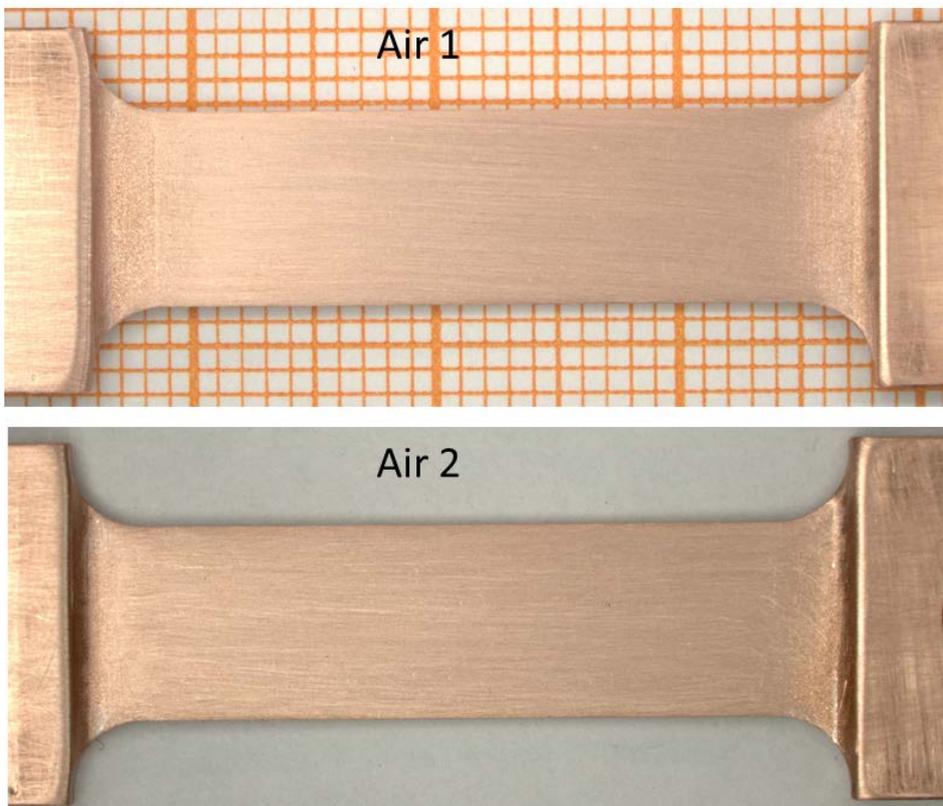
Figure 5-1. Air test specimens after polishing (before testing).

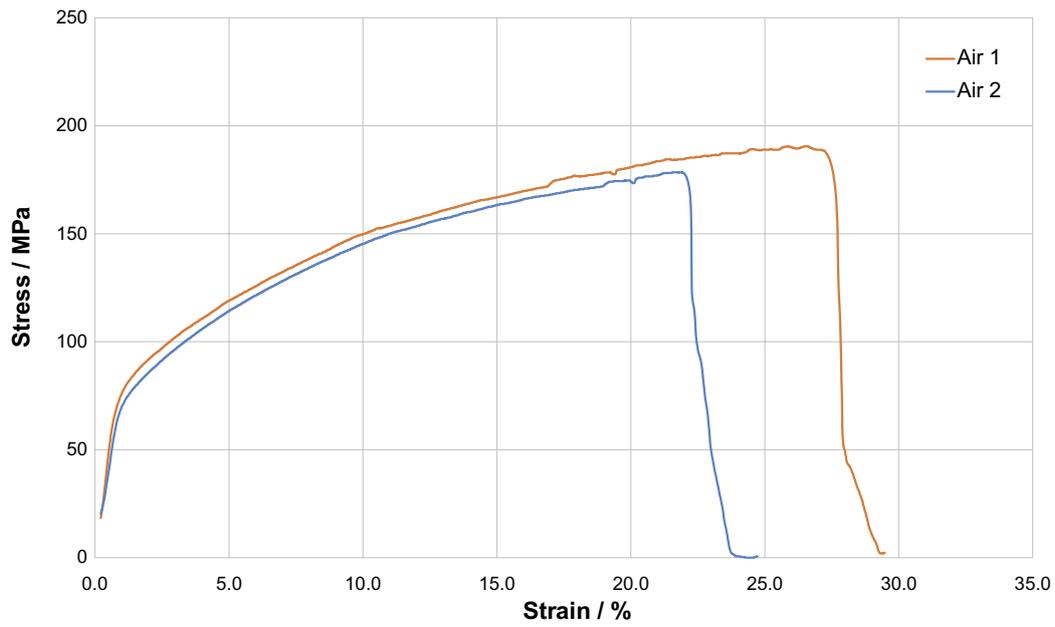
Two specimens were first tested in air to find out the stress-strain behaviour of the material. The strain rate used was $\dot{\epsilon} = 3 \times 10^{-5} \text{ s}^{-1}$. The specimens were photographed before testing, see Figure 5-1. The stress-strain curves are shown in Figure 5-2. The yield stress was about 65 MPa, clearly higher than that reported in Table 3-1 for the material. This is most likely due to the cold deformation produced by the polishing operation. For such a thin specimen, the deformed layer may form a large part of the thickness. The fracture strain was markedly lower, 27 % for specimen Air 1 and 22 % for specimen Air 2, than that reported for the material (42 %, see Table 3-1). Both specimens showed many micro-crack like features after the test, Figure 5-3 and Figure 5-4. Although not a planned part of this study, the surface of the specimen Air 2 was studied with SEM. As evidenced by Figure 5-5, the features are indeed micro-cracks, the length of which is in the range of a few tens of μm .

Figure 5-2. Stress-strain curves of Cu-OFP in air.

The main purpose in the air tests was to measure the stress-strain curve of Cu-OFP for the specimen design used in this study, to establish a solid ground for selecting the stress level for the further tests in sulphide containing water. Since the results show that the fracture strain for this specimen design is markedly lower than what was expected based on the material data shown in Table 3-1, and to maintain direct comparability with earlier results in sulphide containing water, it was decided to perform the sulphide tests at the same stress level as before, i.e. 135 MPa. Since the gauge thickness of the samples is only about 0.45 mm (after removing the EDM affected layer), the cold deformation introduced in polishing reaches through a substantial part of the cross-section. Therefore, the material is in partially cold deformed state after the polishing. Thus, the measured fracture strain falls clearly below the level normal to annealed material.

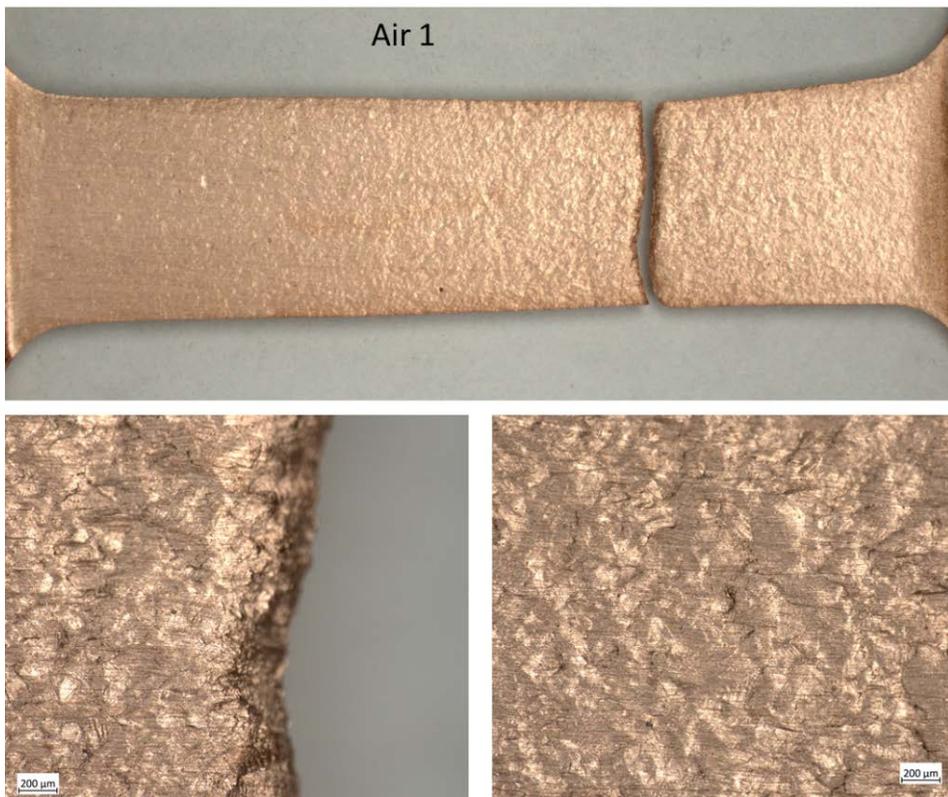
Figure 5-3. Surface appearance of specimen Air 1 after the test.

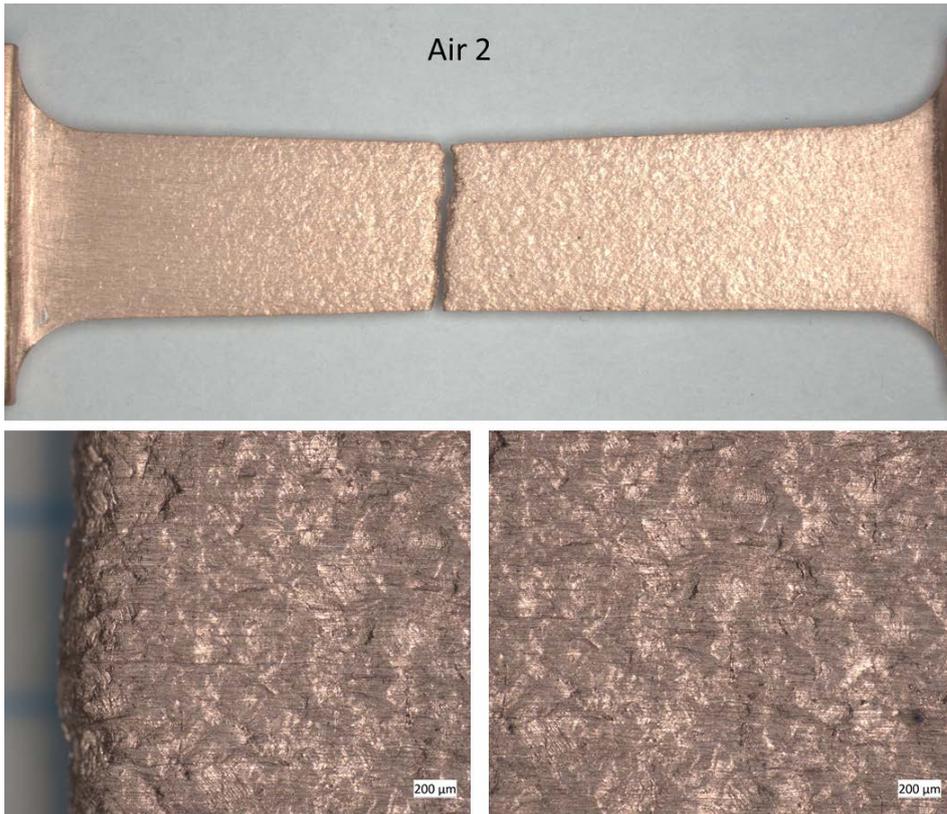
Figure 5-4. Surface appearance of specimen Air 2 after the test.

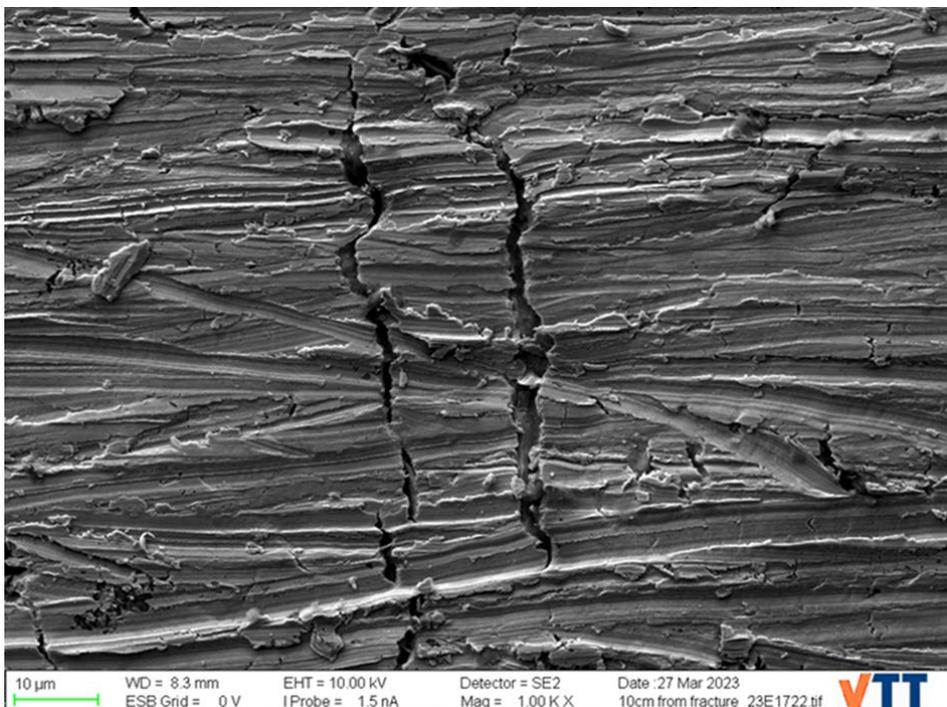
Figure 5-5. SEM-picture of one micro-crack found on the surface of specimen Air 2 (located about 1 cm away from the main fracture surface). Here the loading direction is horizontal.

As an additional finding, micro-cracks were found to open up on the Cu-OFP tensile specimen surface tested to fracture in air. The micro-cracks are due to pre-existing defects/weak grain boundaries within the material.

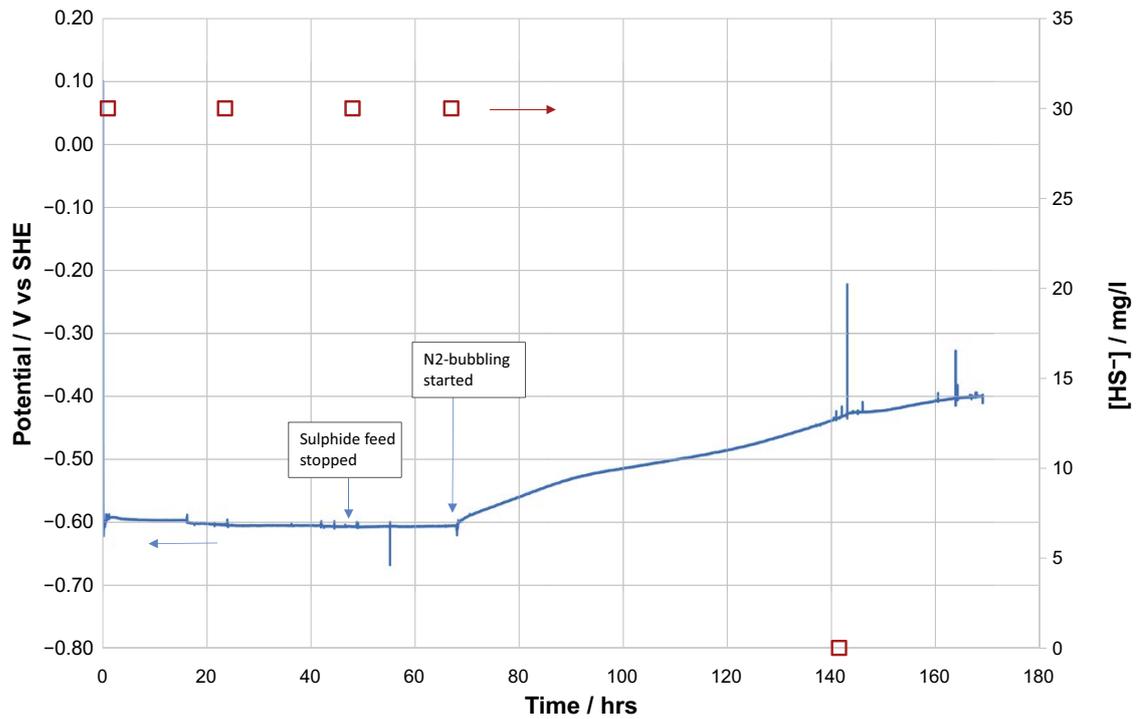
The corrosion potential of the sample is shown as a function of exposure time in Figure 5-6. Also the sulphide measurement results are shown in the figure at appropriate times, and indicate that during the sulphide feed the sulphide concentration stayed at the targeted level. The sulphide feed was stopped at $t = 48$ hrs. At about $t = 67$ hrs, bubbling was started with 5N N_2 -gas to remove the H_2S in the autoclave gas phase and thus expedite the removal of sulphide from the water phase as well. At this point, the corrosion potential started to increase, indicating decreasing of the sulphide concentration in the water. In our experience, the corrosion potential, during transient conditions in the electrolyte, is typically dominated by the existing surface film. For a thick film (like in this case), it may take quite a while to adjust to the changes in the environment. Based on this, we would not expect to see a direct, in-time, dependency of the corrosion potential measured and the HS^- concentration in the electrolyte.

Figure 5-6. The corrosion potential and sulphide concentration as a function of time for sulphide test 1.

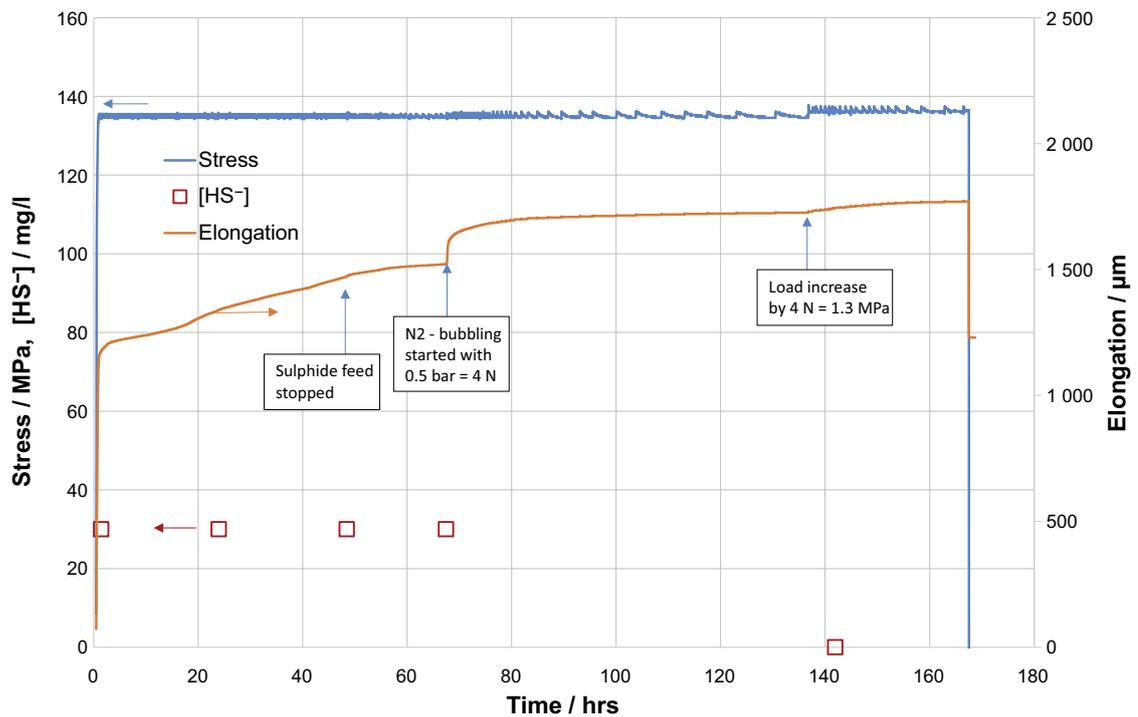
The stress and elongation during the first test are shown in Figure 5-7 as a function of time. Also the sulphide measurement results are shown in the figure at appropriate times. The corrosion potential and strain rate are shown in Figure 5-8 as a function of time. After stopping the sulphide feed at $t = 48$ hrs, no acceleration of elongation rate (creep rate) was observed for the next about 19 hrs. The sulphide concentration measured at this point (at about $t = 67$ hrs) showed that the concentration was still at the same level, i.e. 30 mg/l, as during the sulphide feed. At about $t = 67$ hrs, bubbling was started with 5N N_2 -gas to remove the sulphide in the autoclave water phase. An immediate rapid increase in both the elongation and strain rate was observed, Figure 5-7 and Figure 5-8. During the first 30 minutes the elongation increased by 76.7 μm , corresponding to an additional strain of about 0.26 %.

Figure 5-7. The stress and elongation and sulphide concentration as a function of time for sulphide test 1.

During the sulphide feed, the system was at atmospheric pressure (due to the outlet line being open to the discharge vessel). However, when the N_2 bubbling was initiated, an overpressure of 0.5 bar was applied, resulting in an increase in the loading of about 4 N, causing an increase in the stress level by about 1 MPa (to 136 MPa). In order to find out the effect of the increase of the stress level on the creep behaviour, an increase of the load by 4 N was deliberately made at about $t = 138$ hrs (i.e. after the creep rate had stabilized after the increase due to the start of the N_2 bubbling and accompanied pressure increase). As seen in Figure 5-7 the increase of the load by 4 N resulted in a transient increase in elongation and strain rates, albeit much smaller than in the case of the initiation of the N_2 bubbling. In this case, during the first 30 min, the elongation increased by 0.29 μm , corresponding to an additional strain of about 0.001 %.

This result indicates that the increase of elongation rate (and creep rate), as a consequence of starting the bubbling with 5N N_2 -gas to remove the H_2S in the gas phase (at about $t = 67$ hrs) was caused dominantly by another reason than the increase by 4 N in the pure mechanical loading.

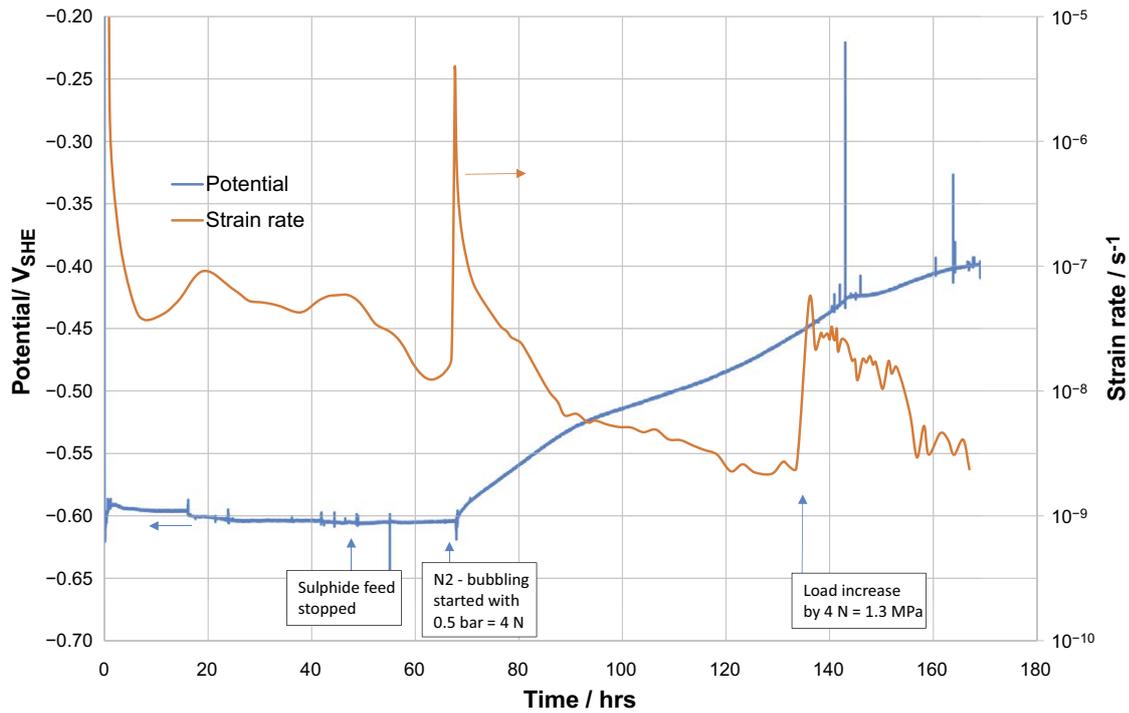
Figure 5-8. The corrosion potential and strain rate as a function of time for sulphide test 1.

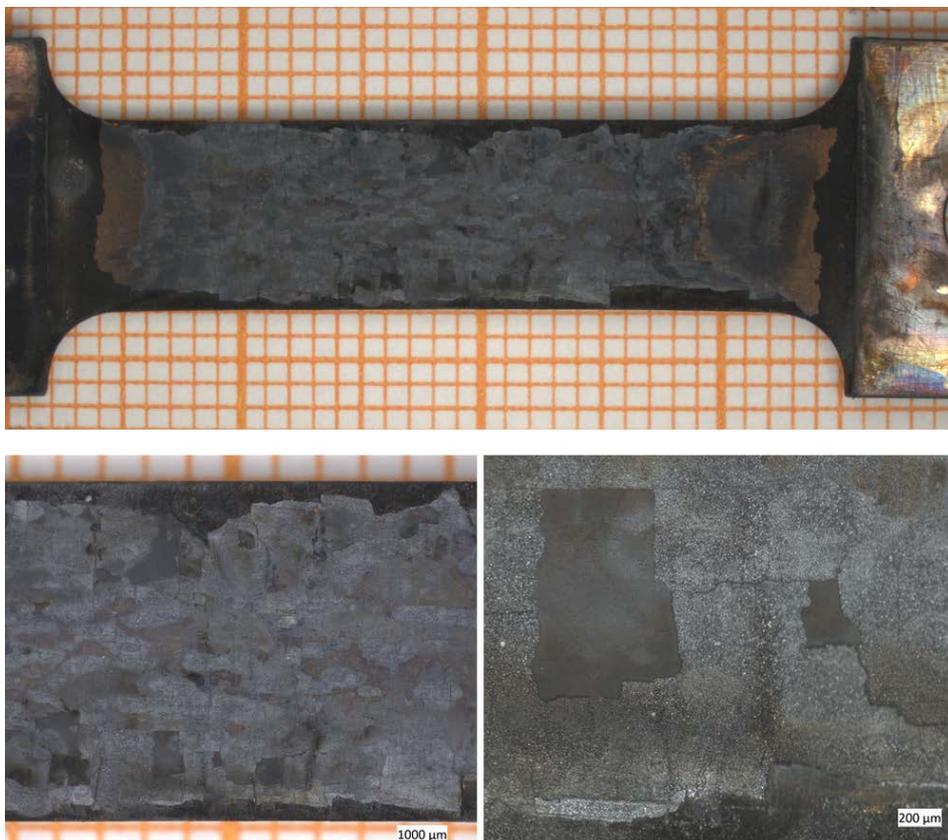
Figure 5-9 shows the surface appearance of the creep specimen after sulphide test 1. The sulphide film has clearly exfoliated from most of the surface. This is due to the creep straining, since the coupon sample exposed in the same experiment did not show similar exfoliation of the sulphide film, Figure 5-10.

Figure 5-9. The surface appearance of the creep sample after sulphide test 1.

Comparing Figure 5-9 and Figure 5-14 it is clear that while almost all of the surface film on the sample from sulphide test 1 had exfoliated, the surface film on the sample from sulphide test 2 had stayed mostly adhered to the base metal surface (only one area showed signs of exfoliation). Since the total permanent strain level in the two samples was about the same (about 4.7 % and 4.2 % for sulphide test 1 and 2, respectively), the exfoliation of the surface film during sulphide test 1 would not be expected to be related to the total strain level achieved.

The sulphide film on the creep specimen from sulphide test 1 had mostly exfoliated, Figure 5-9, whereas that from sulphide test 2, Figure 5-14, showed an almost intact appearance. This indicates that exfoliation occurred only after removing sulphide from the water. The other possibility is that exfoliation occurred on both specimens, and the surface film on the specimen in sulphide test 2 was quickly repaired by the sulphide present in the water. This possibility is, however, unlikely, since the exfoliation occurs as rather thick and large pieces of the surface film, which would be expected to leave a noticeable “footprint” on the surface, even if further sulphide film formation would occur.

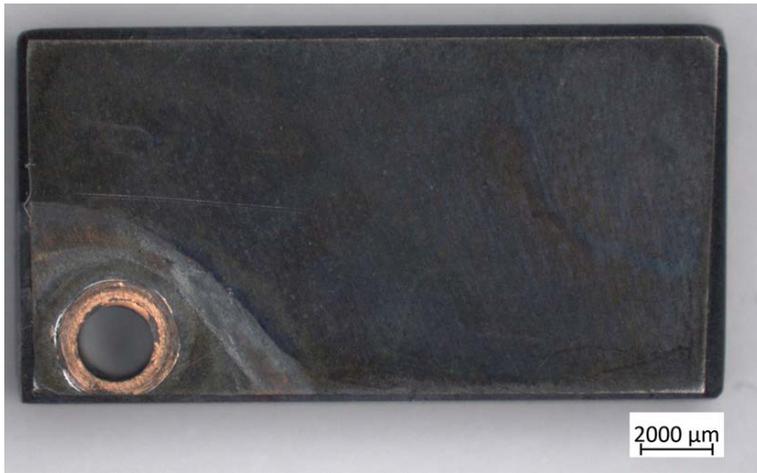
Figure 5-10. The surface appearance of the coupon sample (no straining) after sulphide test 1.

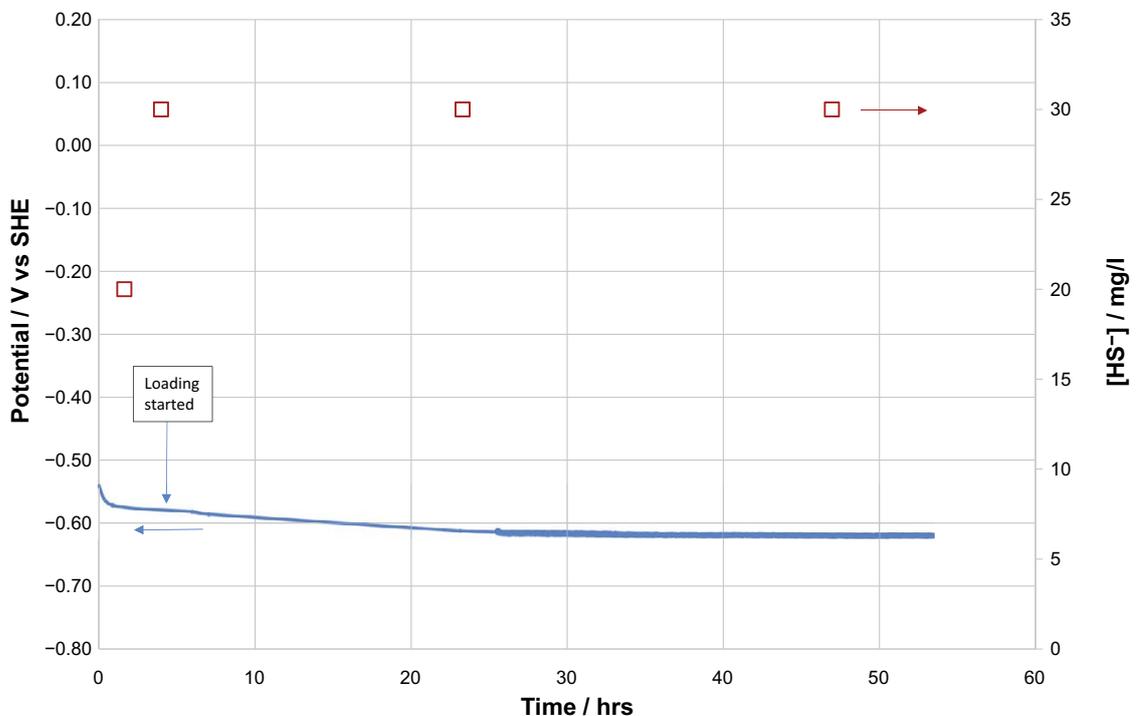
The corrosion potential and the sulphide concentration are shown in Figure 5-11 as a function of time. Before starting the creep test, the sulphide concentration was measured from the outlet as 20 mg/l. After this, the inlet concentration was checked, and found to be at the expected level of 30 mg/l. After some trouble shooting a small leakage was found in one of the piping connections, and fixed. The troubleshooting period lasted for about 0.5 hrs, after which the outlet was checked again at about $t = 4$ hrs and found to be at the correct level. After this, the loading was initiated at about $t = 4$ hrs. The stress and elongation during the second sulphide test are shown in Figure 5-12 as a function of time. Also the sulphide measurement results are shown in the figure at appropriate times. Figure 5-13 shows the strain rate and corrosion potential as a function of time. After the initial period the corrosion potential and the strain rate remained rather stable during the exposure.

Figure 5-11. The corrosion potential and sulphide concentration as a function of time for sulphide test 2.

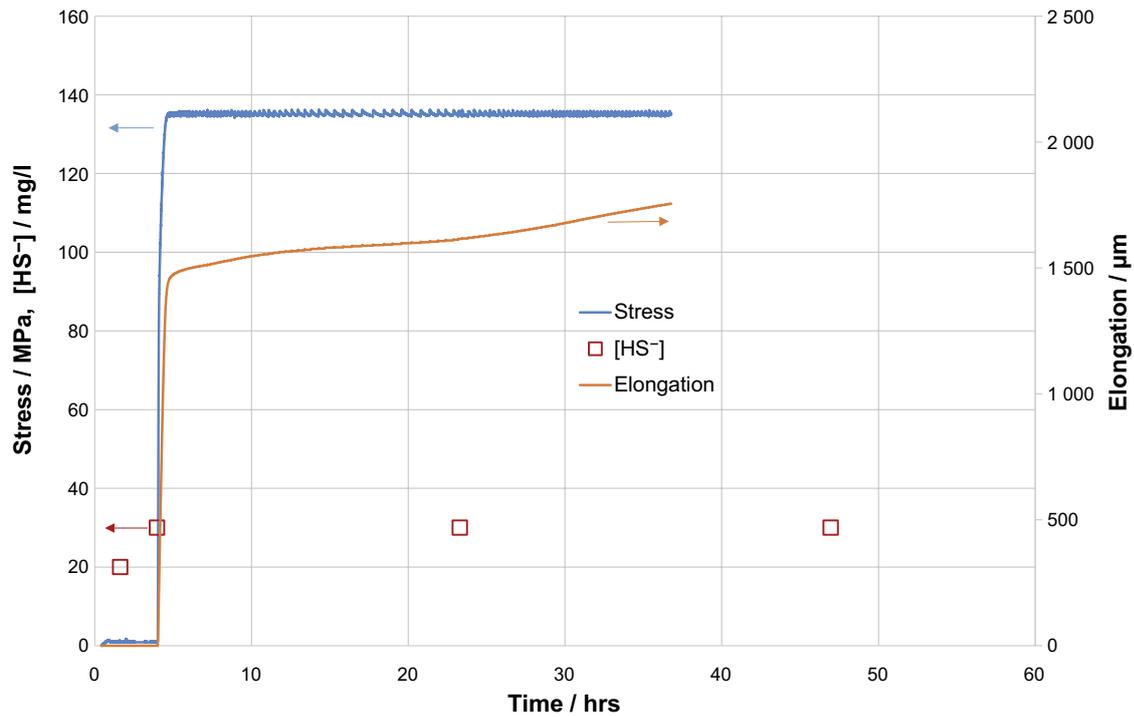
Figure 5-12. The stress and elongation as a function of time for sulphide test 2. The times of measurement and levels of sulphide measured are also indicated.

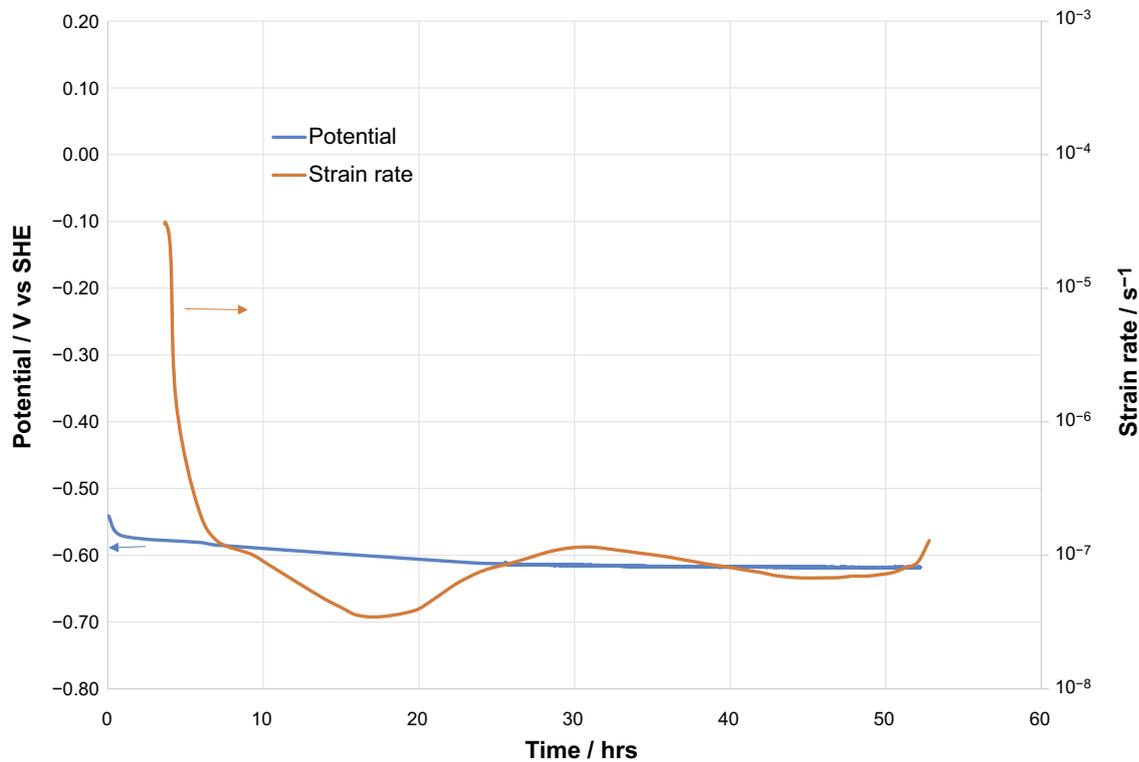
Figure 5-13. The corrosion potential and strain rate as a function of time for sulphide test 2.

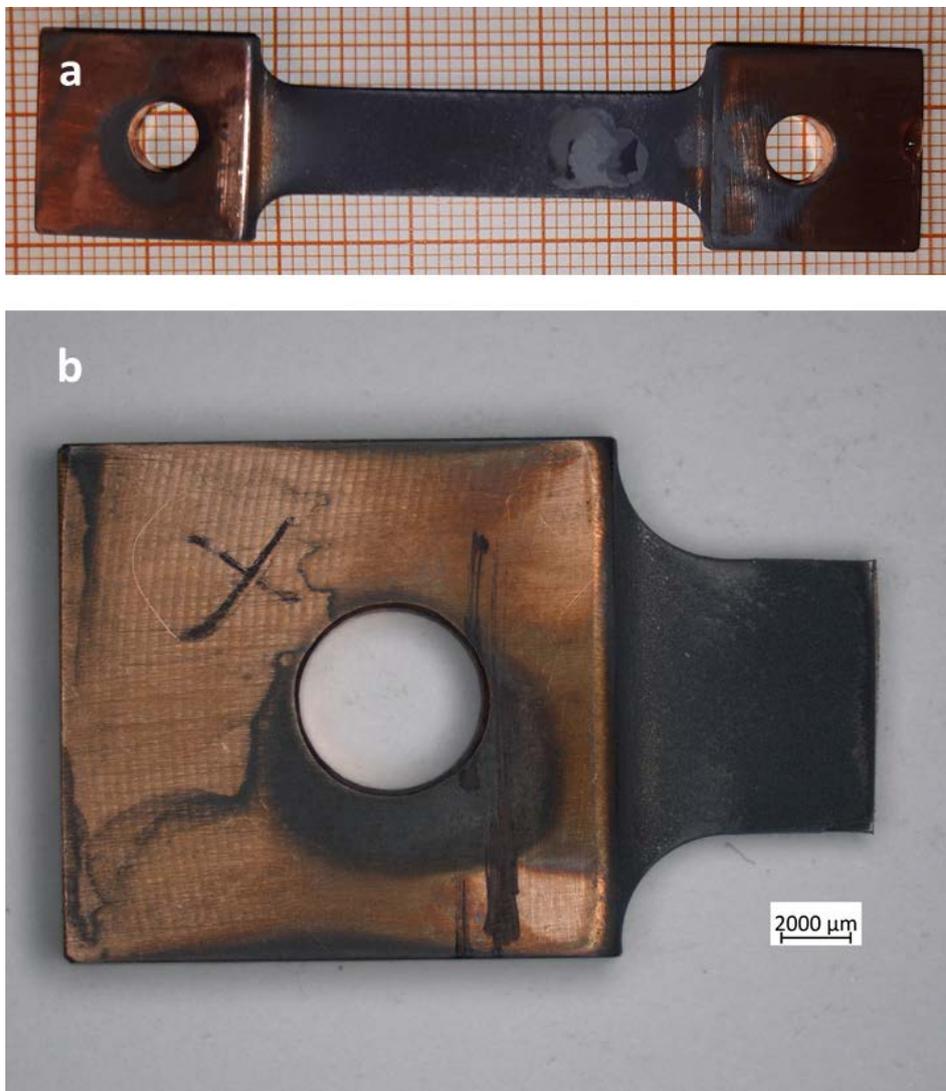
The sample from sulphide test 2 was removed from the autoclave immediately after reaching 48 hrs of exposure and photographed by mobile phone camera (Figure 5-14a), since it was necessary to minimize the time between opening up the autoclave, preparing the HME-samples and placing them in a liquid nitrogen container. Roughly 2/3 of the body waist part was cut off, the sulphide film was

Figure 5-14. The surface appearance of the creep sample after sulphide test 2; a) photo by mobile phone camera and b) the remaining piece from which the SEM-samples were made (after cutting off the parts that went to hydrogen measurement).

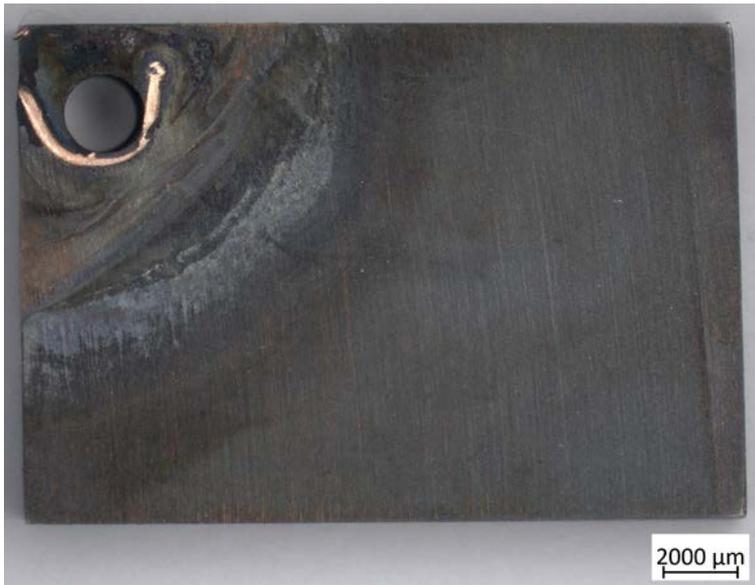
Figure 5-15 shows the surface appearance of the coupon specimen exposed during the sulphide test 2, with no signs of surface film exfoliation.

Figure 5-15. The surface appearance of the coupon sample after sulphide test 2.

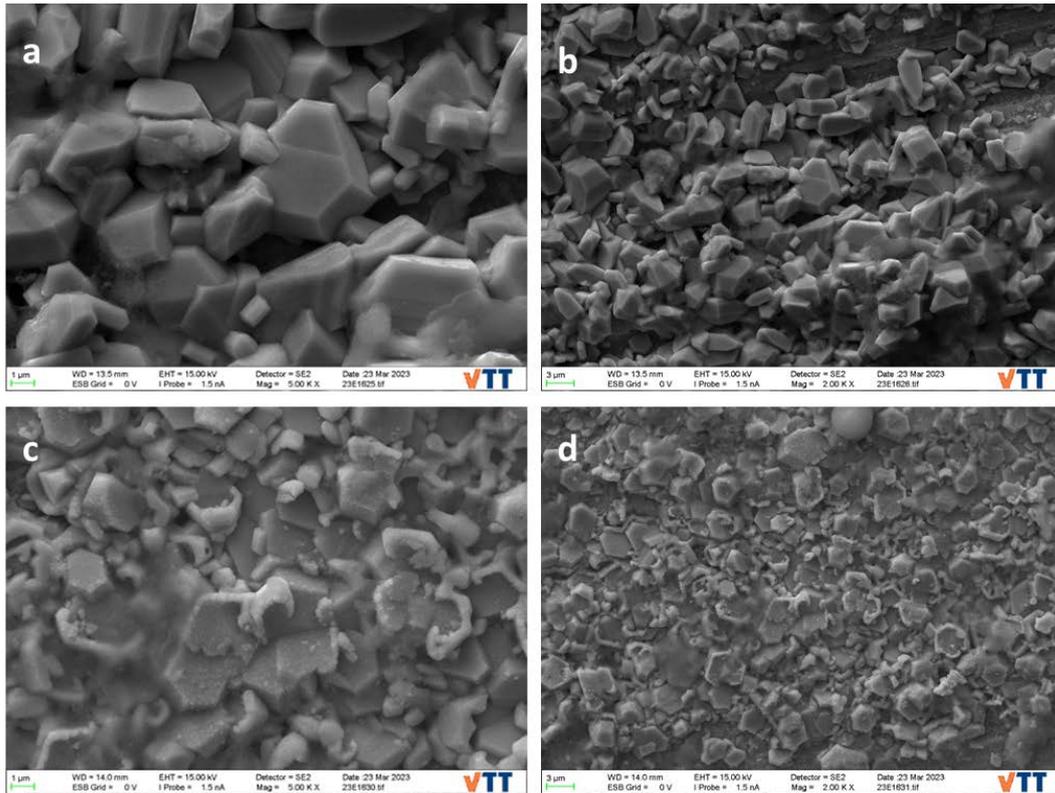
Two coupon samples were studied with SEM; one coupon from each sulphide exposure (the coupons were exposed in the same experiments as the creep specimens). Figure 5-16 shows the surface morphology of both coupon samples. The surface layer crystals in case of sulphide test 2 (in which at the end of the 48 hr exposure the sample was immediately removed from the sulphide containing water), Figure 5-16a and b, are well defined and somewhat larger in comparison to the crystals in case of sulphide test 1 (in which the sample stayed in water for about 100 hrs after the sulphide was removed). The surface morphology indicates (rounded edges of the surface crystals in sulphide test 1) that after removal of sulphide from the water, the copper sulphide crystals have a tendency to dissolve. In addition, as shown in Table 5-1 (see Section 5.3.4), the total film thickness in case of both coupon and creep samples was lower (by a factor of about 2) for sulphide test 1, in comparison to sulphide test 2, despite of the much longer exposure time in case of sulphide test 1. However, no marked difference was found in the chemical composition of the surface layers (outer layer) in the two sulphide tests, Figure 5-17. It is noteworthy here that O was found in both sulphide test 1 and 2, with somewhat higher concentration in the surface layer on the sample from sulphide test 1. More than half of the spots showed some Ni, the obvious source of which is dissolution from the autoclave walls.

Figure 5-16. Surface morphology of the coupon samples from sulphide test 2 (a and b) and sulphide test 1 (c and d).

The morphology of the surface film on the creep specimens is shown in Figure 5-21. When comparing with the surface films on the coupon specimens, Figure 5-16, the surface film can be described as nano-crystalline. The EDX analyses of the creep specimen from sulphide test 2, Figure 5-22a, showed a clearly smaller amount of S in the surface film present in areas from where the thick sulphide film had exfoliated than in the corresponding coupon sample, about 17 a% and 30 a%, respectively. The difference in sulphur concentration may be related to the presence of only a single layer of sulphide film on the creep specimen, i.e. a lower concentration of sulphur in the film indicates a lower surface concentration of sulphur in the vicinity of the film on the water side, and therefore less probability for supersaturation and resulting deposition of the outer layer crystals. Hypothetically, this can be explained by the dynamic creep strain constantly revealing new fresh surface which rapidly gets sulphidized and thereby prevents supersaturation nearby the surface, since the rate of sulphide film formation and overall Cu-OFP corrosion in sulphide environment is supposed to be mass transfer limited. Another way of looking into this finding is the nano-crystalline film forming on highly energetically favourable new nucleation points being exposed due to creep strain, thus effectively consuming the nearby HS^- -ions and preventing supersaturation necessary for the deposition of the outer layer crystals. These considerations would also explain the much smaller average crystal size in the case of the creep specimens.

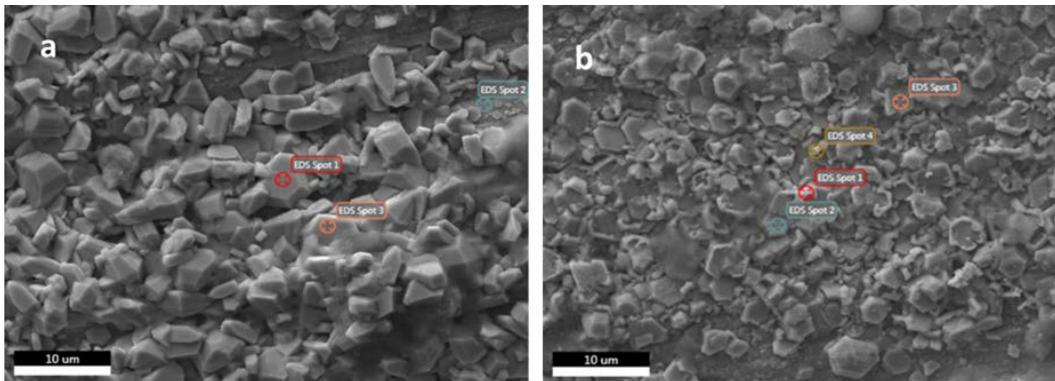
Figure 5-17. SEM-EDX analyses of the coupon samples from sulphide test 2 (a) and sulphide test 1 (b). Concentrations in atomic %, normalized to 100 % after the contribution of carbon has been removed from the data.

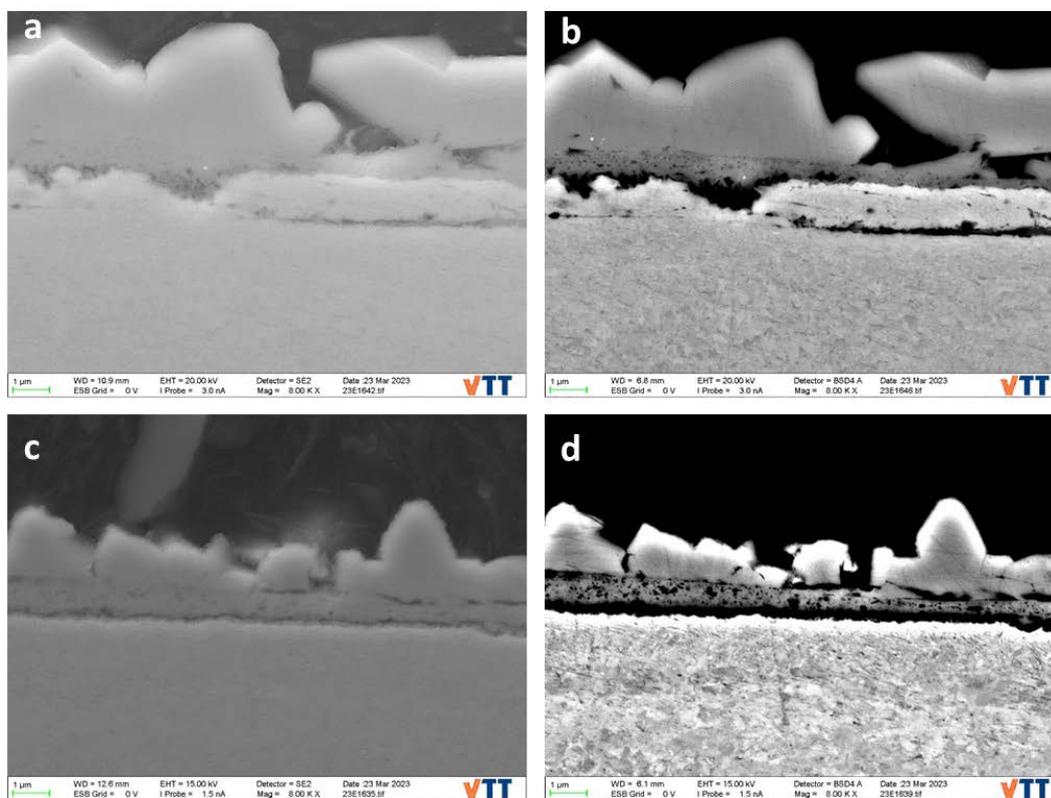
The surface films on the coupon specimens revealed a double-layer structure, i.e. an outer layer and an inner layer, Figure 5-18. The thickness of the inner layer on sulphide test 1 and sulphide test 2 coupon specimens was 0.9 μm and 1.1 μm , whereas the total thicknesses were 2.2 μm and 4.8 μm , respectively. In the cases where the contribution of carbon (from the SEM-sample preparation) was not insignificant, the concentrations of elements other than carbon were normalized to 100 % (excluding carbon). The EDX-map in Figure 5-19 shows that both surface film layers in case of sulphide test 2 consist of Cu and S (with a small amount of Na originating in the buffer solution, and a very small amount of P), rather evenly distributed within the two layers. It is surprising that no O was found, although the corresponding surface sample showed about 5.8 a% of O. The film on the sample from sulphide test 1 had an almost identical composition, with only a small percentage of O. However, the EDX-map in case of sulphide test 1, Figure 5-20, shows a thin but clear O and Cu enriched layer at the interface between the inner layer and the matrix (the O and Cu enriched layer is discernible also in the BSE picture, Figure 5-18d). The thickness of the O and Cu enriched layer is over 100 nm, and can thus not be a remnant of the airborne oxide, the thickness of which is only a few nm.

Figure 5-18. Cross-sections of the coupon samples from sulphide test 2 (a and b) and sulphide test 1 (c and d). Left = SE and right = BSE mode.

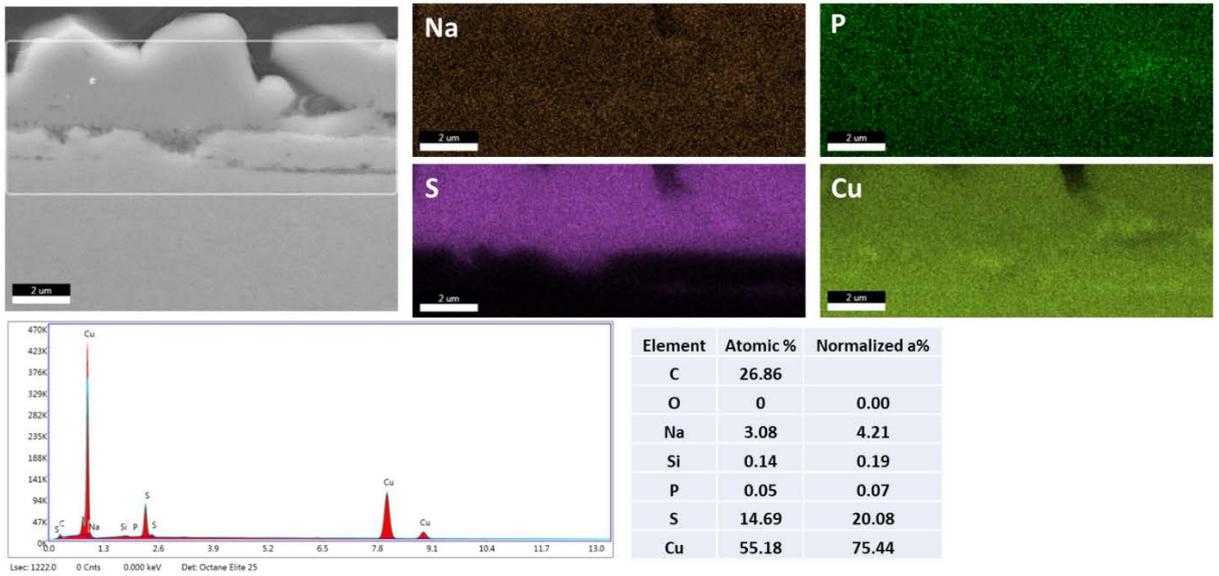
Figure 5-19. SEM-EDX analyses of the coupon sample from sulphide test 2.

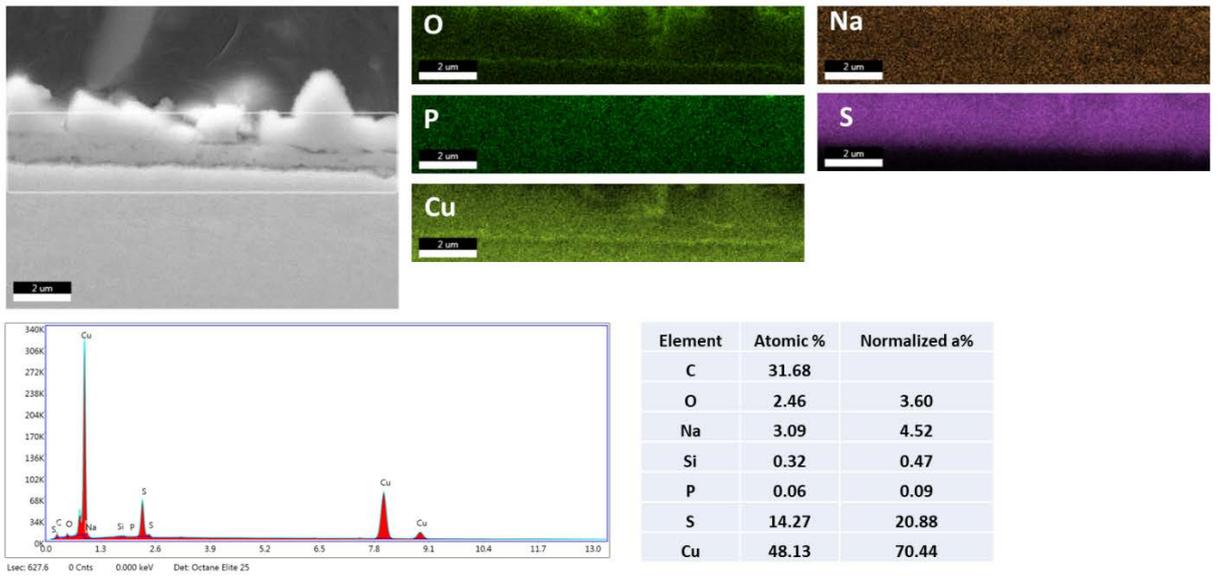
Figure 5-20. SEM-EDX analyses of the coupon sample from sulphide test 1.

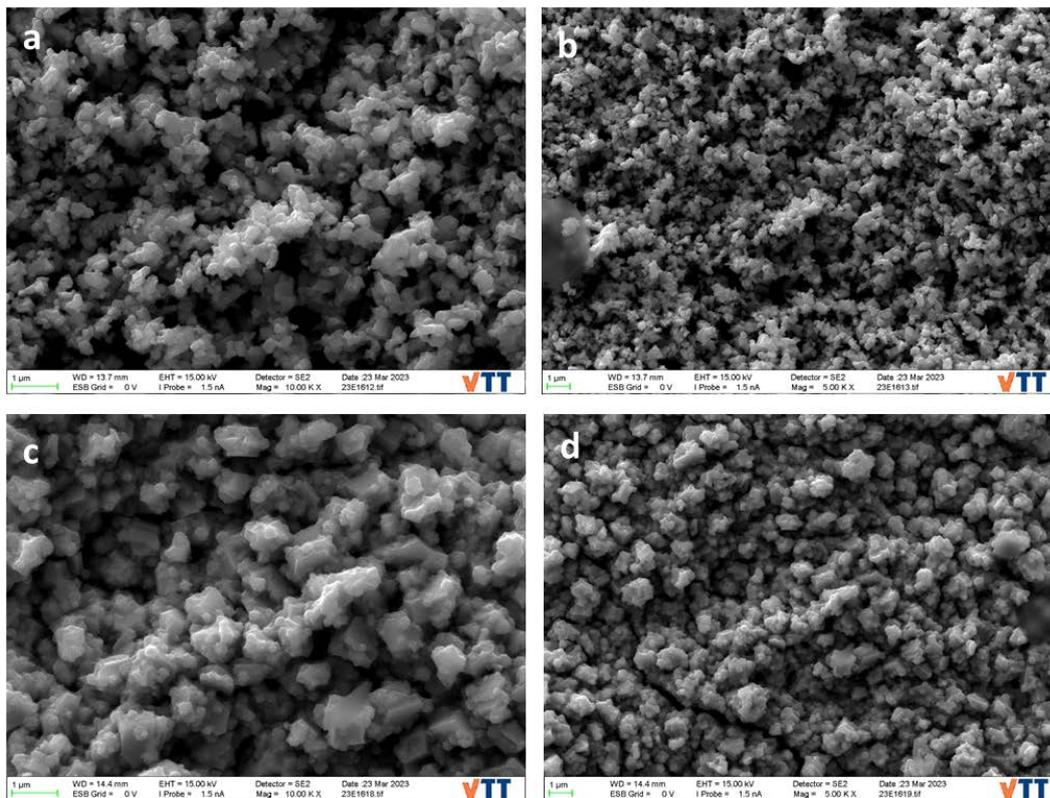
Figure 5-21. Surface morphology of the creep samples from sulphide test 2 (a and b) and sulphide test 1 (c and d).

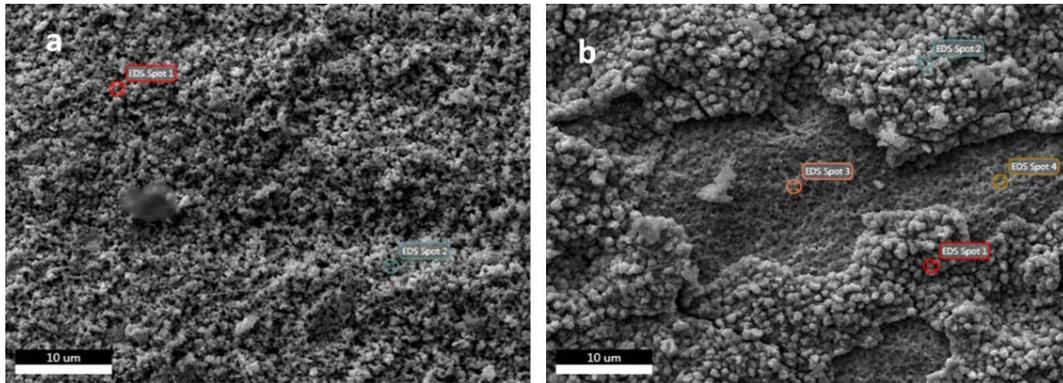
Figure 5-22b shows EDX analyses from two areas on the creep specimen from sulphide test 1, one with the (nano-crystalline) sulphide film (EDX spots 1 and 2) and one from which the sulphide film has exfoliated (EDX spots 3 and 4). The sulphide film (EDX spots 1 and 2) showed a composition rather close to that on the corresponding coupon sample (Figure 5-17), while the area from which the sulphide film had exfoliated (EDX spots 3 and 4), showed basically only Cu (with a small amount of Ni). The total surface area of fully exfoliated regions like that shown in Figure 5-22b was still smaller than those that showed a nano-crystalline outer film.

Figure 5-22. SEM-EDX analyses of the creep sample from a) sulphide test 2 and b) sulphide test 1. Concentrations in atomic %, normalized to 100% after the contribution of carbon has been removed from the data where necessary.
