TR-23-19

Creep of Cu-OFP in presence of sulphides

Tiina Ikäläinen, Timo Saario, Zaiqing Que

VTT

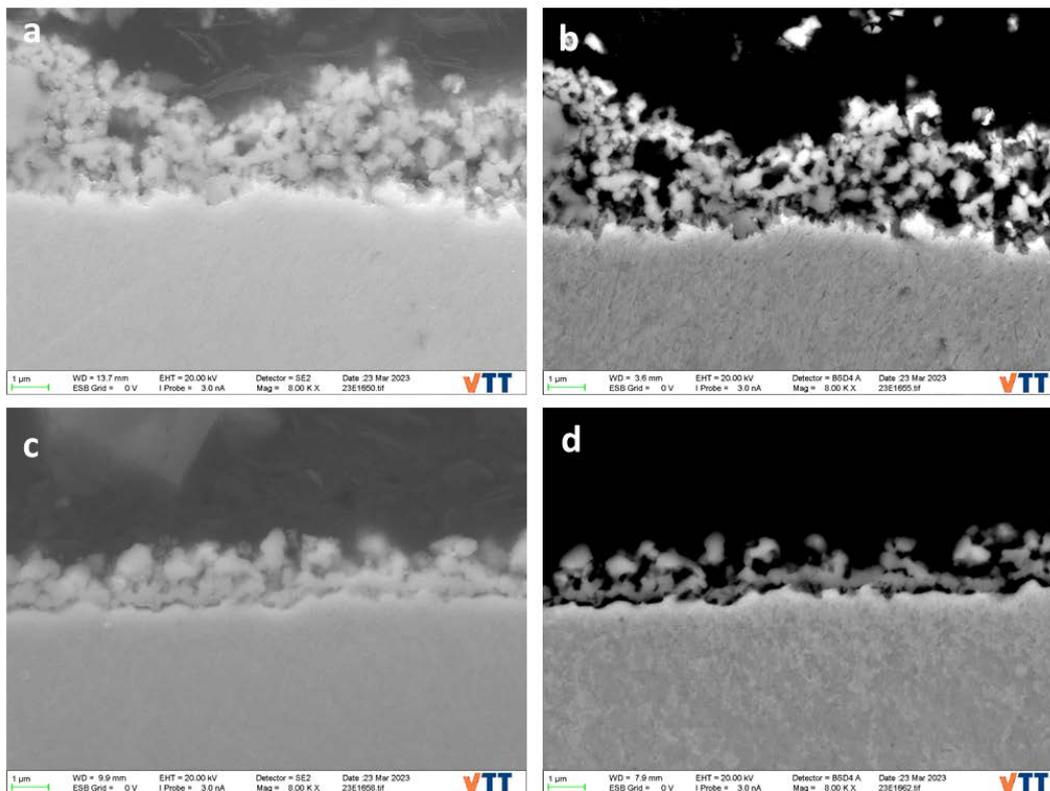
As shown in Figure 5-23, the surface film on both of the creep samples had a single-layer structure, with much more porosity than in the corresponding coupon samples (see Figure 5-18). The thickness of the film formed on the creep specimen from sulphide test 1 and 2 was 2 μm and 6 μm , respectively. The EDX-map in Figure 5-24 shows that the surface film layer in case of sulphide test 2 consists of Cu and S (with a small amount of Na and O, and a very small amount of Si and P). On the other hand, the EDX-map in case of sulphide test 1, Figure 5-25, shows almost four times higher concentration of O and somewhat lower concentration of Cu and S, as well as a thin Cu and O enriched layer at the interface between the inner layer, similar to but not nearly as clear as that found in the corresponding coupon sample, Figure 5-20. The coupon sample from sulphide test 2 did not show such O and Cu enriched layer, Figure 5-19, while the creep sample from the sulphide test 2 showed a possible, very weak, O and Cu enriched layer, Figure 5-24. Thus it seems that the appearance of the O and Cu enriched layer is favoured by the sample being under continuous straining and by the sample being exposed to a sulphide free water after initial exposure to a HS^- containing water. The layer could thus be related to the dissolution of the existing sulphide film, accelerated by the continuous straining.

Figure 5-23. Cross-sections of the creep samples from sulphide test 2 (a and b) and sulphide test 1 (c and d). Left = SE and right = BSE mode.

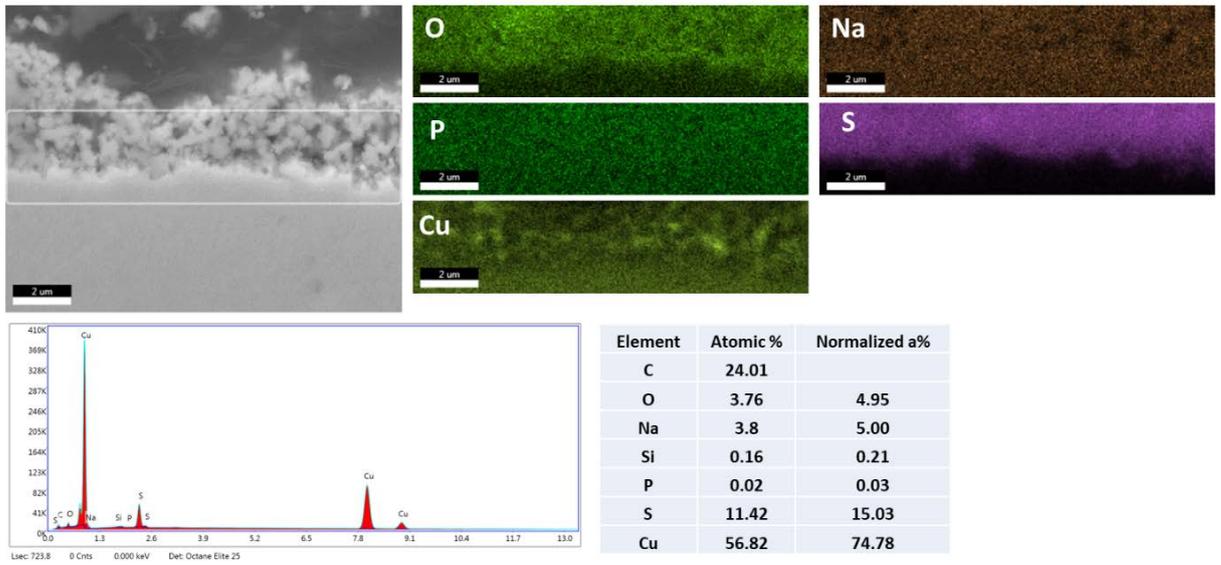
Figure 5-24. SEM-EDX analyses of the creep sample from sulphide test 2.

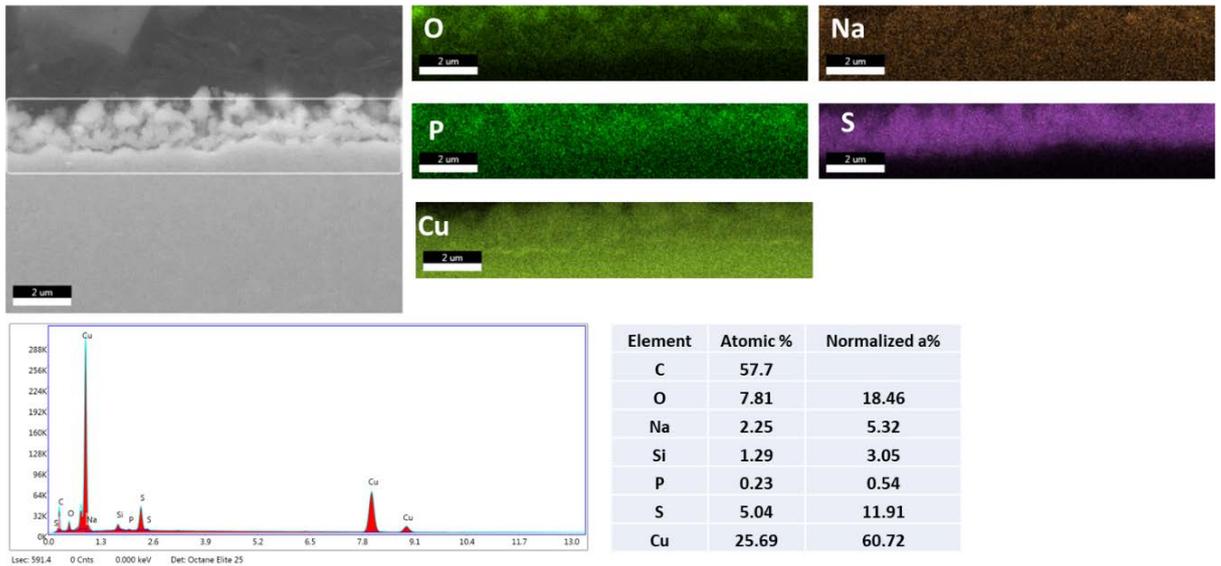
Figure 5-25. SEM-EDX analyses of the creep sample from sulphide test 1.
