Technical Report

TR-19-13

Stress corrosion testing of copper in near neutral sulfide solutions

SVENSK KÄRNBRÄNSLEHANTERING AB

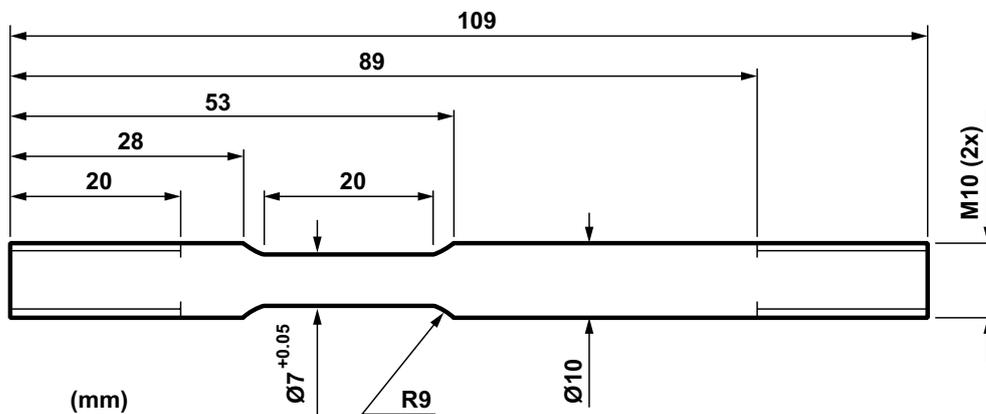
Figure 2-1. Drawing for the test rods.

The copper material was supplied by SKB and cut from lid TX#219. Test rods were cut from the base material by spark cutting followed by turning into shape. The test rods were fully annealed by treatment in molten salt at 600 °C for 10 minutes and quenching in water for about 60 s or until the test rod could be touched by hand. Any remaining traces of salt were carefully removed from the whole test rod using 320 grit paper in a lathe at slow speed. The final polish of the middle section of the test rod, the section that will be exposed to the solution, was 600 grit paper, also in a lathe. Finally, the rods were degreased using ethanol and rinsed in deionized water immediately before mounting in the SSRT cell. Figure 2-1 shows the drawing for the test rods. Figure 2-2 shows the collection of nine test rods produced. Figure 2-2 also shows the approximate locations of O-rings that seal the inner test environment from the atmosphere. The lower O-ring is stationary, relative to the test cell and relative to the test rod. The upper O-ring is stationary relative to the test cell but moves relative to the test rod. The upper part of the test rod gradually slide through the O-ring, as the straining proceeds. More than one O-ring were frequently used for the upper as well as the lower end of the test rod.

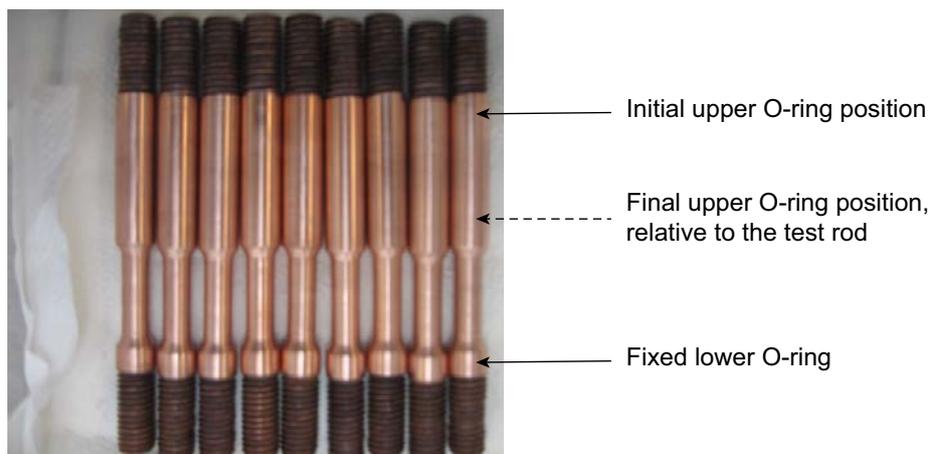
Figure 2-2. The collection of nine test rods produced. Approximate locations of O-rings used to seal the inner test environment from the atmosphere are shown.

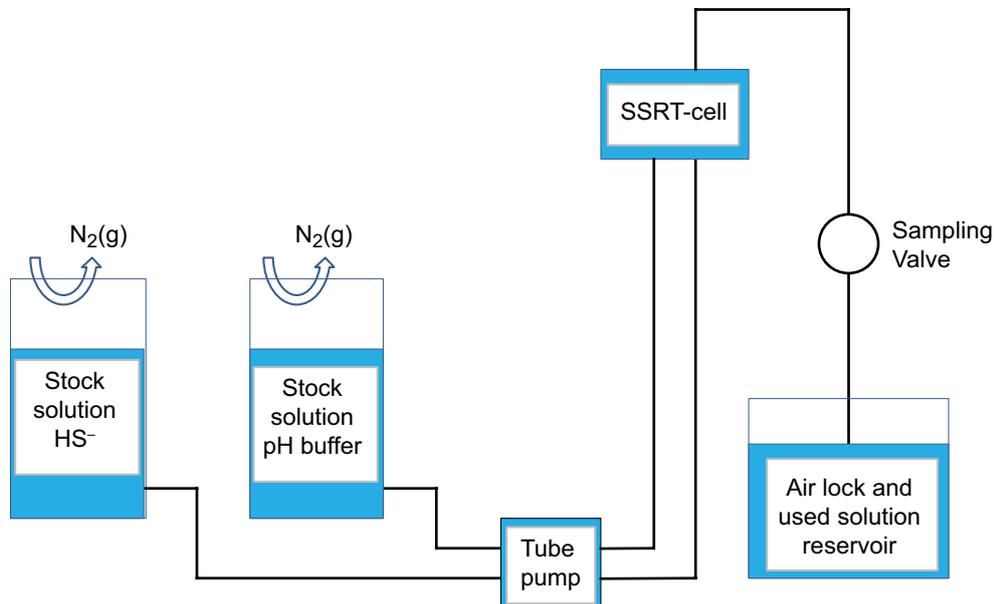
Figure 2-3. Schematic sketch of the solution flow system during SSRT-test of copper.

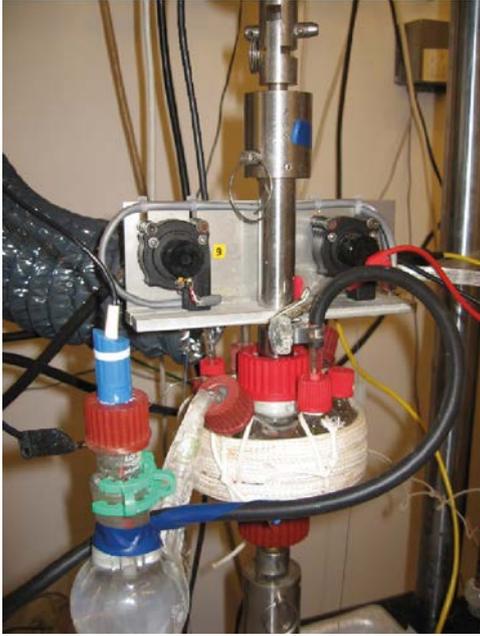
Figure 2-4. Photograph of the SSRT-cell with a mounted test rod.

Figure 2-4 shows the SSRT-cell with a mounted test rod. The glass bulb to the lower left is a cell for the reference electrode which is kept at room temperature. The reference electrode is Ag/AgCl(sat. KCl), but the results are reported relative to the Saturated Calomel Electrode (SCE) subtracting a potential difference of 45 mV from the measured values (Bard and Faulkner 1980). The sampling valve is connected to the black tube and located just outside the lower left corner of the photograph. Figure 2-5 shows the parts when the cell is dismantled. Figure 2-6 shows the upper, moving end of the test rod and Figure 2-7 shows the lower, stationary end. The green O-rings mounted around each end of the test rod seal radially against a hole in the white Teflon cylinders.

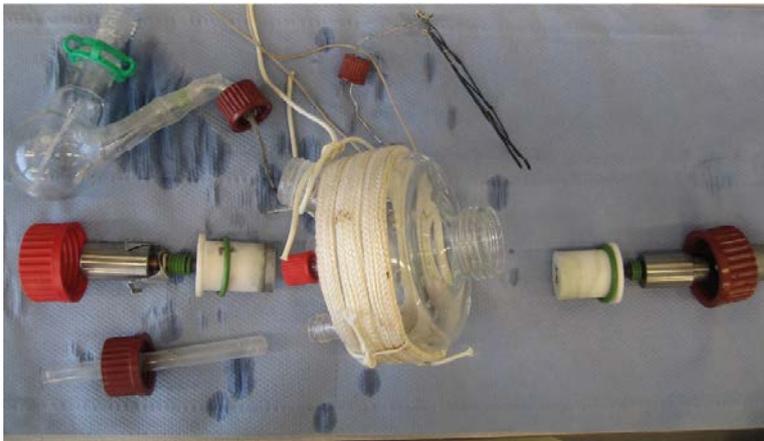
Figure 2-5. Parts of the SSRT-cell, dismantled.

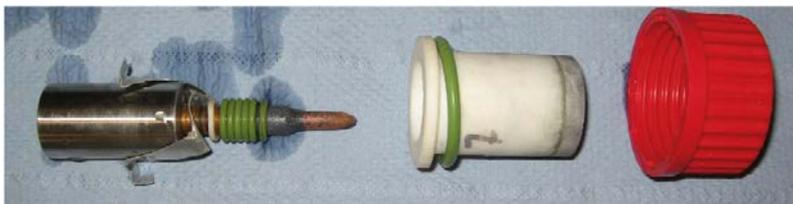
Figure 2-6. Parts of the SSRT-cell, dismantled. Upper, moving side of the test rod after testing.

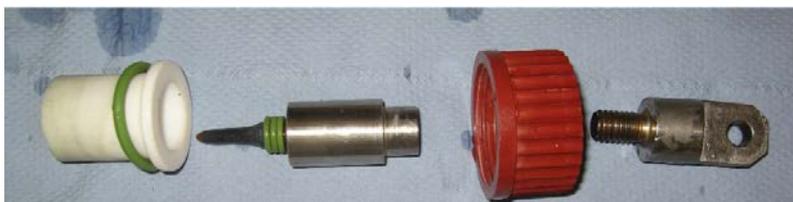
Figure 2-7. Parts of the SSRT-cell, dismantled. Lower, stationary side of the test rod after testing.

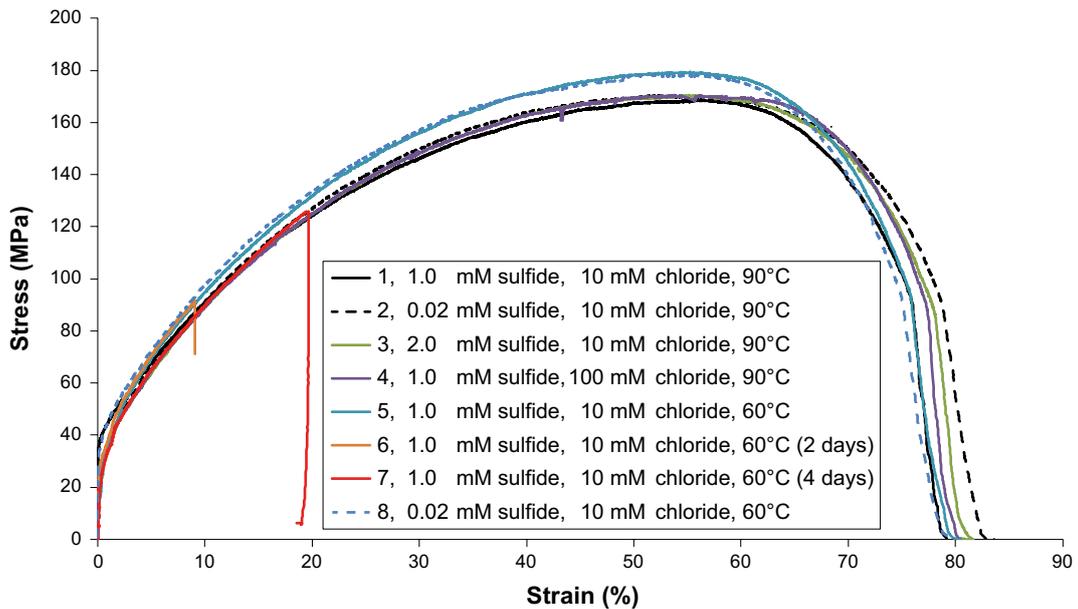
Figure 3-1. Stress-strain curves for copper in near neutral solutions with sulfide and chloride.

Figure 3-1 shows that the maximum stress applied to obtain the set strain rate is slightly lower at 90 °C than at 60 °C. Within each temperature, no significant influence of the composition of the test solution is seen. Final rupture occurs at a strain of about 80 % with a variation that is not uncommon in slow strain-rate tests.

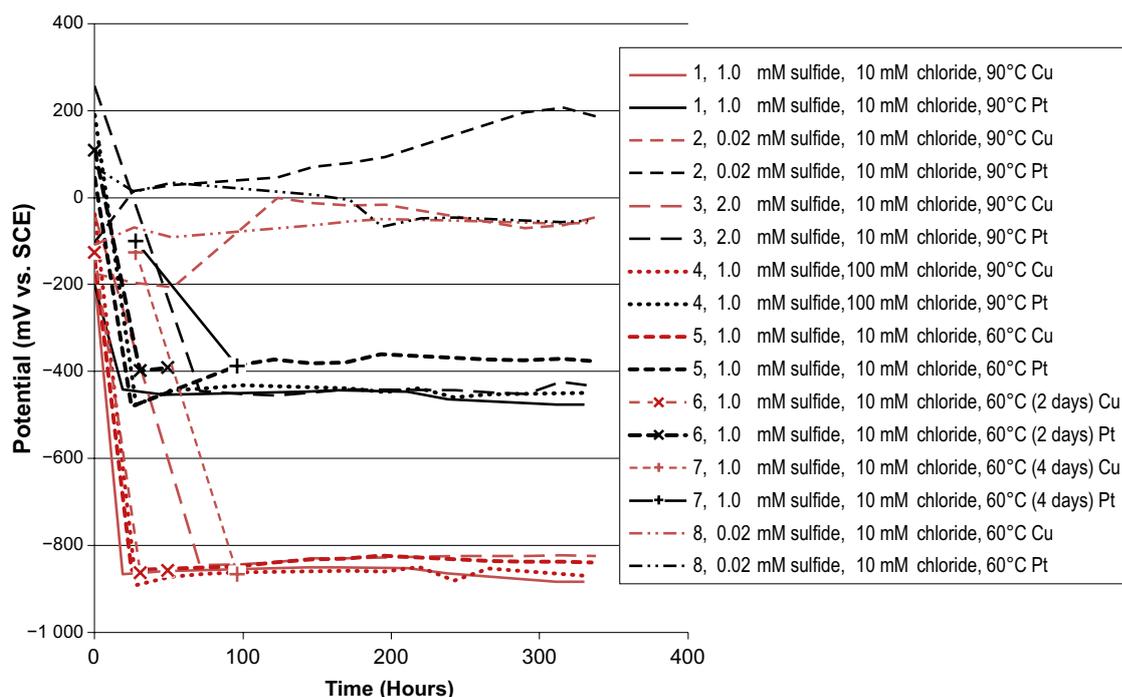
Figure 3-2. The corrosion potential for the copper test rods (red curves) and the potential for a platinum wire (black curves) in the same solution.

Figure 3-2 shows the corrosion potential for the copper test rods and the potential for a platinum wire in the same solution. Figure 3-2 shows corrosion potentials of about -850 mV at 90°C and at 60°C for the higher sulfide concentrations (1 mM or 2 mM) but about -50 mV for 0.02 mM sulfide. The Pt-potentials are about 400 mV more positive than the corrosion potentials of copper, for the higher sulfide concentrations. The relatively high and increasing Pt-potential in Run #2 can be seen as an indication of oxygen influence in this experiment. However, all copper test rods turned black during the tests. A greenish spot on the test rod from Run #2 could be seen at a site where the O-rings around the test rod seal the test cell from the atmosphere. Green spots could be seen also on the test rod from Run #8. The green color indicates the presence of Cu(II) and oxidation by oxygen.

Comparing the values in Table 3-1 with the corrosion potentials for copper in Figure 3-2, it is evident that hydrogen evolving corrosion was possible in all experiments with 1 mM sulfide but not with 0.02 mM sulfide. The corrosion observed with this low sulfide concentration also resulted in a black corrosion product, with the appearance of $\text{Cu}_2\text{S}(\text{s})$, that covered the test rods.

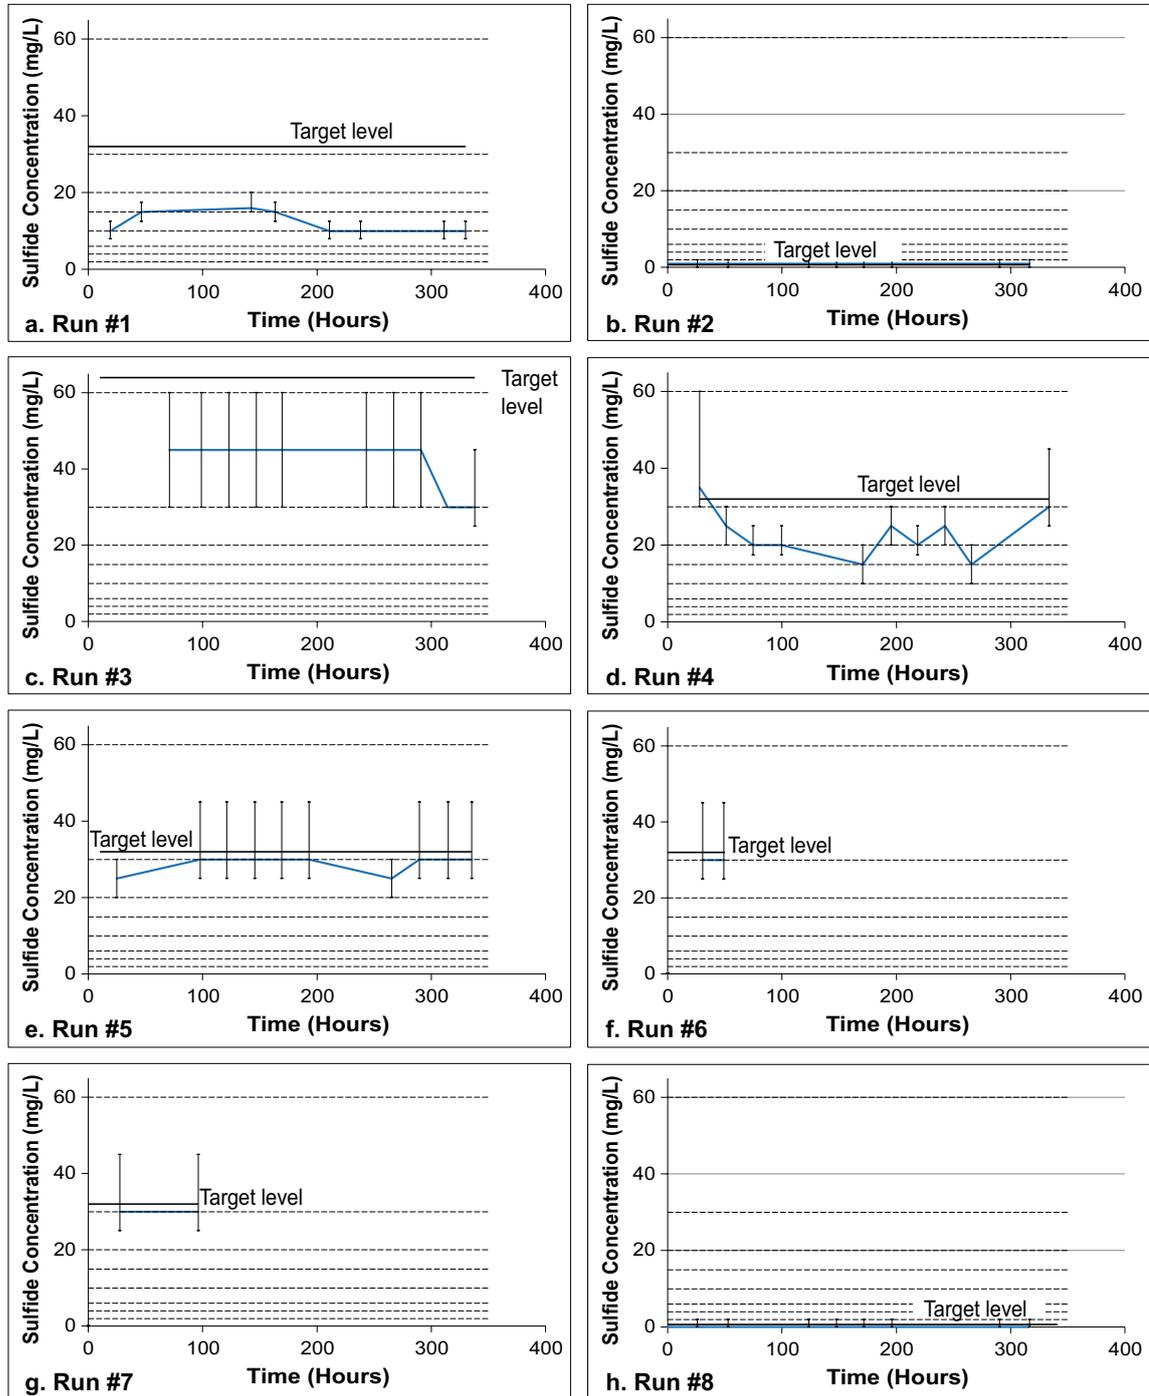
Figure 3-3. Sulfide concentrations measured in solution from the cell. The dashed lines indicate the sulfide levels for the color standards. Kindly note that the error bars include only the possible errors from comparisons of the sample color to the color standards. There is also an error caused by the delay between sampling and analysis.

Figure 3-3 shows the sulfide concentrations measured in solution from the cell. The error bars are constructed from the color standards for the visual analysis.

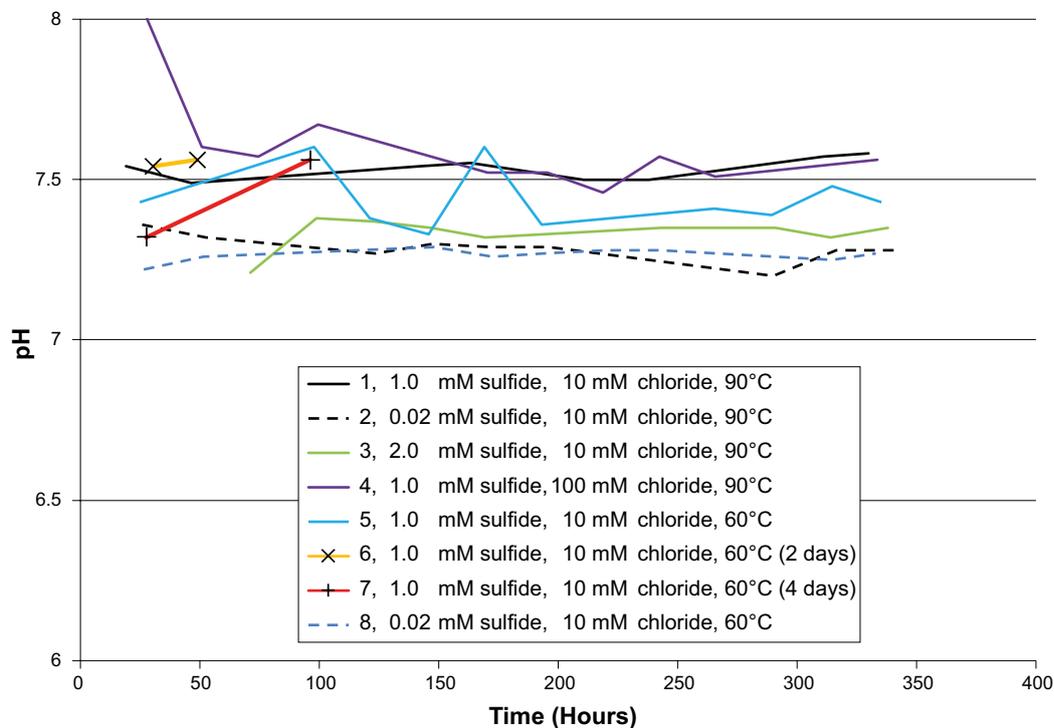
Figure 3-4. pH measured in the solutions from the cell.

Figure 3-4 shows the pH measured in solution from the cell. Figure 3-4 shows that there were some variations in pH during experiments and between experiments. The 10 mM phosphate pH-buffer was apparently not sufficient to fully neutralize the alkalization from the sulfide stock solution. The influence of the corrosion process on the pH can probably be neglected. Runs #2 and #8, with the low sulfide concentration, show small deviations from the buffer of pH 7.2.

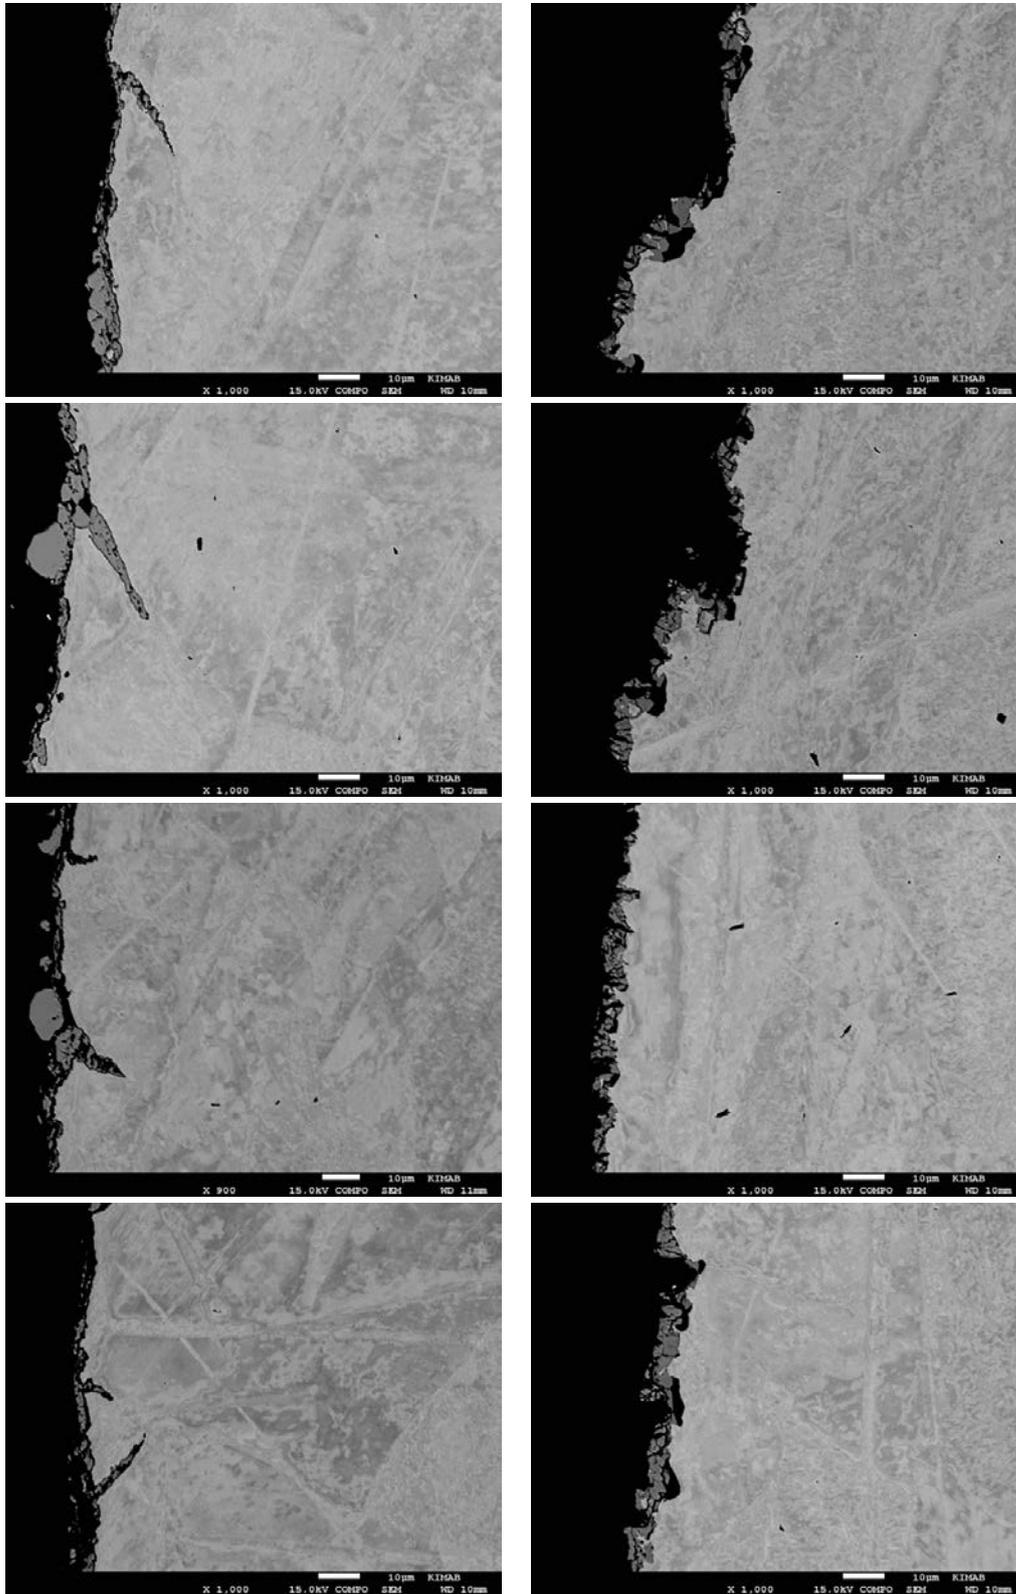
Run #1. 1 mM sulfide, 10 mM chloride, 90°C

Run #2. 0.02 mM sulfide, 10 mM chloride, 90°C

Figure 3-5 shows a sequence of SEM-images of longitudinal cross sections of test rods from Run #1 in the left hand column with similar images from Run #2, for comparison, in the right hand column.

The images in the left hand column of Figure 3-5 show cracks or crack-like features that extend to about 20–30 μm from the surface. The images in the right hand column show no such cracks but only an unevenly corroded surface. Figure 3-6 shows the approximate distribution of cracks along the longitudinal cross section of one of the halves of the test rod from Run #1.

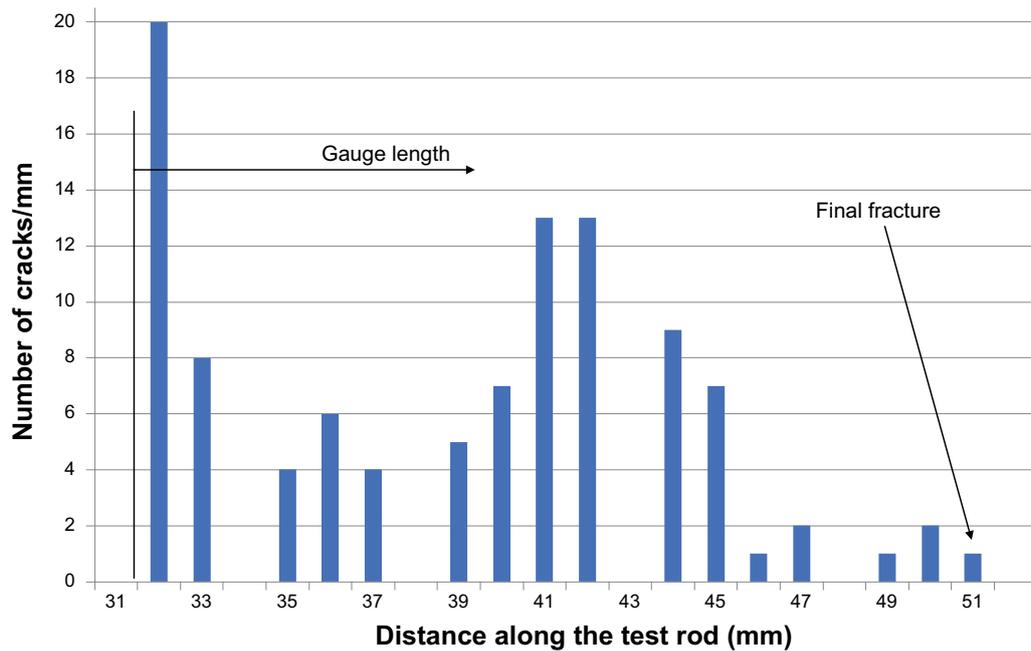
Figure 3-6. Approximate distribution of cracks along the longitudinal cross section of one of the halves of the test rod from Run #1 (1 mM sulfide, 10 mM chloride, 90 °C).

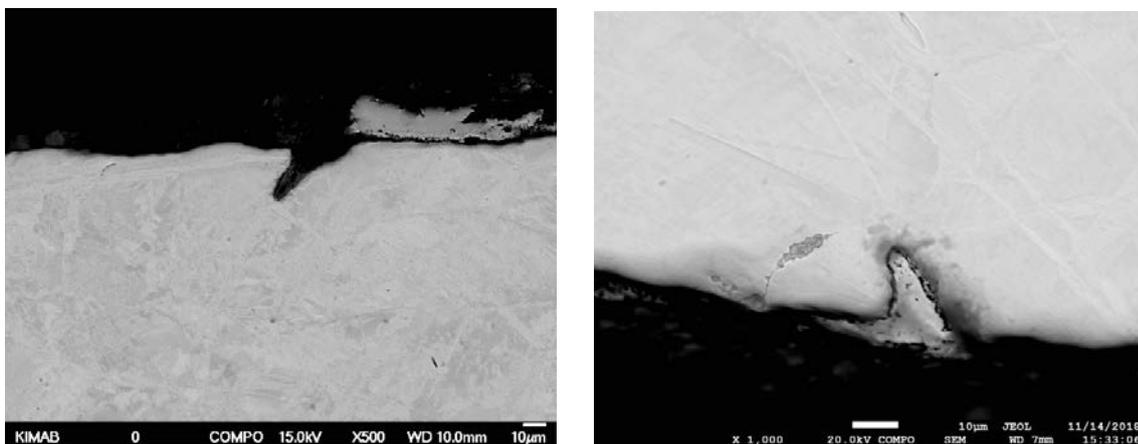
Figure 3-7. SEM-images of the cross section of the test rod from Run #3, (2 mM sulfide, 10 mM chloride, 90 °C).

It was noted that the cross section of the test rod showed cracks of similar depth as Run#1 but the cracks were fewer and generally notably wider. One exception is the thin crack to the left of the large, wide crack in the right image in Figure 3-7.

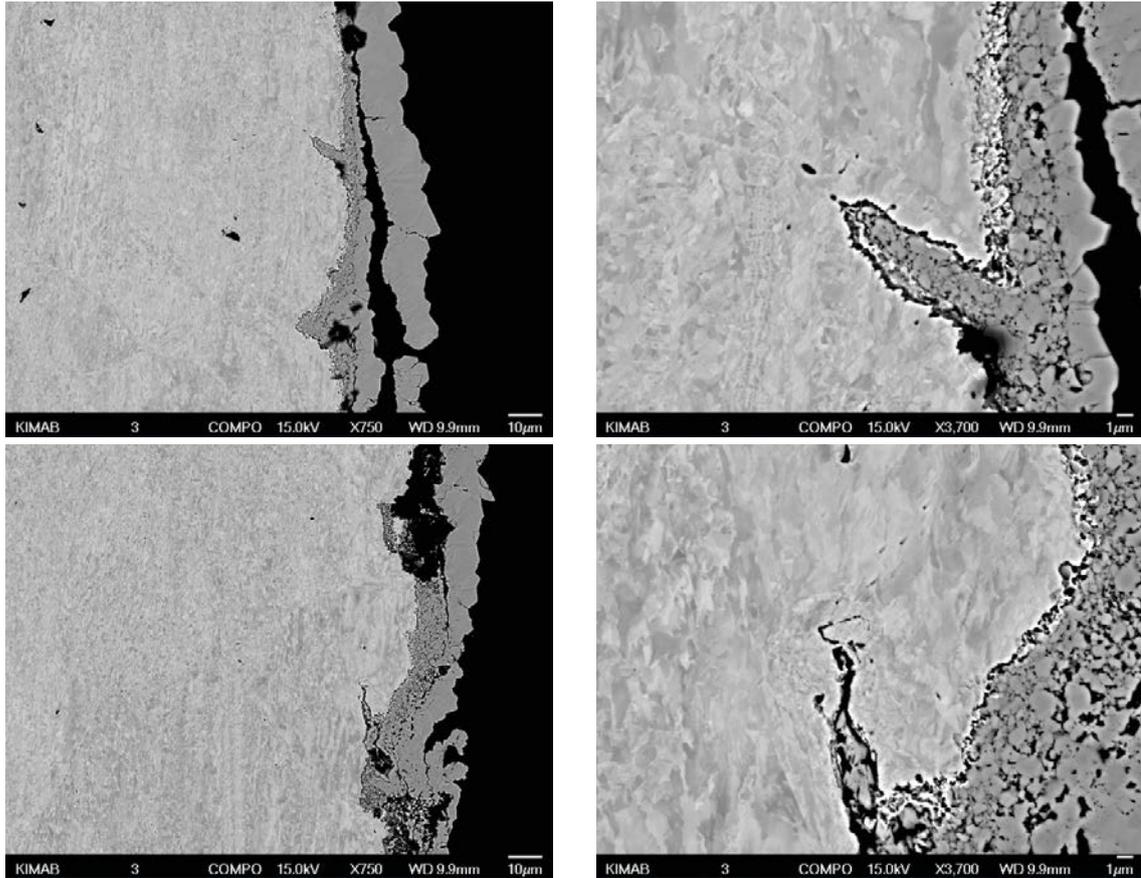
Figure 3-8. SEM-image of the cross section of the test rod from Run #4, (1 mM sulfide, 100 mM chloride, 90 °C). The upper right image shows a magnification of the middle part of the left image. The lower right image shows a magnification of the middle part of the left image.

Figure 3-8 shows SEM-images of the cross section of the test rod from Run#4, with 1 mM sulfide and 100 mM chloride. The right hand image shows a magnification of the middle part of the left hand image. The shapes of the cracks are generally more similar to the relatively wide cracks found for Run #3 than the more narrow cracks from Run #1. However, the lower images in Figure 3-8 show an example of a deep lying fine structure of a crack. Just as in Run#3, there were fewer cracks in Run #4 than in Run #1.

The images from Run #4, with 100 mM chloride, in Figure 3-8, show much more solid corrosion products than the images from Run #1, with 10 mM chloride, in Figure 3-5.

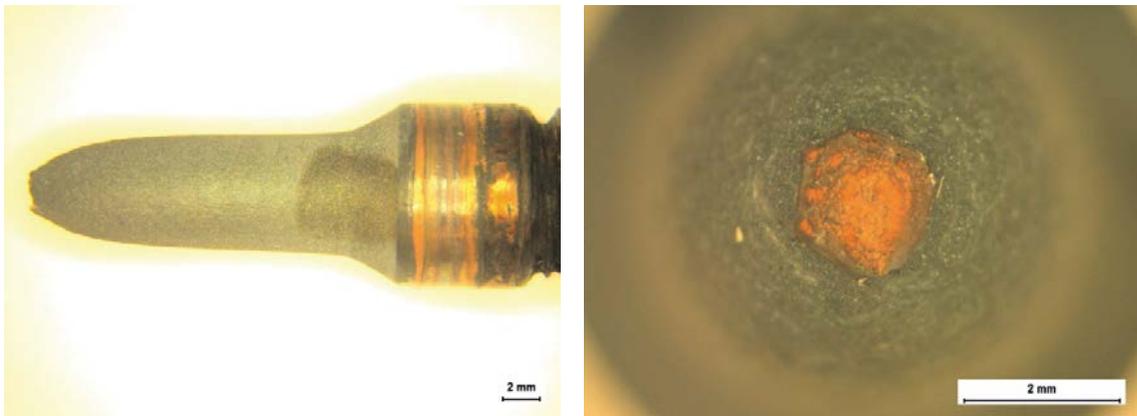
Figure 3-9. Photographs of one end of the test rod strained to rupture in Run #5 (1 mM sulfide, 10 mM chloride, 60 °C).

Figure 3-9 shows photographs of one end of the test rod strained to rupture in Run #5, which was similar to Run #1 but at 60 °C instead of 90 °C.

The final rupture appeared at the middle of the gauge section, approximately. This was found also for previous runs. The axial photo of the rupture reveals a hexagonal profile which was not found in the other experiments where the axial profiles were more rounded in shape but with irregular edges. The straight looking edges extending for about 1 mm in Figure 3-9 suggest a correlation between the site of final rupture and previous surface cracks. Without previous surface cracks, the profile of the fracture would probably have been more irregular in shape.

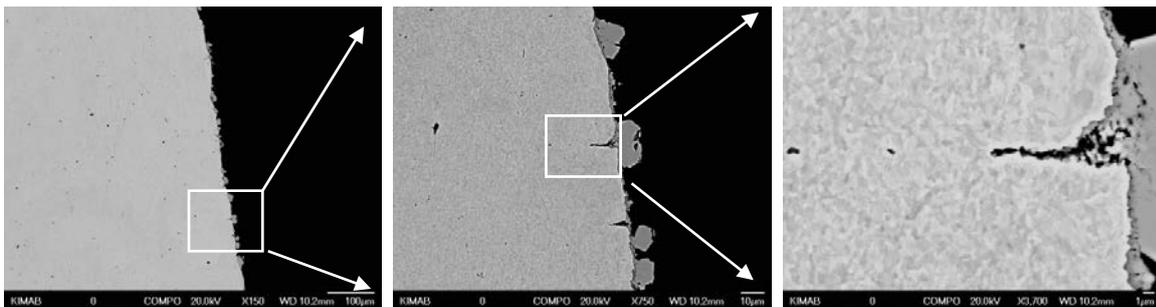
Figure 3-10. A sequence of SEM-images in gradually increasing magnification. Run #5, (1 mM sulfide, 10 mM chloride, 60 °C).

Figure 3-10 shows some SEM-images from Run#5. The left hand image in Figure 3-10 shows an uneven surface profile which at closer inspection is found to contain a large number of cracks. The maximum depth of the cracks is about 10–20 μm which is similar to or slightly shorter than what was found in Run #1 at 90 °C.

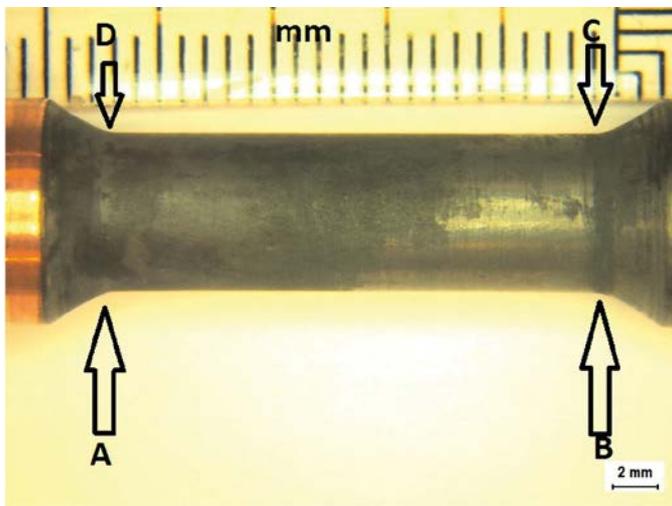
Figure 3-11. Photo of the test rod from Run#6 (1 mM sulfide, 10 mM chloride, 60 °C, 2 days). A ruler with mm scale is included, and the four positions where the diameter of the rod gradually increases are denoted by letters.

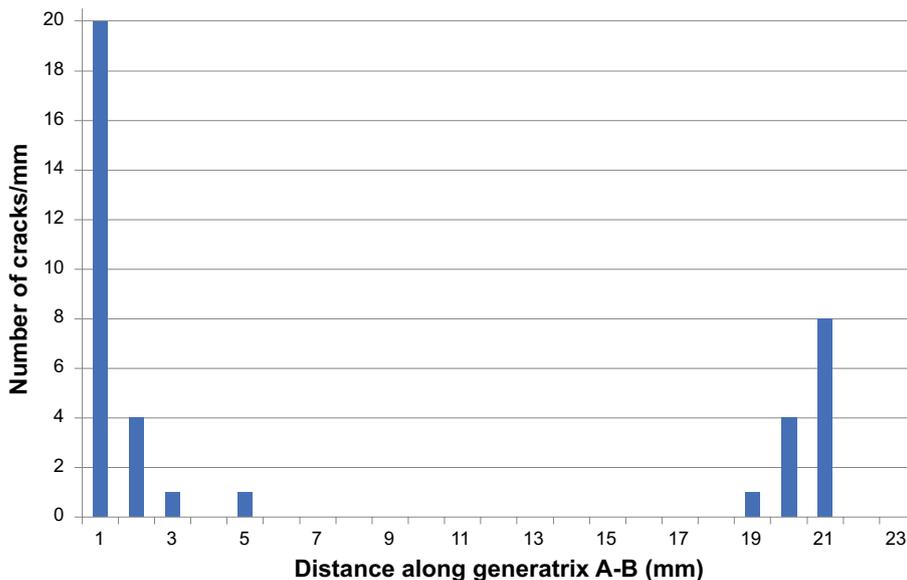
Figure 3-12. Histogram for the number of cracks found at various locations at the test rod in Figure 3-11. The longitudinal cross section was studied (Run #6, 1 mM sulfide, 10 mM chloride, 60 °C, 2 days).

SEM analysis of the longitudinal cross section revealed a number of cracks where the crack density could be correlated with the longitudinal location. Figure 3-12 shows a histogram for the number of cracks found. Figure 3-12 shows that the A-D end of the test rod had more cracks than the B-C end and that no cracks were found in the middle portion of the test rod.

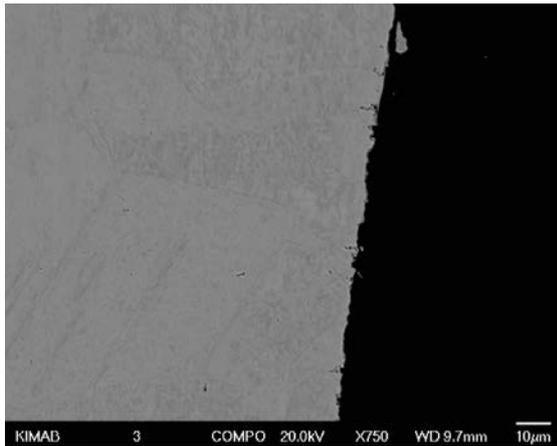
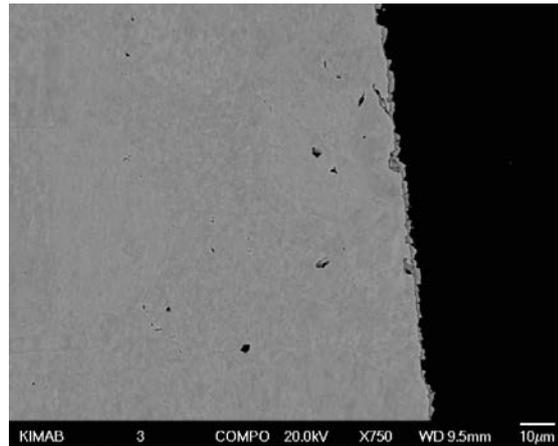
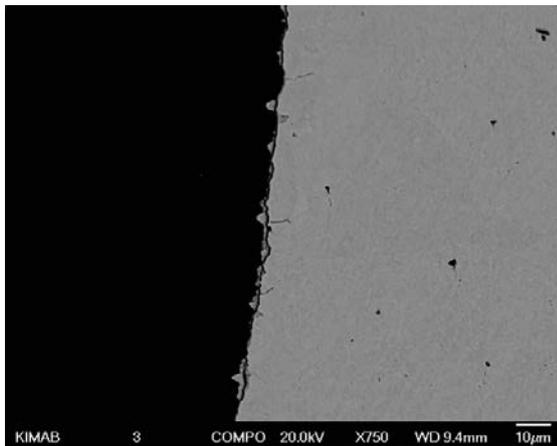
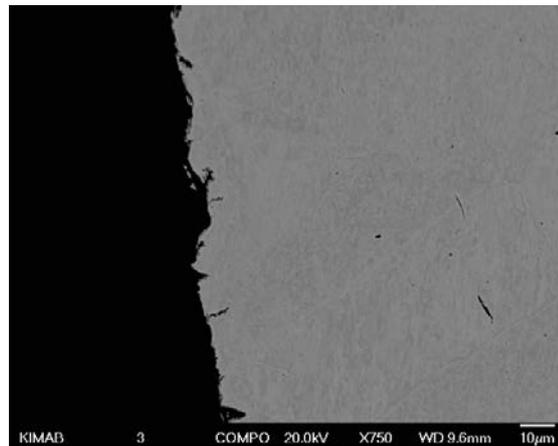
Position A

Position B

Position C

Position D

Figure 3-13 shows representative images from positions A through D in Figure 3-11. Figure 3-13 shows that the maximum depth of the cracks is in the order of 10 μm .

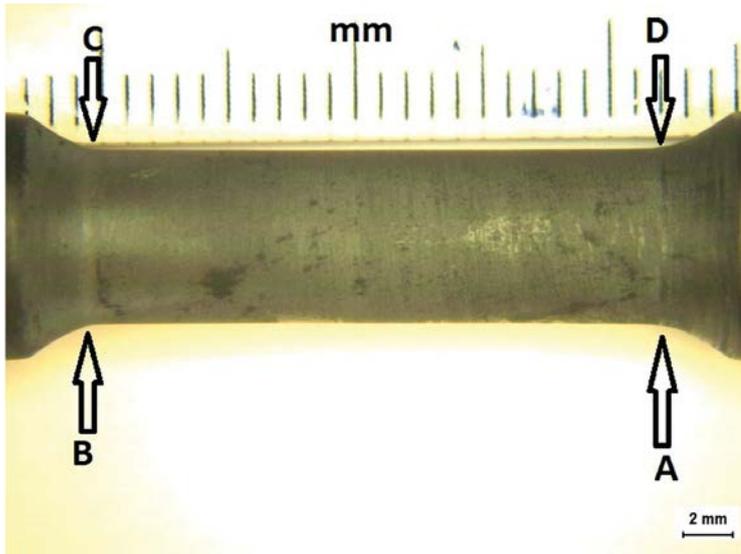
Figure 3-14. Photo of the test rod from Run#7. A ruler with mm scale is included, and two positions where the diameter of the rod gradually increases are denoted by letters (Run #7, 1 mM sulfide, 10 mM chloride, 60 °C, 4 days).

The test rod in Figure 3-14 has a more evenly dull appearance than in Figure 3-11 although some more shiny spots are visible also in Figure 3-14.

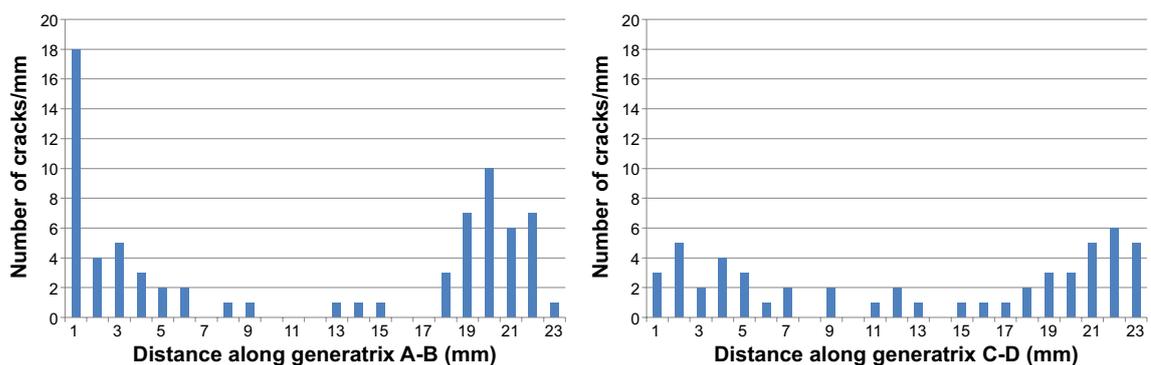
Figure 3-15. Histograms for the number of cracks found at various locations at the test rod in Figure 3-14. The longitudinal cross section was studied along generatrix A-B (left) and C-D (right), from Figure 3-14 (Run #7, 1 mM sulfide, 10 mM chloride, 60 °C, 4 days).

Figure 3-15 shows histograms for the number of cracks found after Run #7.

Comparing the histograms in Figure 3-15 with similar data in Figure 3-12, Figure 3-15 shows a similar concentration of cracks at positions A, B, C and D. However, the distribution of cracks is a bit more even in Figure 3-15 compared to Figure 3-12 and there are some cracks also close to the middle of the test rod.

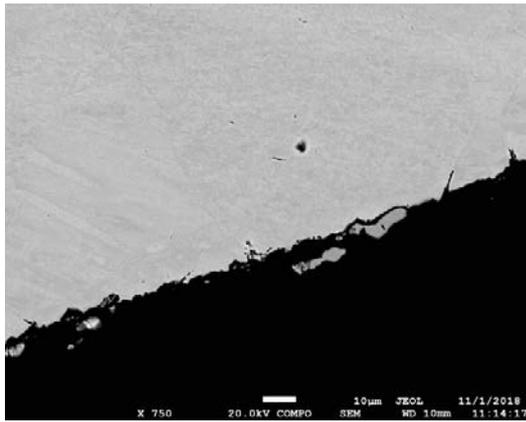
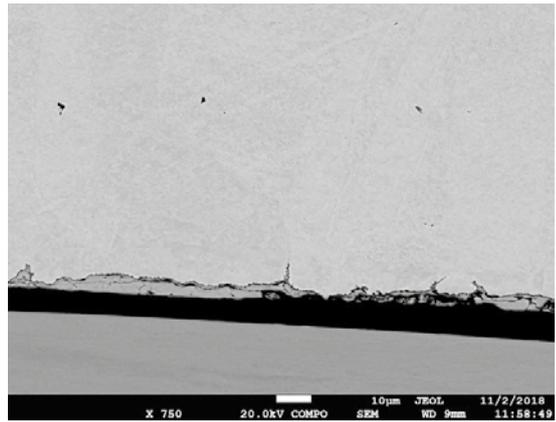
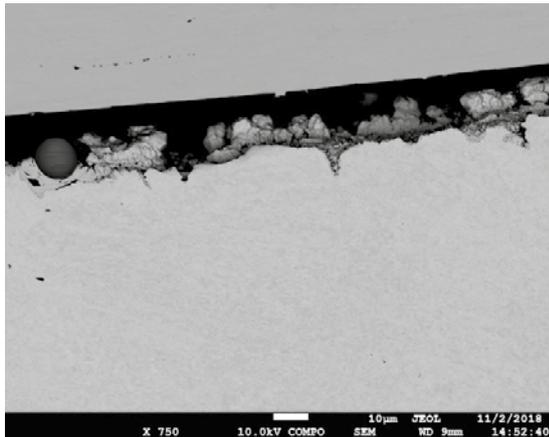
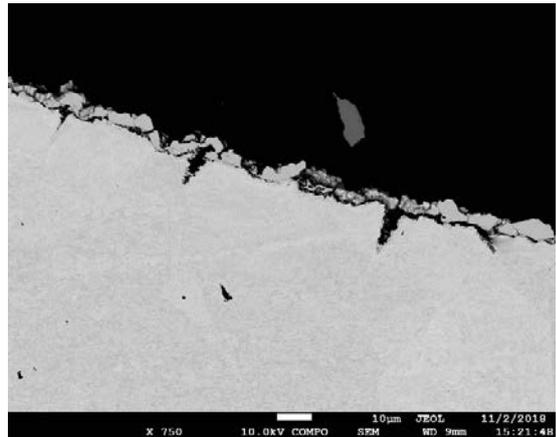
Position A

Position B

Position C

Position D

The maximum depth of penetration is in the order of 10 μm after four days of exposure. This is not significantly different from 10 μm estimated from Run #6 after two days of exposure. At failure, after 14 days of exposure in Run #5, the maximum depth of penetration was estimated to 10–20 μm .

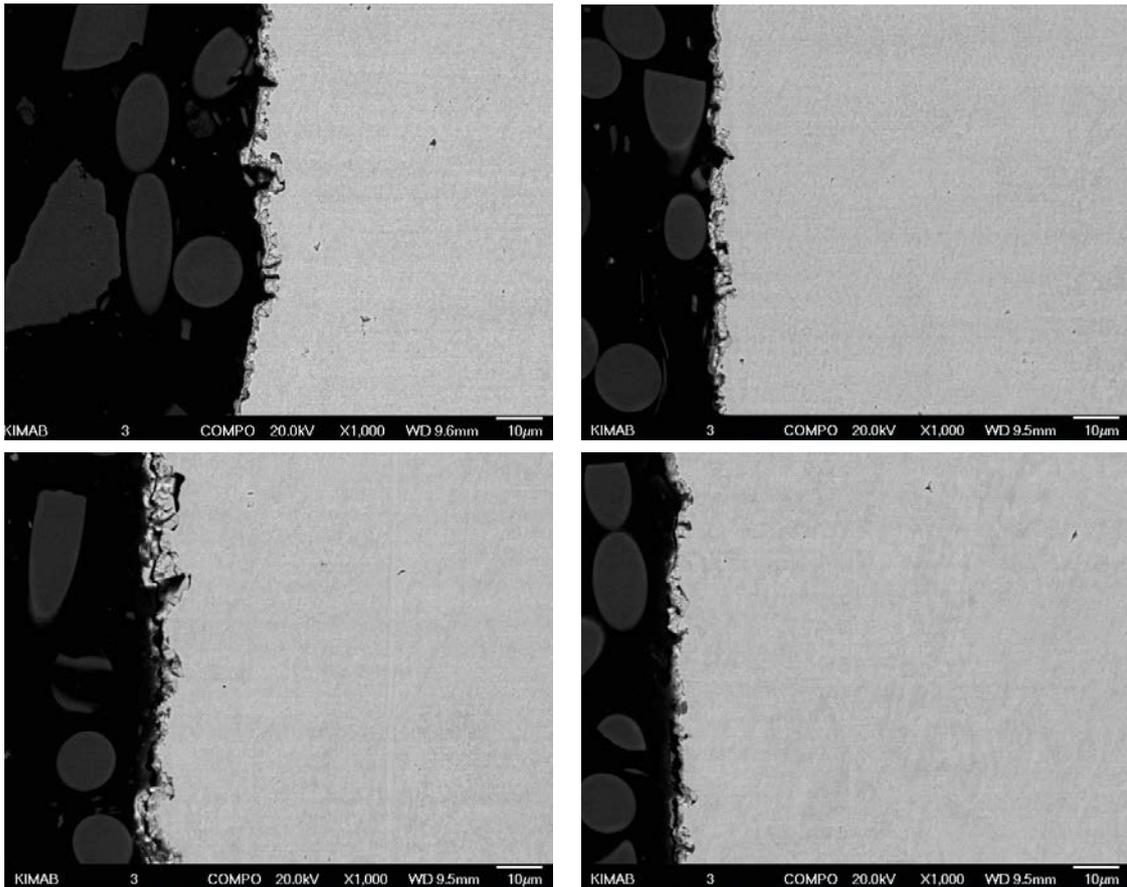
Figure 3-17. A collection of four SEM-images of the polished longitudinal cross section of the test rod in Run #8 (0.02 mM sulfide, 10 mM chloride, 60 °C).

The surface profiles in Figure 3-17 are similar to those found after Run #2 in the right column of Figure 3-5. No cracks or crack-like features are found but an unevenly corroded surface with loosely attached corrosion products.

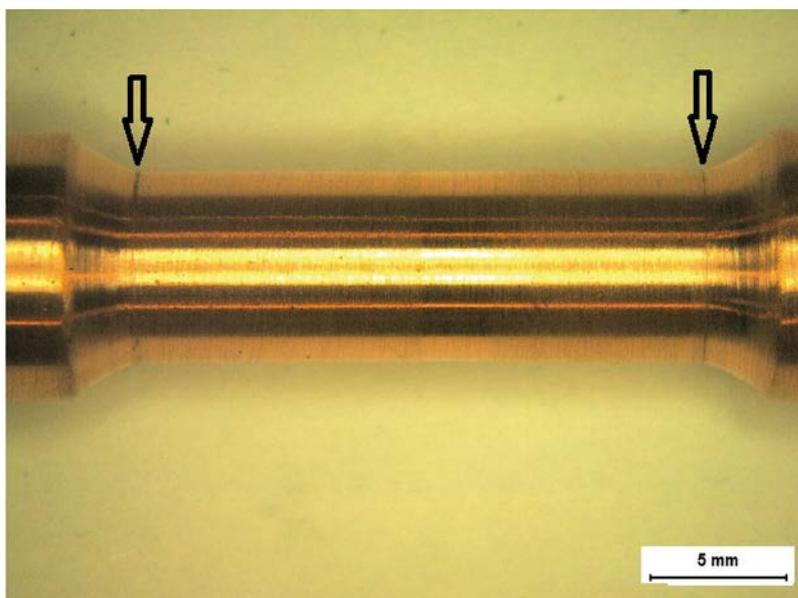
Figure 3-18. Photograph of an unexposed test rod. The arrows indicate circular patches at the border between the gauge length and the transition radius.

One unexposed test rod was also subjected to metallographic examination. Figures 3-18 and 3-19 shows photographs of the test rod.

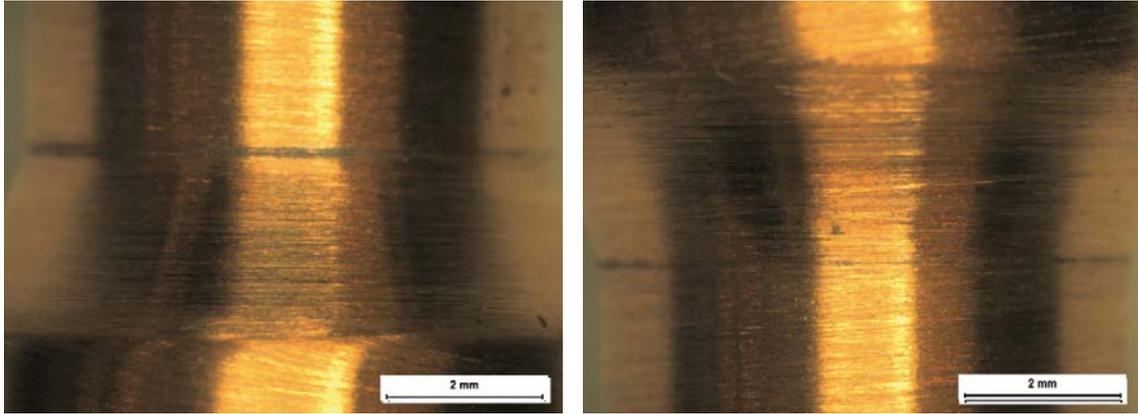
Figure 3-19. Details from Figure 3-18. Borders between the gauge length and the transition radius. Left and right, respectively (unexposed test rod).

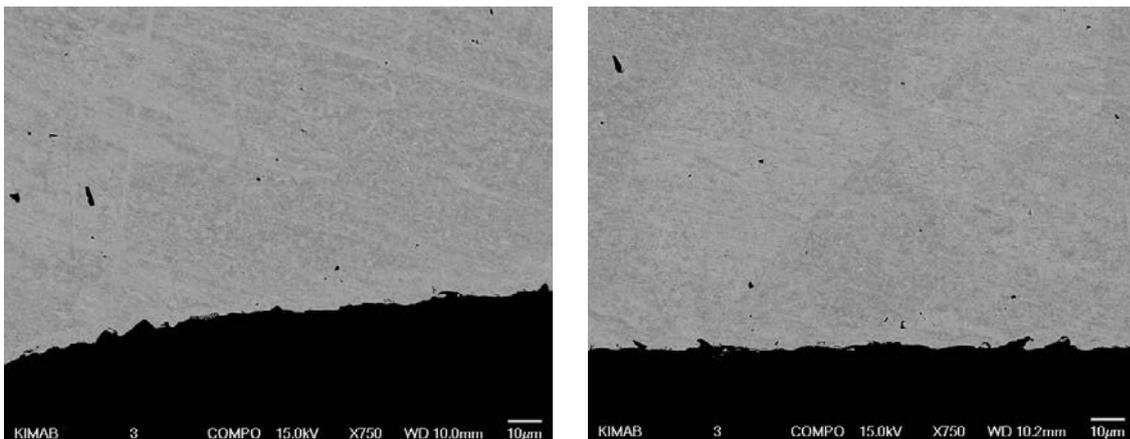
Detail of the transition radius.

Figure 3-20. SEM-images of a longitudinal cross section of an unexposed test rod.

SEM images of the longitudinal cross section are shown in Figure 3-20 and in greater detail in Figure 3-21. The images in Figure 3-21 show that there are material defects in the test rod. Some defects are fully enclosed by copper while other extend to the surface.

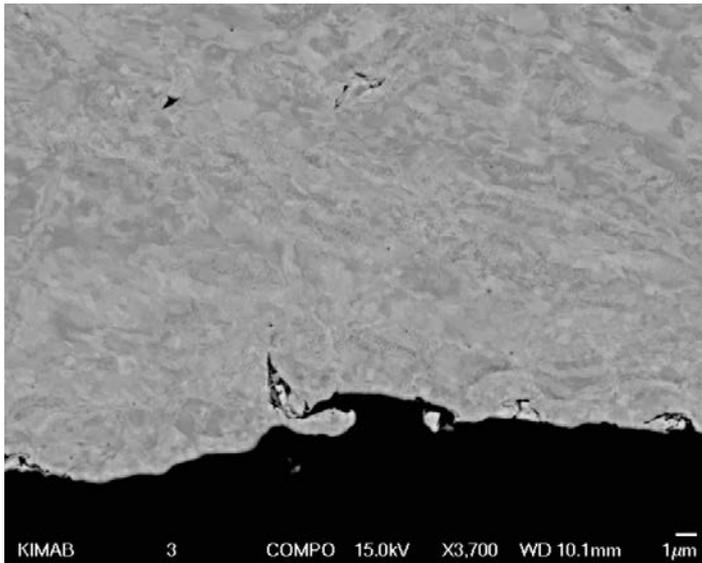
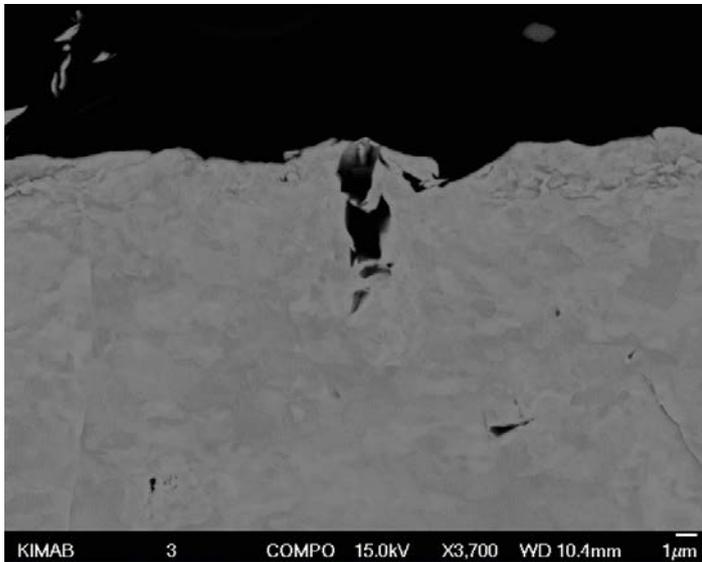
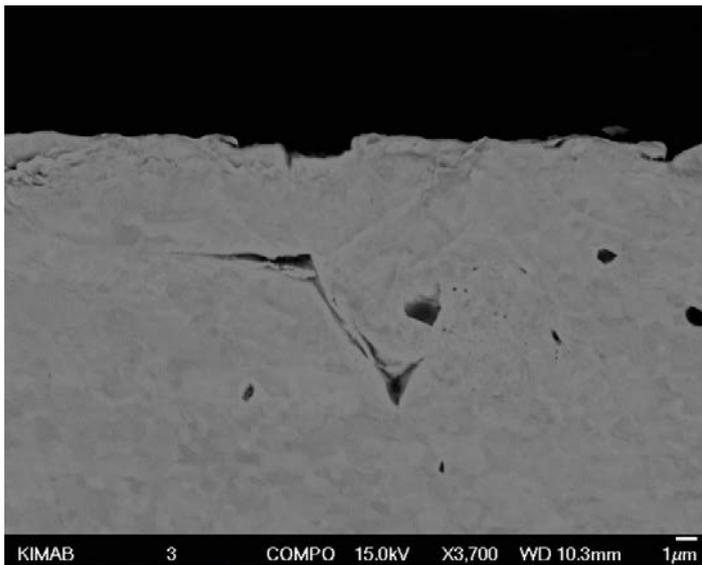
Figure 3-21. Set of three images of material imperfections found in a cross section of the unexposed test rod.

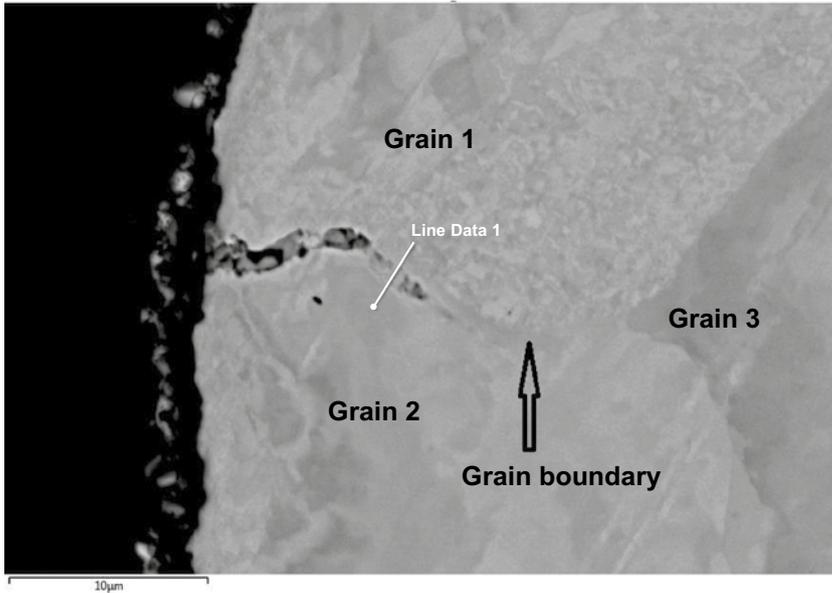
Figure 3-22. A back scatter image of the test rod from Run #1. Three distinct grains are labelled and the grain boundary along which a crack seems to have developed. The location of a line analysis is also labelled (Run #1, 1 mM sulfide, 10 mM chloride, 90 °C).

Figure 3-22 shows a back scatter image from Run #1. An intercrystalline crack is visible to a depth of about 10 μm . Figure 3-23 shows a line analysis for sulfur, oxygen and chlorine along the white line. The width of the sulfur band is about 0.8 μm . The line analyses also revealed the presence of oxygen along the line also outside the apparent boundaries of the crack but at a slightly higher concentration in the crack. A small peak for chlorine was detected in the crack.
