Technical Report

TR-19-13

Stress corrosion testing of copper in near neutral sulfide solutions

SVENSK KÄRNBRÄNSLEHANTERING AB

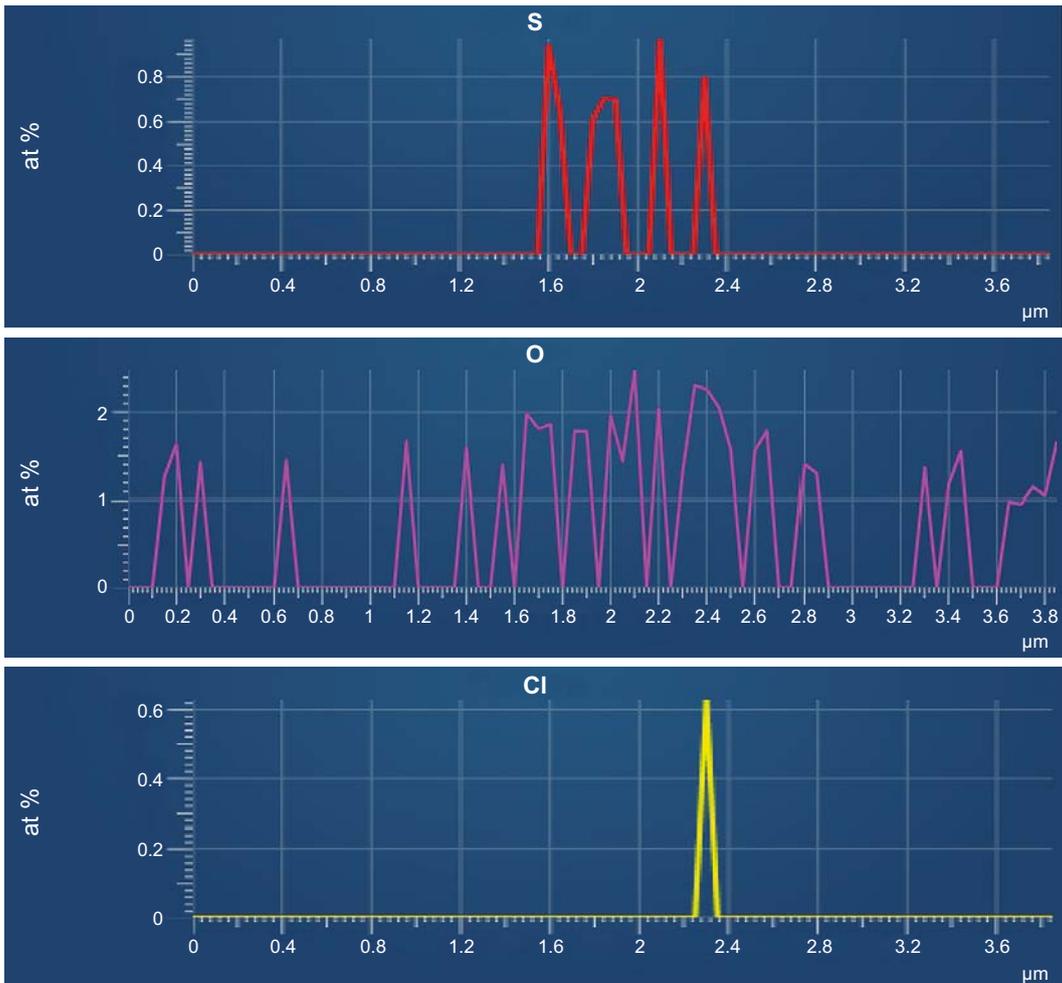
Figure 3-23. Line analysis for sulphur, oxygen and chlorine along the line in Figure 3-22.

Figure 3-22 shows a back scatter image from Run #1. An intercrystalline crack is visible to a depth of about 10 μm . Figure 3-23 shows a line analysis for sulfur, oxygen and chlorine along the white line. The width of the sulfur band is about 0.8 μm . The line analyses also revealed the presence of oxygen along the line also outside the apparent boundaries of the crack but at a slightly higher concentration in the crack. A small peak for chlorine was detected in the crack.

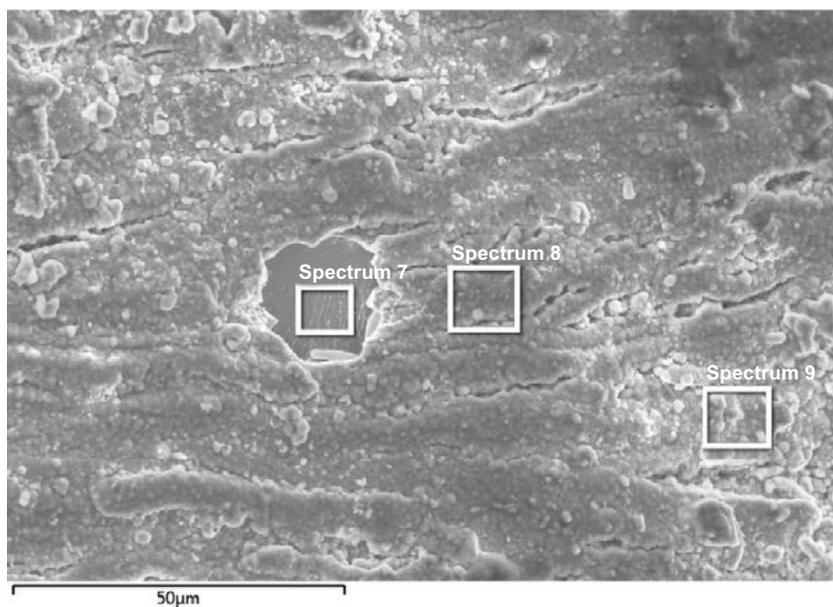
Spectrum Label	C	O	Al	Si	P	S	Cl	Ca	Fe	Cu	Tot
Spectrum 7	7.41	8.02	0	0.26	0.27	0	0	0	0	84.03	100
Spectrum 8	13.28	55.29	1.21	0.1	10.07	3.42	0.13	0.7	0.21	15.59	100
Spectrum 9	16.61	51.46	0.95	0.26	9.98	3.83	0.12	0.84	0.15	15.8	100

Figure 3-24. SEM image of the test rod from Run #2. The locations for three areas of analyses are shown. The element analyses (in at %) are also shown (Run #2, 0.02 mM sulfide, 10 mM chloride, 90 °C).

Figure 3-24 indicates that the layer contains mostly oxygen, carbon and sulphur. Spectrum 7, seemingly located at a bare spot, reveals relatively small amounts of carbon and oxygen, along with copper. Notably, a relatively high concentration of phosphorus was found in the two locations with adherent scale.

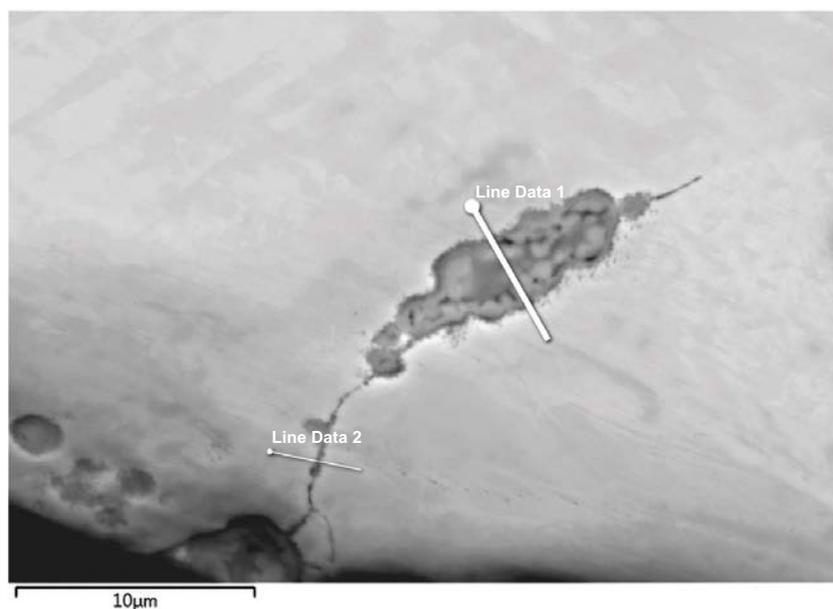
Figure 3-25. Image of the thin crack in the right image of Figure 3-7. The curves show the element analyses along the Line Data 1 (Run #3, 2 mM sulfide, 10 mM chloride, 90 °C).

Figure 3-25 shows an image of the thin crack in the right image of Figure 3-7. Figure 3-26 shows the element analyses along the Line Data 1.

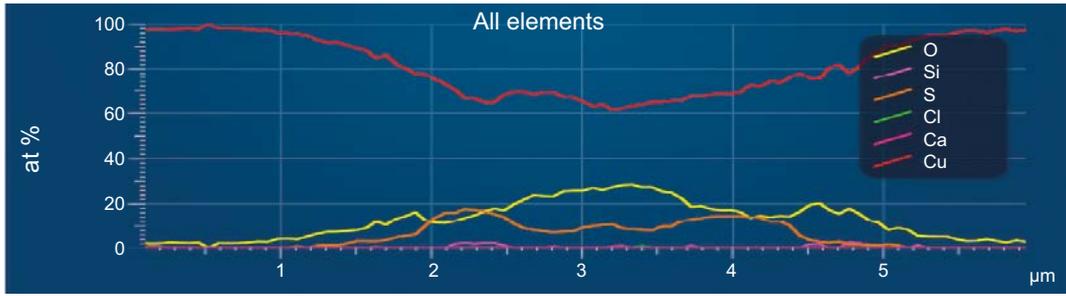
Figure 3-26. Element analyses along the Line Data 1 in Figure 3-25. (Run #3, 2 mM sulfide, 10 mM chloride, 90 °C).

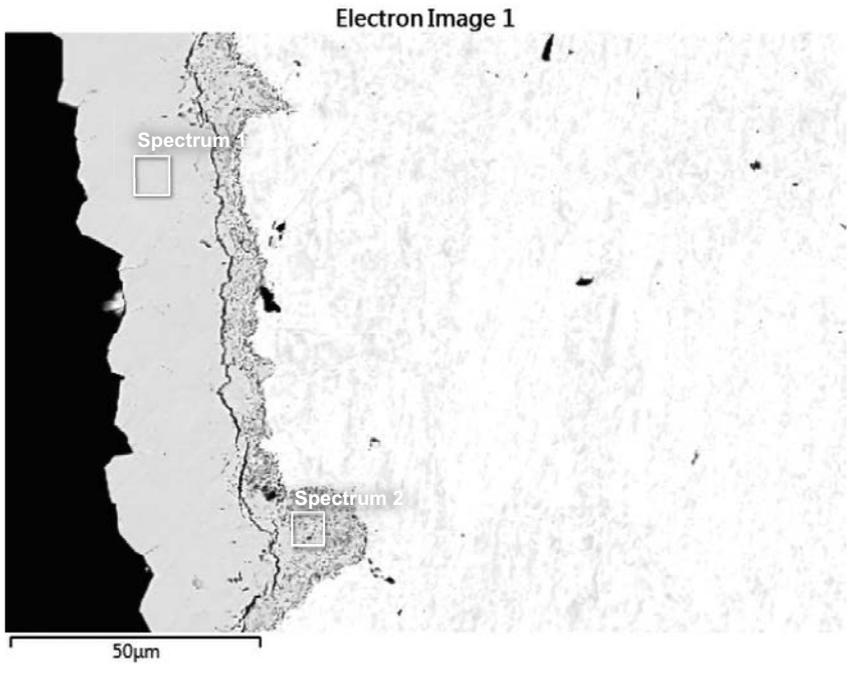
Spectrum Label	C	O	Si	S	Cl	Cu	Tot
Spectrum 1	3.65	0.42	0.09	29.04	0	66.8	100
Spectrum 2	5.11	4.11	0.23	25.96	0	64.59	100

Figure 3-27. An image of the polished longitudinal cross section of the test rod from Run #4. The element analyses (in at %) are also shown (Run #4, 1 mM sulfide, 100 mM chloride, 90 °C).

The image in Figure 3-27 shows what appears to be two distinct layers of corrosion products with very similar compositions. The outer layer appears more crystalline or at least more dense and the inner layer seems more porous. The layers of corrosion products are much thicker than for the previous runs, at least the corrosion products that adhere to the copper surface. This was observed also in Figure 3-8 from the same test rod.

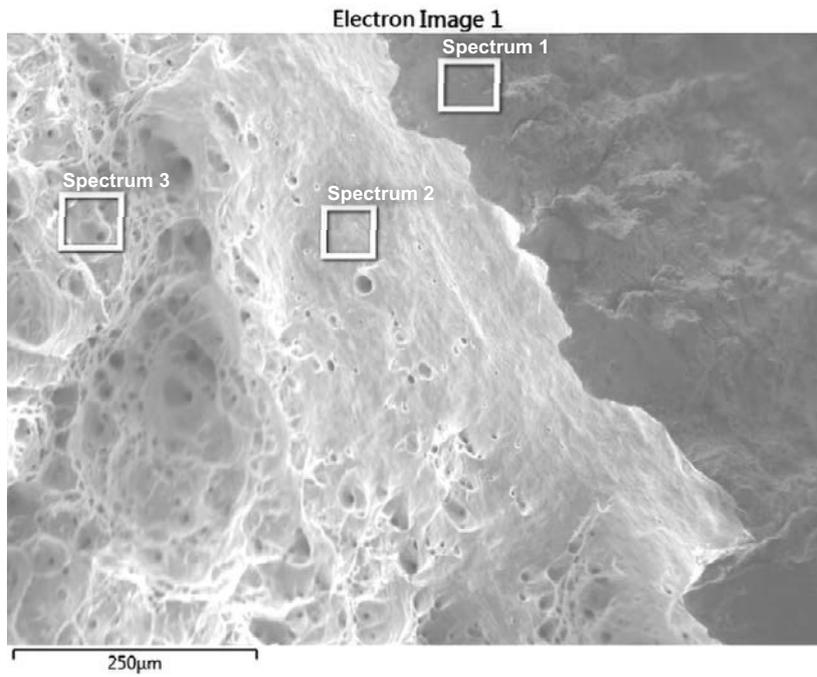
Spectrum Label	C	O	Si	S	Ca	Cu	Tot
Spectrum 1	0	1.39	0.64	11.21	0.18	86.58	100
Spectrum 2	0	0	0.82	8.19	0.17	90.82	100
Spectrum 3	0	0	0	2.61	0	97.39	100

Figure 3-28. SEM image of the test rod from Run #5, 1 mM sulfide, 10 mM chloride, 60 °C. The fracture zone is seen to the left and the outer surface to the right. The locations for three areas of analyses are shown. The element analyses (in at %) are also shown.

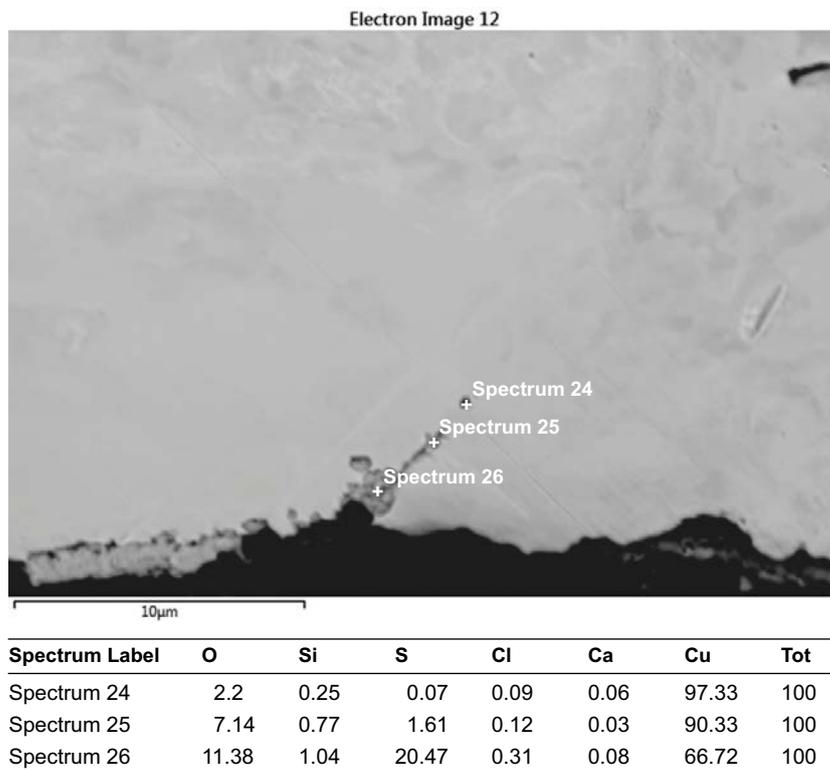
Figure 3-30. Image of the polished longitudinal cross section of the test rod from Run #7, 1 mM sulfide, 10 mM chloride, 60 °C, 4 days. The locations for three areas of analyses are shown. The element analyses (in at %) are also shown.

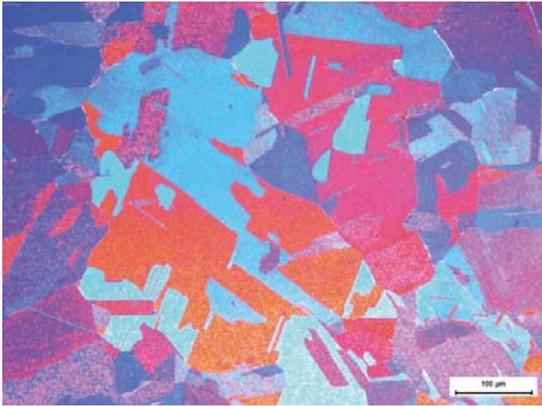
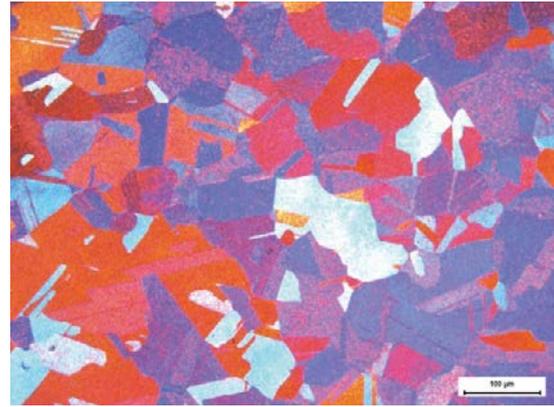
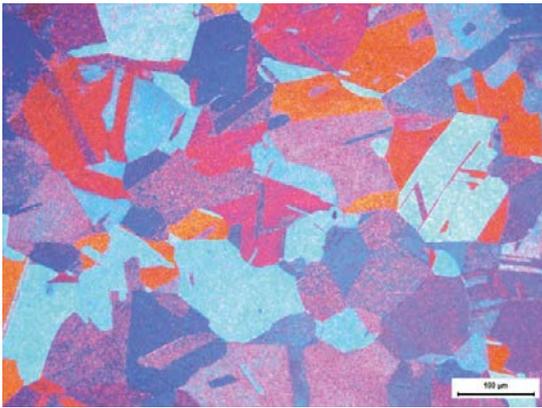
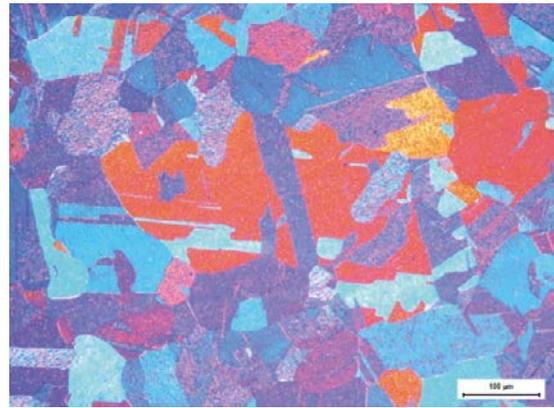
Test rod from Run #5

Test rod from Run #6

Test rod from Run #7

Unexposed test rod

As the images in Figure 3-32 show, the grains are highly irregular in shape. Counting the number of grain boundaries from left to right in the image of the unexposed test rod, we end up with values between 17 and 21. The image spans a distance of 704 μm, from left to right. Divided by the number of grains, say 20, a measure of the average grain size is about 35 μm.

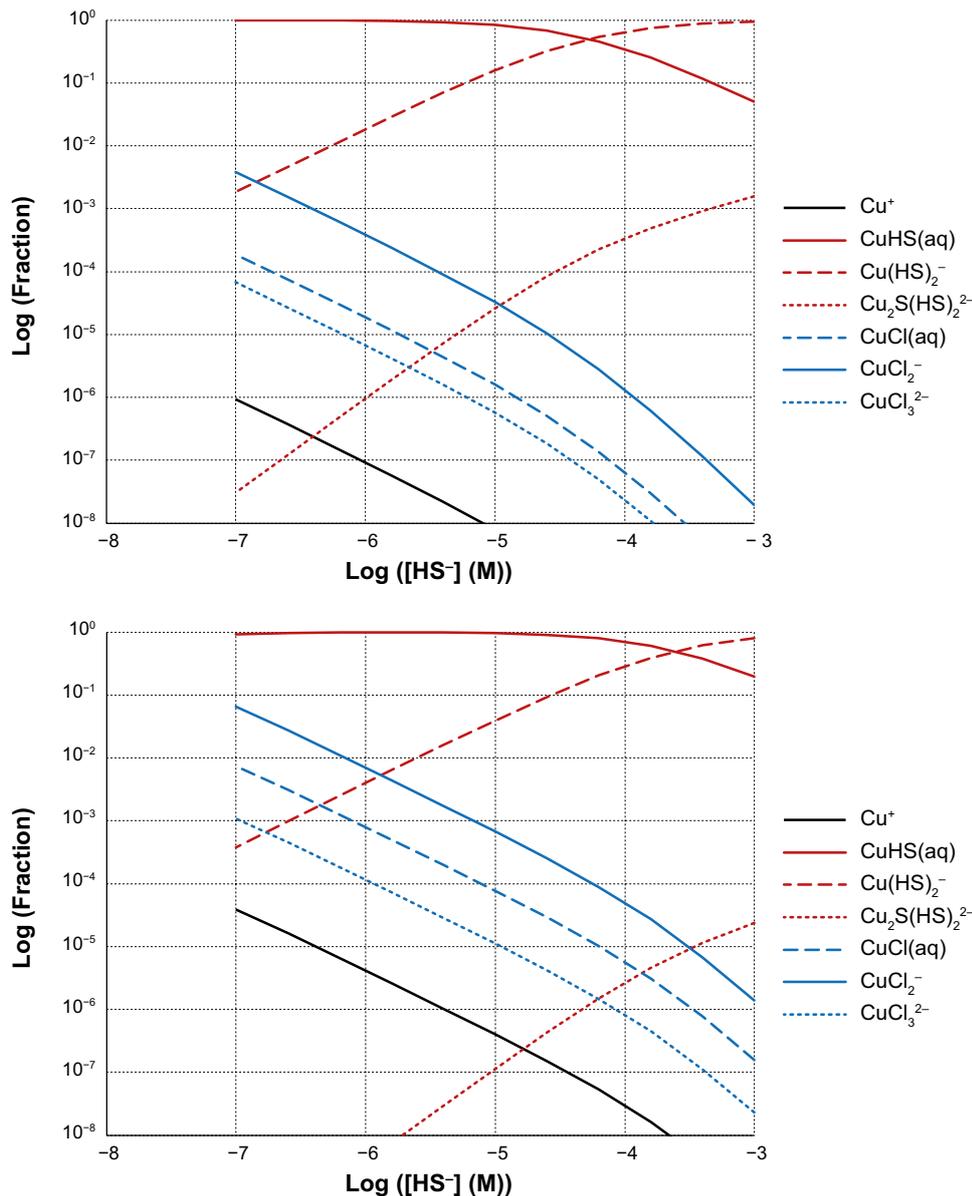
Figure 4-3. Distribution diagrams for dissolved copper in 0.1 M chloride as function of sulfide ion concentration. 25 °C upper diagram and 90 °C lower diagram.

While Figure 4-2 shows that copper chloride complexes cannot be significant primary corrosion products because the corrosion potential, at least at 90 °C, is too low, Figure 4-3 shows that a ligand exchange from sulfide to chloride can also not be significant.

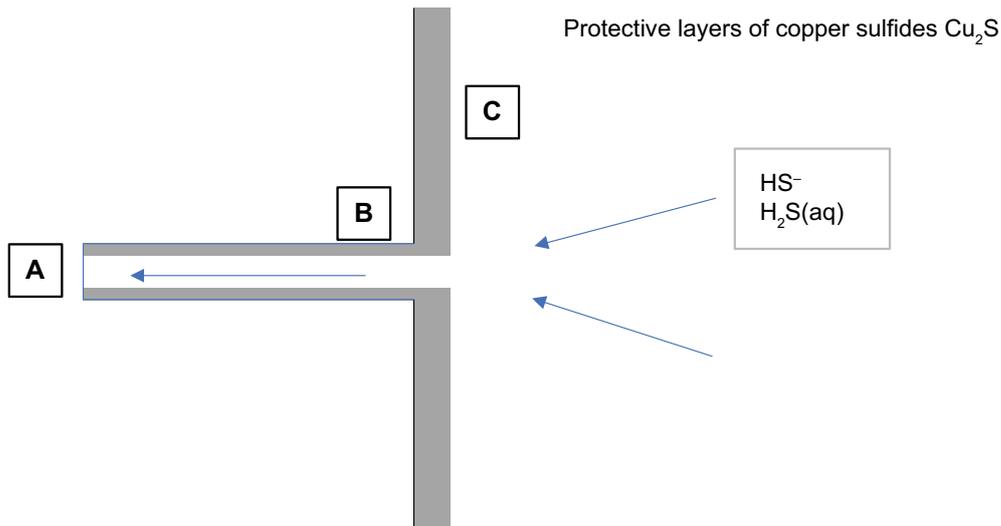
Figure 4-4. Sketch of a propagating crack induced by sulfide from the solution.

Sulfide, in near neutral solutions, appears in two aqueous forms, hydrogen sulfide ion, HS^- and dihydrogen sulfide $\text{H}_2\text{S}(\text{aq})$. The latter neutral $\text{H}_2\text{S}(\text{aq})$ dominates below pH 7.0 and HS^- dominates at higher pH values. In the tested solutions with pH values between 7.2 and 7.5 only about 10 % of the total sulfide concentration is present as $\text{H}_2\text{S}(\text{aq})$.

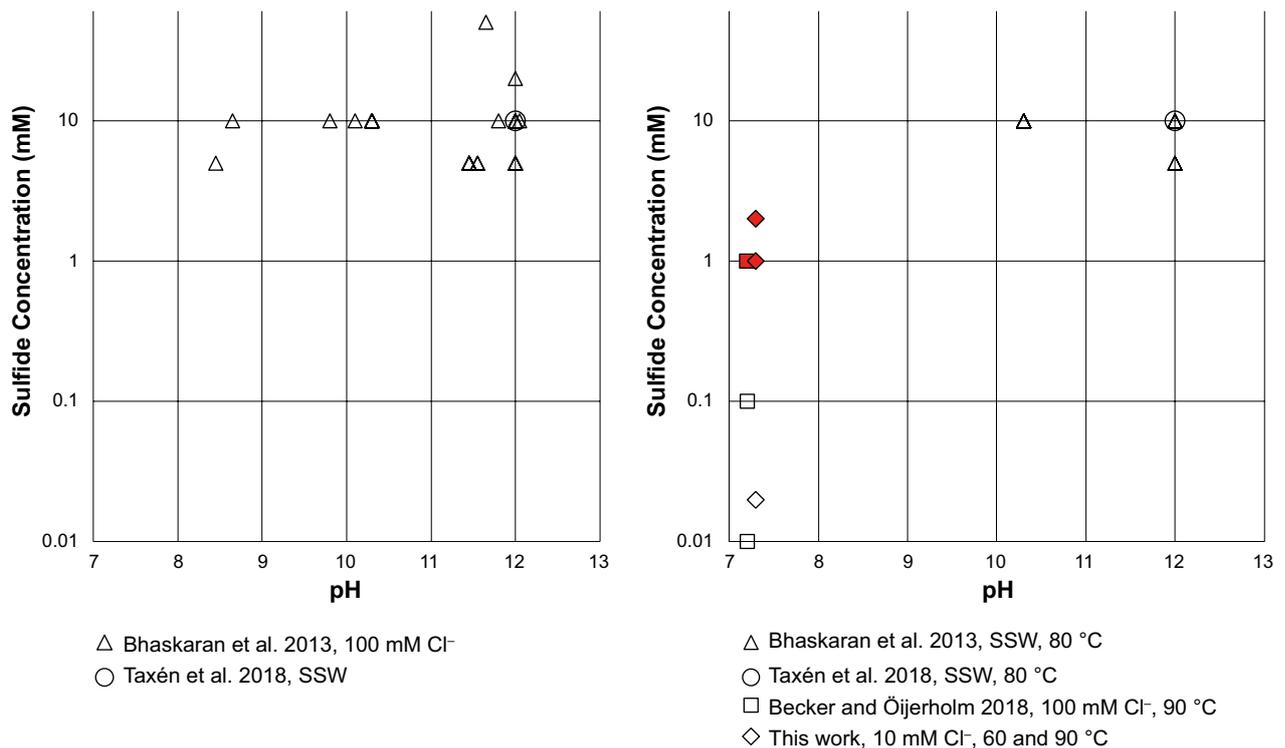
Figure 4-5. Summary of the experimental result from previous work on SSRT testing of SKB-copper. Room temperature results in the left diagram and results for higher temperatures in the right diagram. Red symbols indicate conditions where signs of SCC were found.
