**Feasibility study of detection of  
defects in thick welded copper**

**Tekniska Röntgencentralen AB  
Stockholm, Sweden April 1983**

The report describes a feasibility study of detecting defects in welded material using focussed ultrasonic beams. The ultrasonic testing has been applied to both electron beam welded thick walled copper containers and copper containers sealed by hot isostatic pressing.

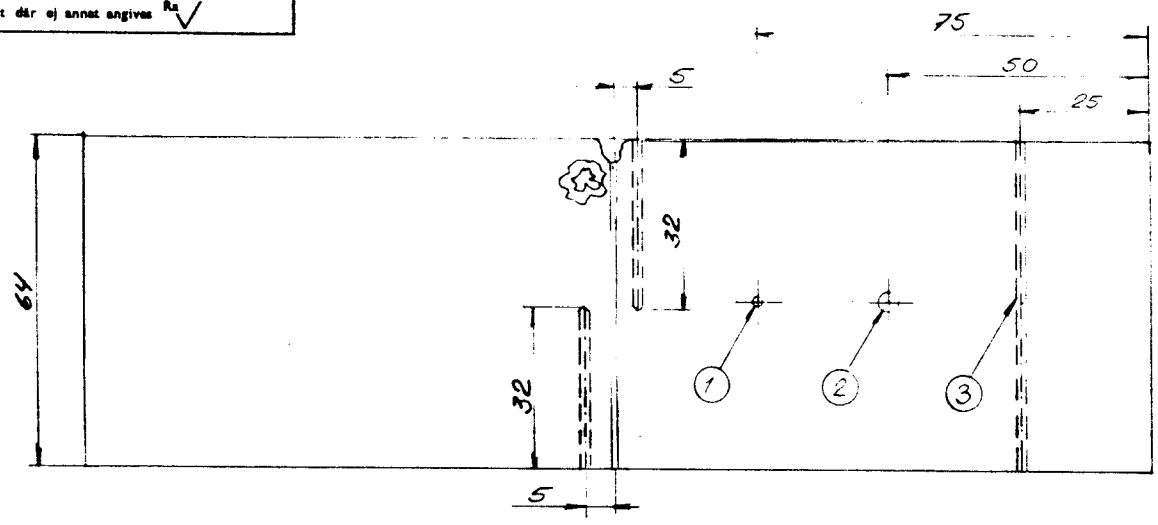
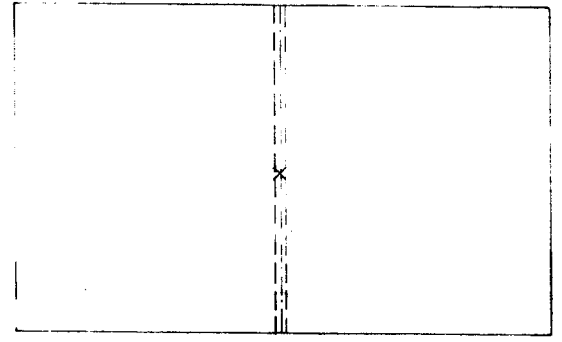
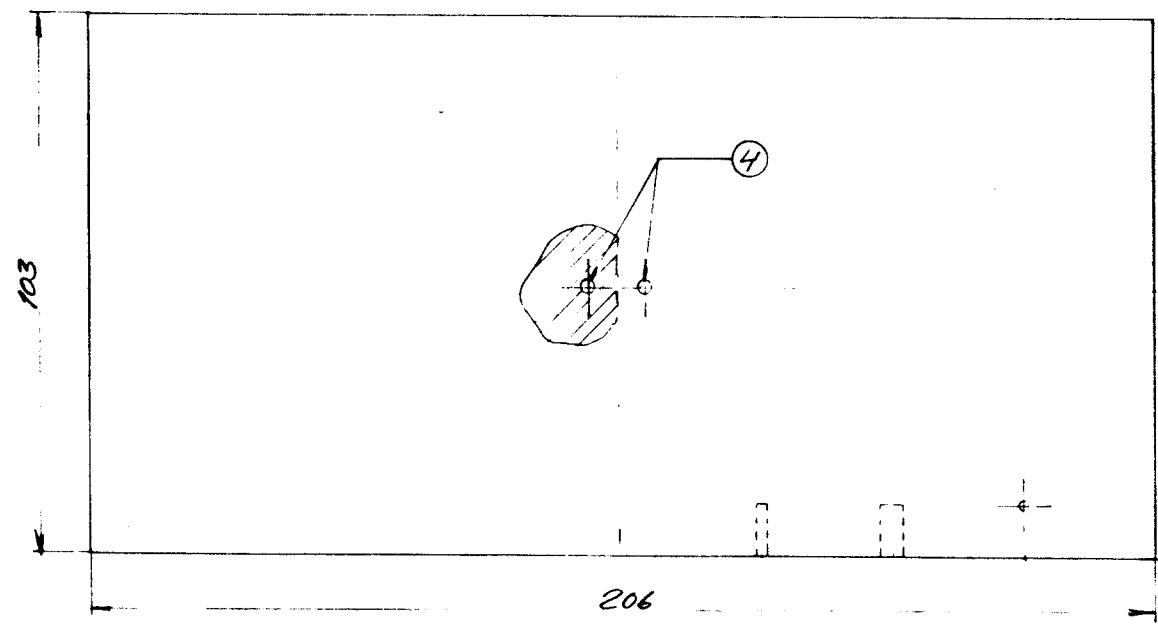
SVETSPROV				KOPPAR			
Det.-nr	Ant.	Bemärkning		Material		Med.-nr Åmso Dimension	
Konstr.	Ricad	Kop	Konstr.	Scand	Godk	Skala	Erstgör
	CGO					///	
<b>TRC</b>						SKBF MANTELPROV BRÄNSLEFÖRVARING	
						Dat. 1982-06-02	
						Rita.-nr SP 30186

Representative defects for sensitivity calibration and sizing in the form of cylinder boreholes and flat bottom holes have been made in a copper block at actual sound paths. See drawing SP No 30186, enclosure 1.

Defect No	Type of Defect	Diam	Length
1	Flat bottomed hole	Ø2	10
2	"-	Ø4	10
3	Cylinder borehole	Ø2	64
4	"-	Ø2	32

For detailed information see appendix 1 drawing SP 30186, appendix 3 drawing SP 30200 and appendix 5 drawing SP 30201.

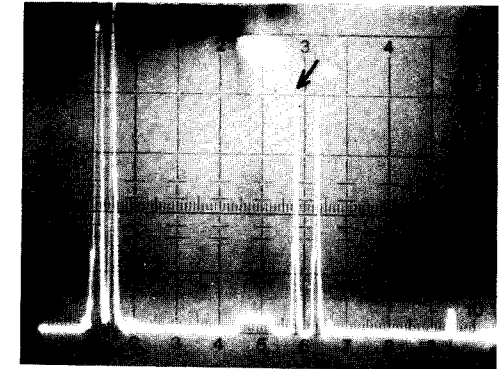
flat bottomed hole Ø2 mm 50dB

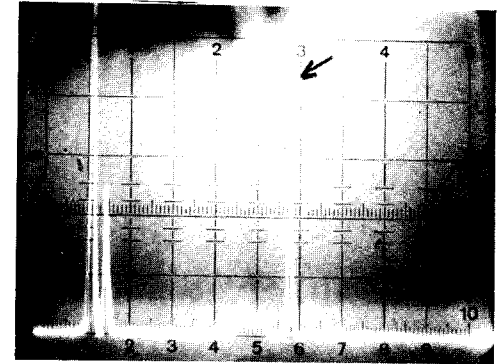
flat bottomed hole Ø4mm 40dB

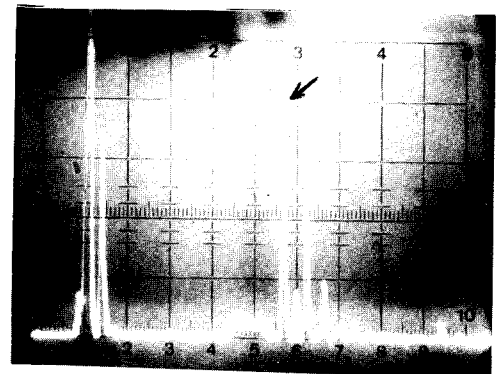
cylinder borehole Ø 2mm 44dB

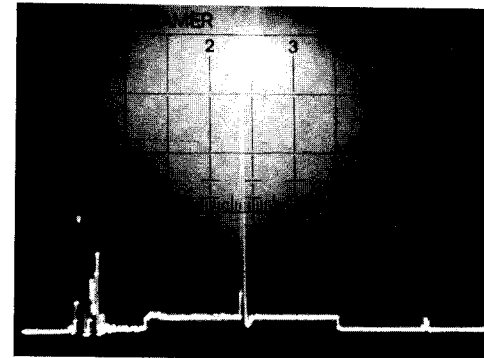
Ø2 cylinder borehole  
"above" weld

On registration sheet 2 one can see in addition to the sensitivity calibration a registration aiming at assessing the differences in sensitivity for two equally sized reference defects placed above, respectively below, the welded zone. The relative difference was measured to be 6dB.

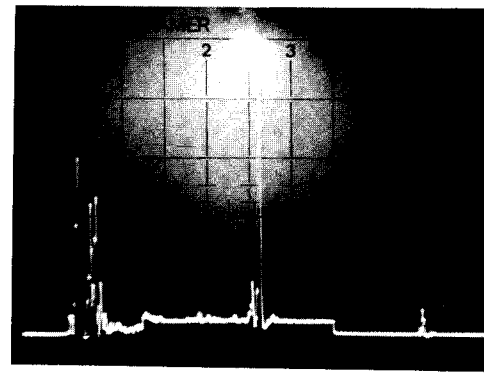
Ø2 cylinder borehole  
"below" weld

The relative  
sensitivity  
is 6dB lower

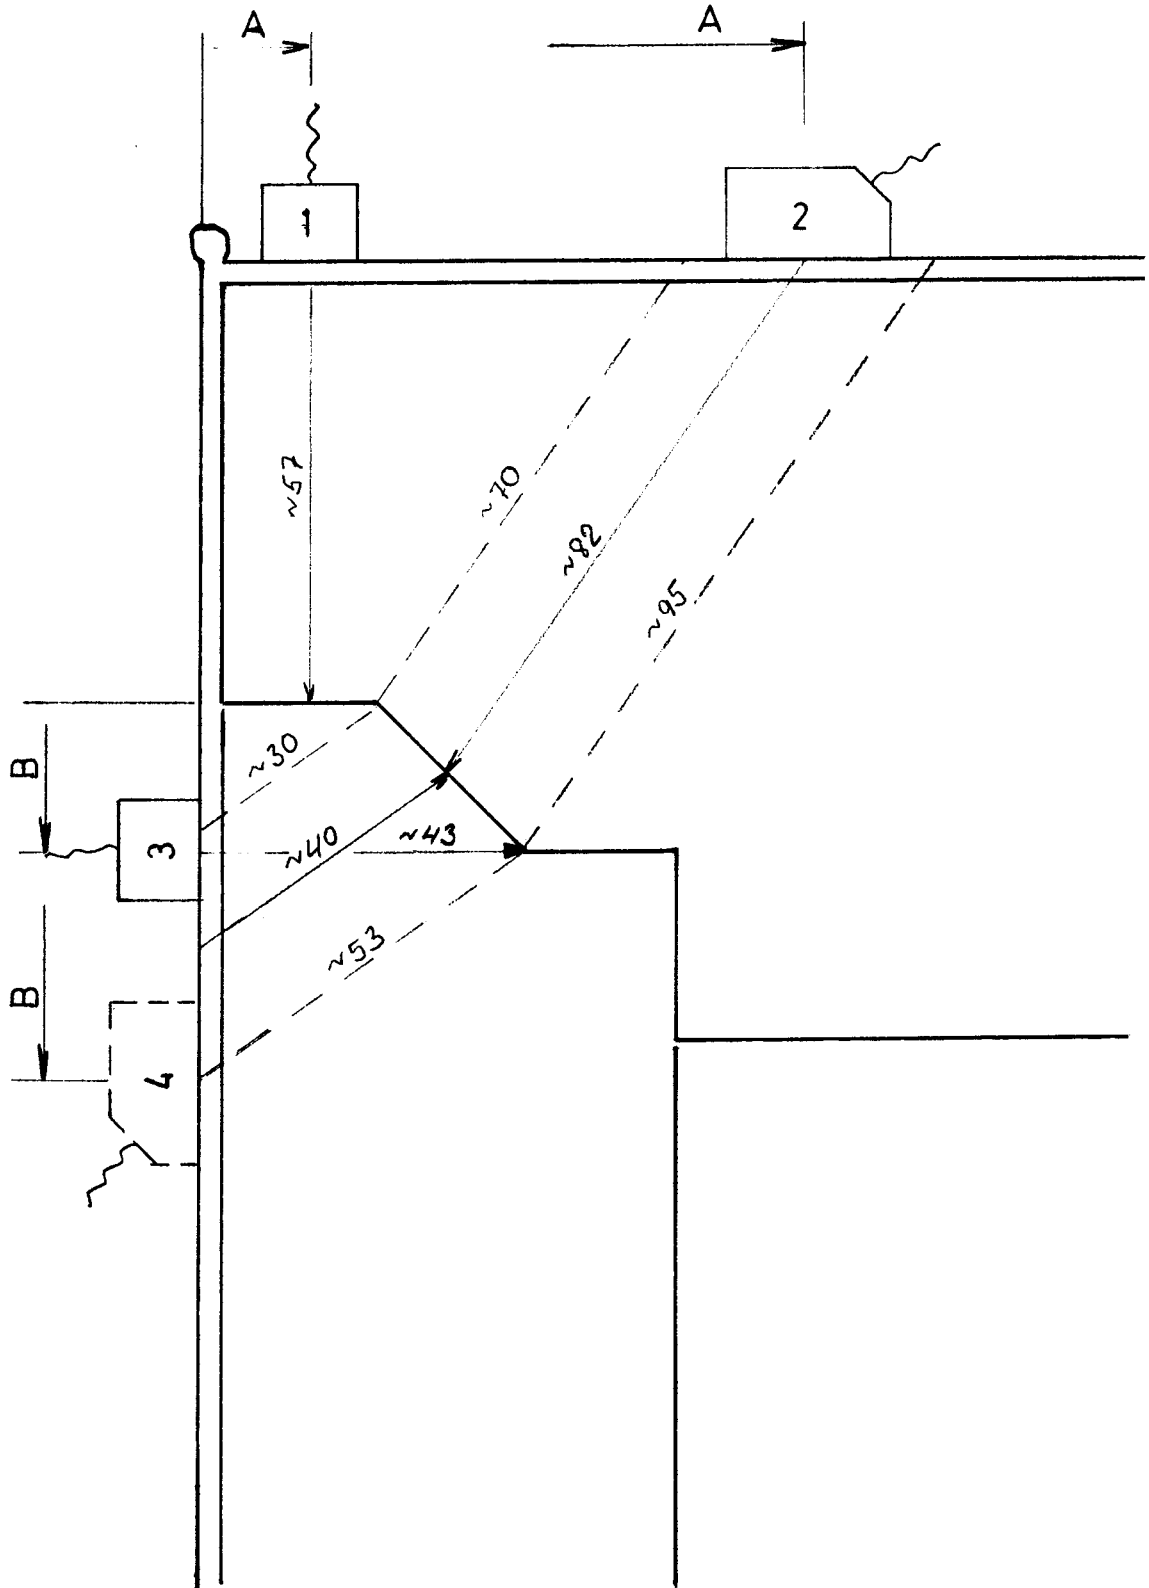
SKBF - Manual ultrasonic testing of copper canister.  
Directions of probing

Testing was performed from the outer surfaces of the lids and from the outer surfaces of the cylinder, see drawing "Directions of probing".

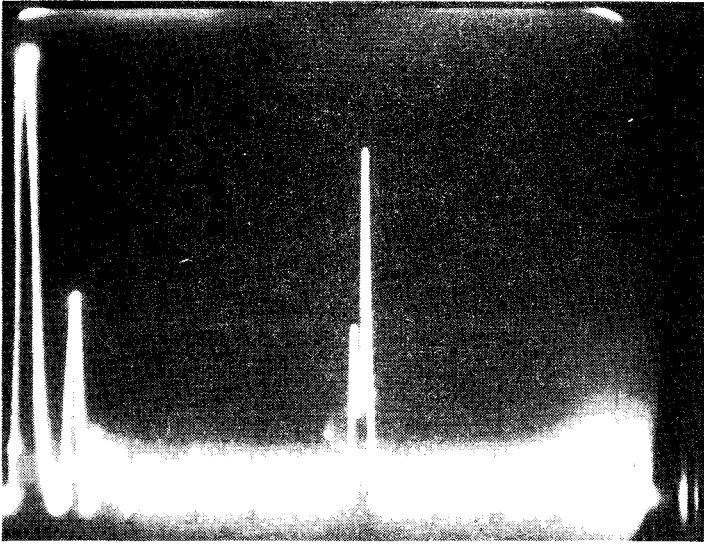
Photo no 1

With normal beam probe in position 1, indications were obtained throughout the whole tested area, see photographs nos 1 and 7.

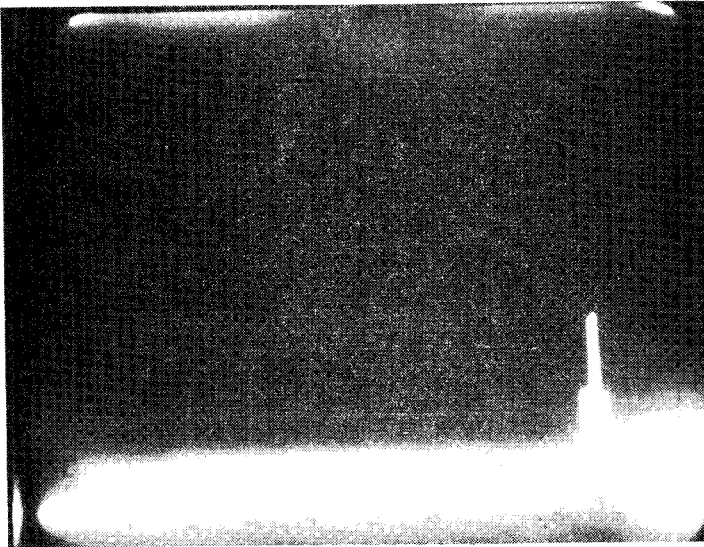
Photo No 2

With angle beam probe in positions 2 and 4 indications were obtained in randomly chosen areas. See photographs nos 2, 4, 5, 6, 8, 10, 11 and 12.

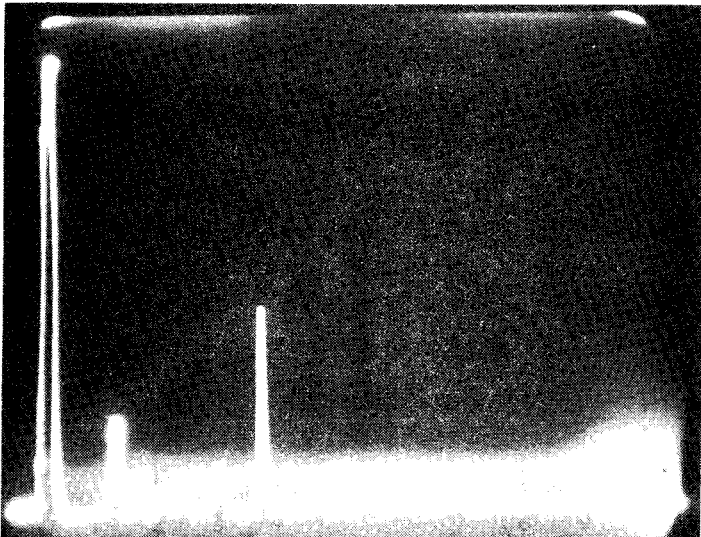
Photo no 3

With normal beam probe in position 3, indications were obtained in randomly chosen areas, see photographs nos 3 and 9.

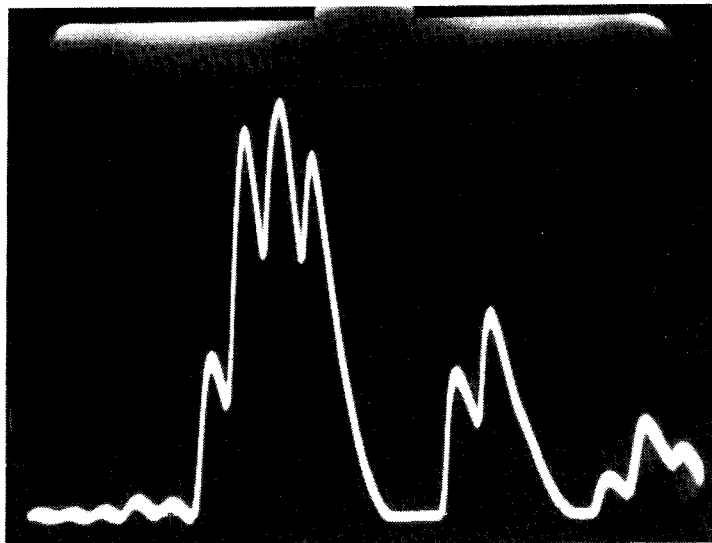
Photo no 13

Local lack of bonding between copper sheet and cylinder and between sheet and lid could be established, see photograph no 13.

Photograph no 13 shows a position where the sheet-metal 2.5 mm has not been bonded to the container.

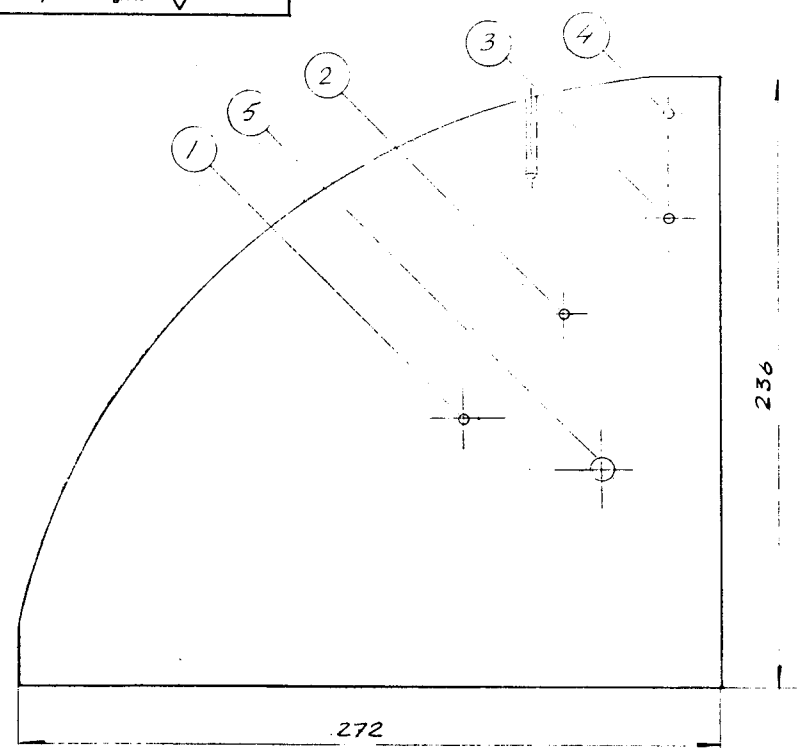
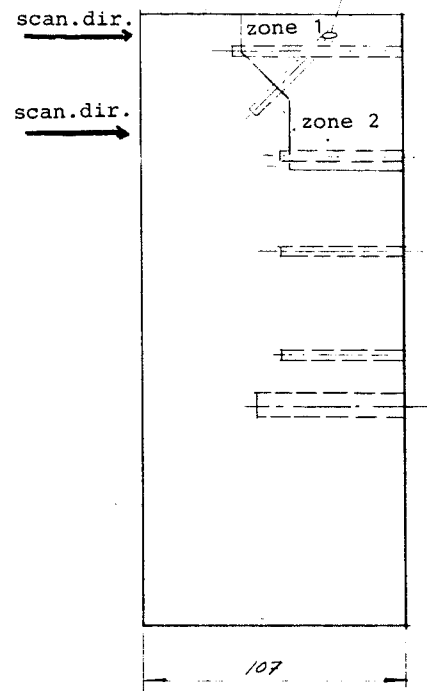
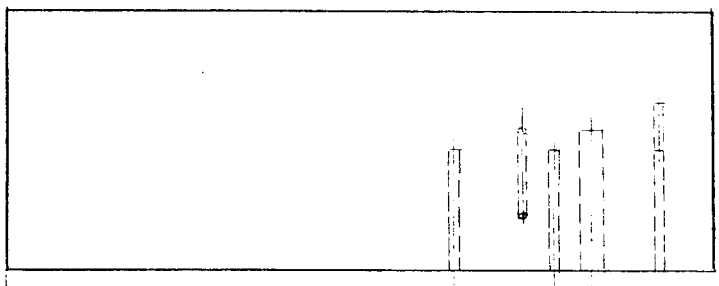
Det.-nr		Ant.	Benämning			Material	Mod.-nr Ämne Dimension	Anm.	
Konstr.	Ritad	Kop.	Konstr.	Stand.	Godk.	Skala	Erstärer	Erstär av	
TRC		RGH	SKBF. Bränsleför- varing.			1:2	SP 30200		Dnr 830408
TEKNISKA RÖNTGENTCENTRALEN AB		Svetsprov Robertsfors 1					Rien.-nr

Pos.	Designation	Diam.	Depth	Comment
1	Flat bottomed hole	3.0 mm	35 mm	From scanned end
2	"-	3.0 mm	53 mm	"-
3	"-	3.0 mm	53 mm	"-
4	"-	3.0 mm	35 mm	"-
5	"-	10.0 mm	45 mm	"-
6	"-	3.0 mm	62 mm	"-

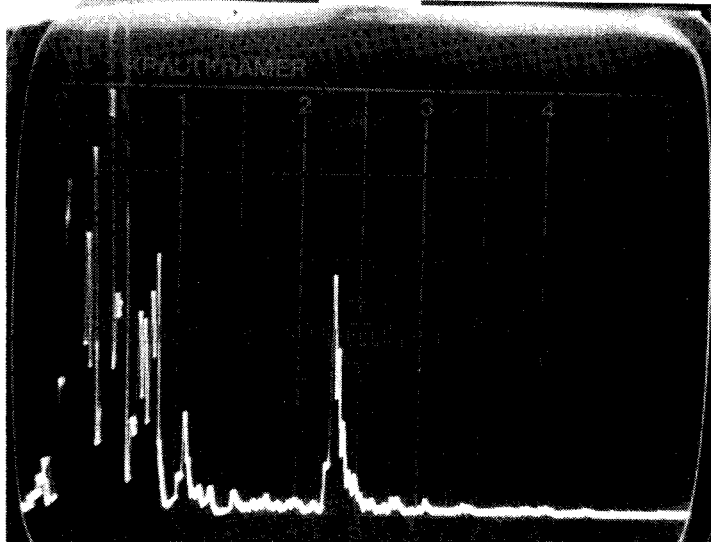
Figure 1  
Flat bottomed hole  $\varnothing$  10 mm  
Sound distance 45 mm  
Amplification 46 dB  
Water distance 105 mm

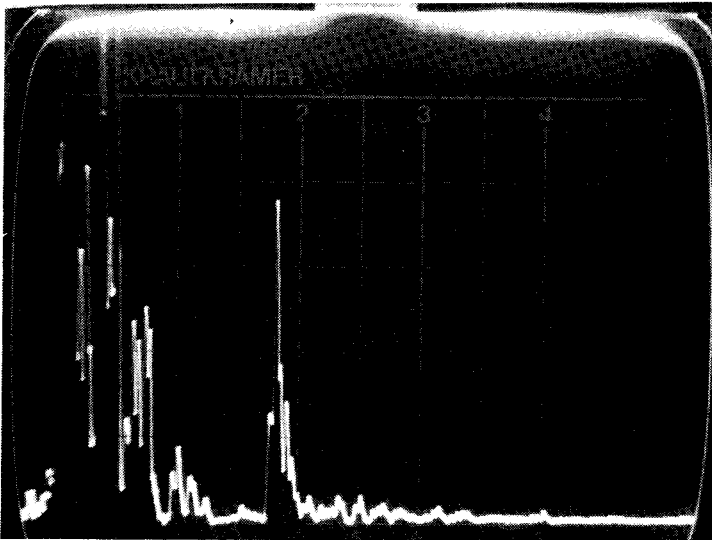
Figure 2  
Flat bottomed hole  $\varnothing$  3 mm  
Sound distance 35 mm  
Amplification 46 dB  
Water distance 105 mm

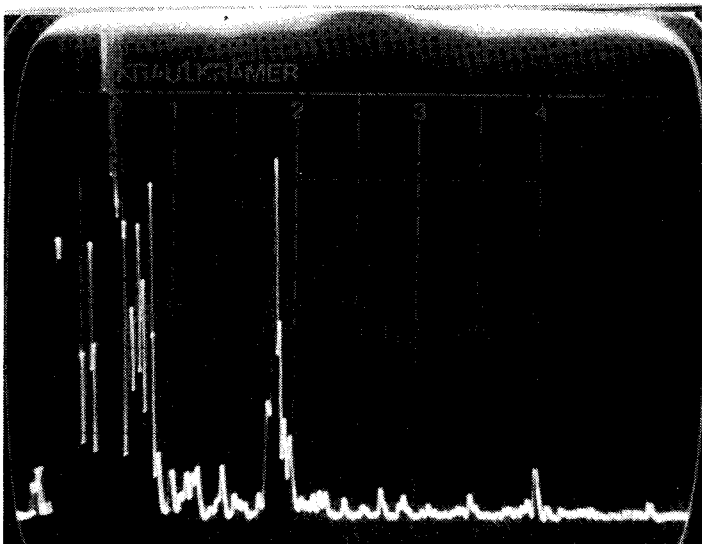
Figure 3  
Indication from welded zone  
Sound distance 35 mm  
Amplification 46 dB  
Water distance 105 mm

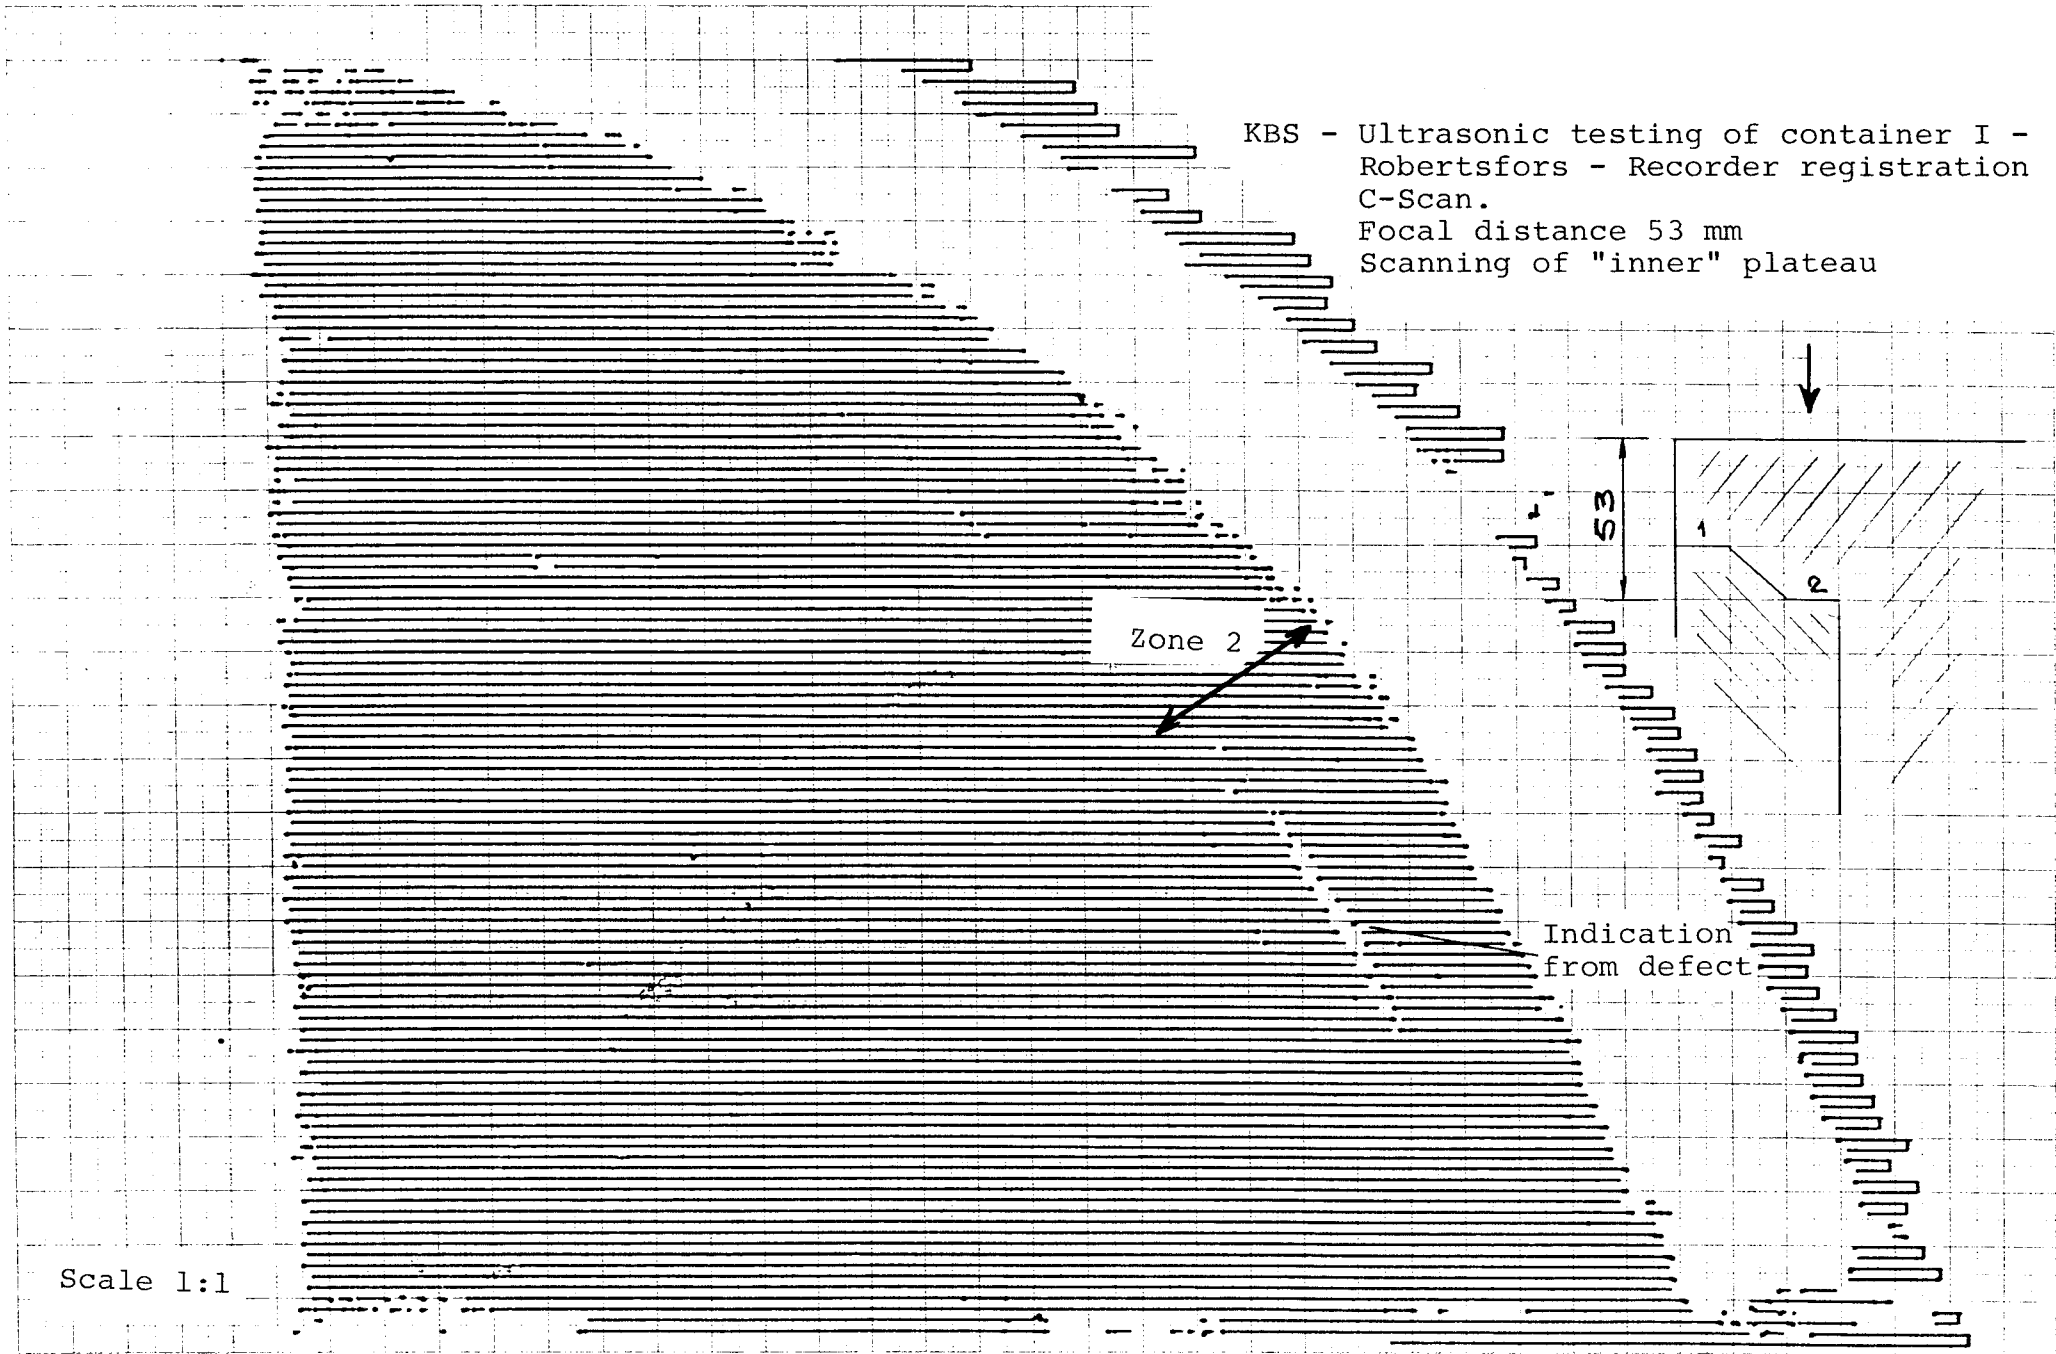
KBS - Ultrasonic testing of container I -  
Robertsfors - Recorder registration  
C-Scan.  
Focal distance 53 mm  
Scanning of "inner" plateau

3. Later when mechanised examination was performed it was verified that this sample showed big discrepancies. As can be seen in appendix 3 zone 1 is indicated as a large defect. In zone 2 one indication of major size was found.

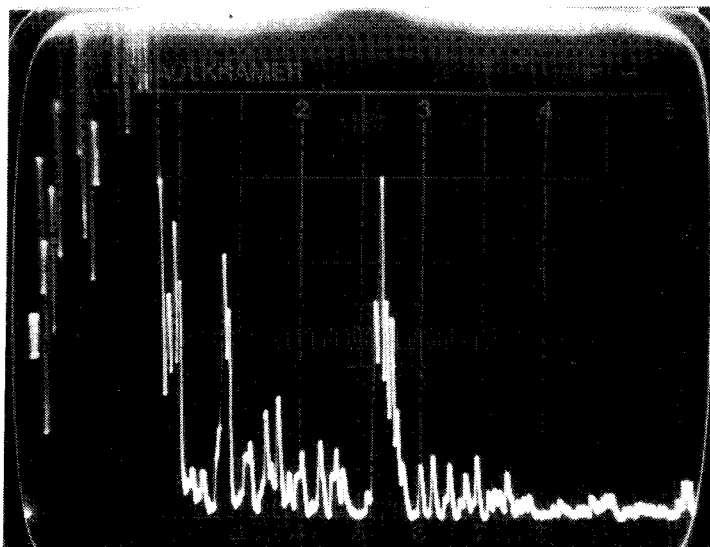
Figure 4  
Flat bottomed hole  $\varnothing$  3 mm  
Sound distance 53 mm  
Amplification 60 dB  
Water distance 45 mm

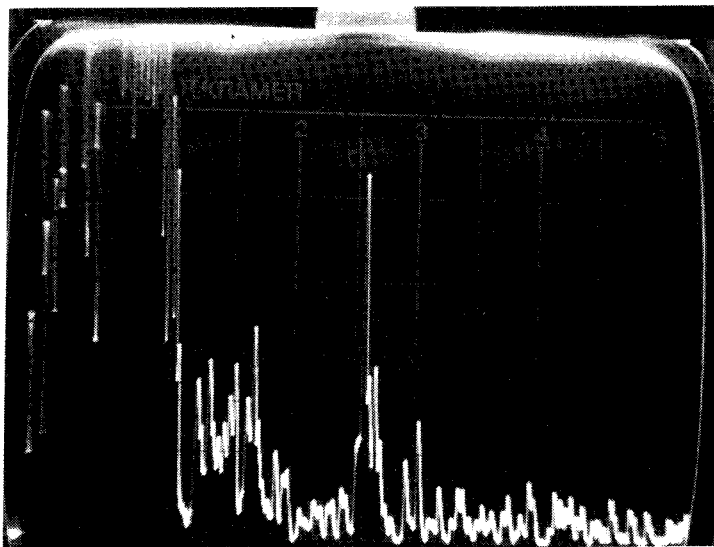
Figure 5  
Indication from welded zone  
Sound distance 53 mm  
Amplification 60 dB  
Water distance 45 mm

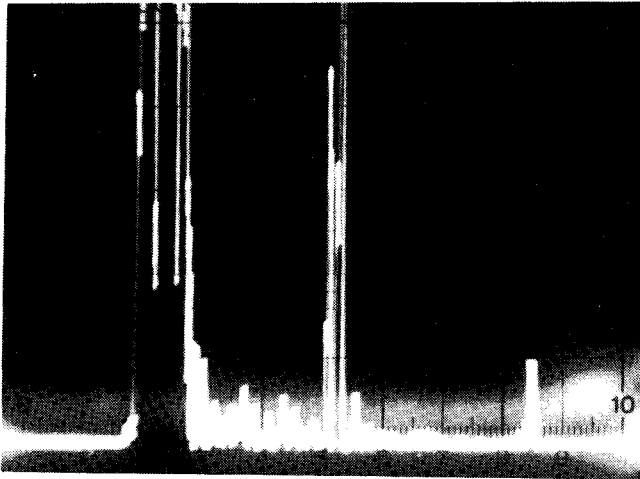
Figure 1

Flat bottomed hole  $\varnothing$  2 mm  
Sound distance 75 mm  
Amplification 62 dB  
Water distance 150 mm

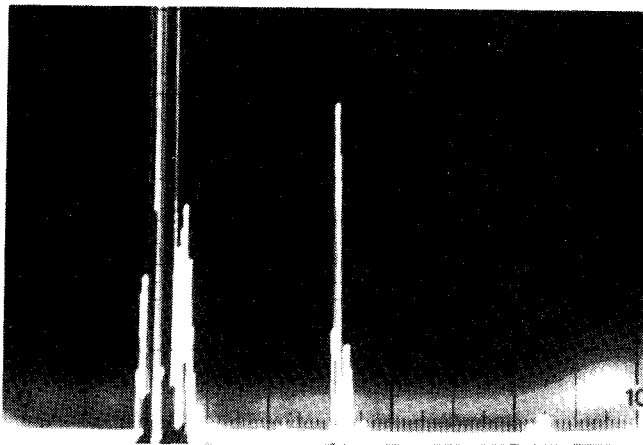
Figure 2

Flat bottomed hole  $\varnothing$  4 mm  
Sound distance 75 mm  
Amplification 48 dB  
Water distance 100 mm

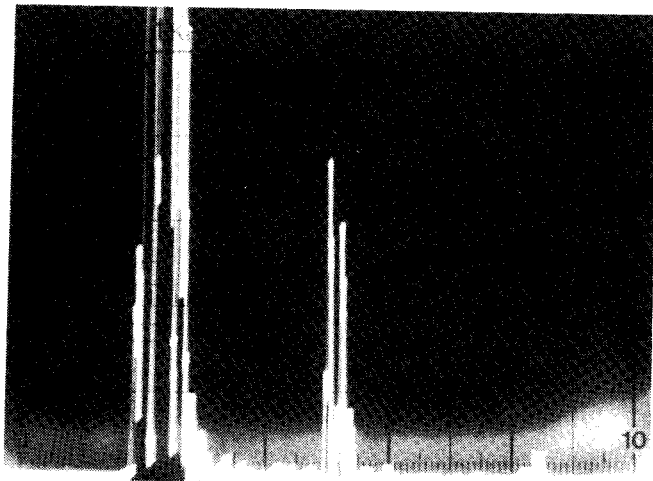
Figure 3

Cylinder bore hole  $\varnothing$  2 mm  
Sound path 75 mm  
Amplification 56 dB  
Water distance 100 mm

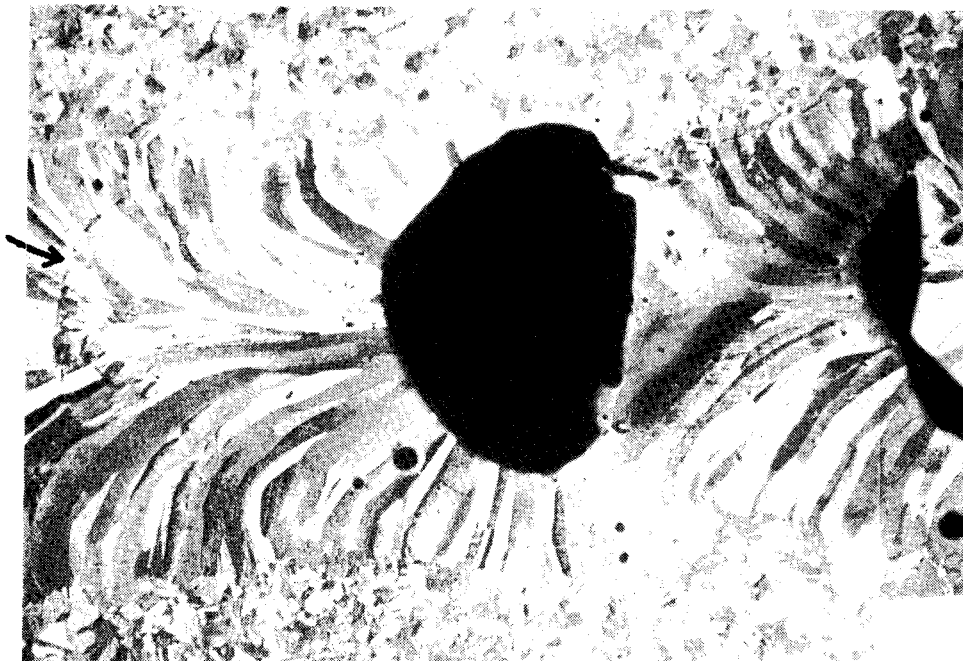
Two figures are also enclosed, showing two section planes perpendicular to each other through ultra sonic detected and center punch marked defects in the weld in d. In the figure can be seen both some spherical gas pores, and a type of defects previously found by ASEA during their investigations, and which consist of more or less halfcylinder-shaped oxide shell porosities, (at the arrow in fig 1) and also some bigger holes (the hole in fig 1 is partly filled with a fused metal under the section plane). In the direction of the electron beam with the cylinder surface about perpendicular to the growth direction of the crystals. In the perpendicular section (fig 2) it can be seen at the edges of the fusion zone the remains of the outer parts of a defect similar to the one at the arrow in fig 1.

Figure 1  
Section plane  
⊥ direction  
of the electron  
beam  
15X

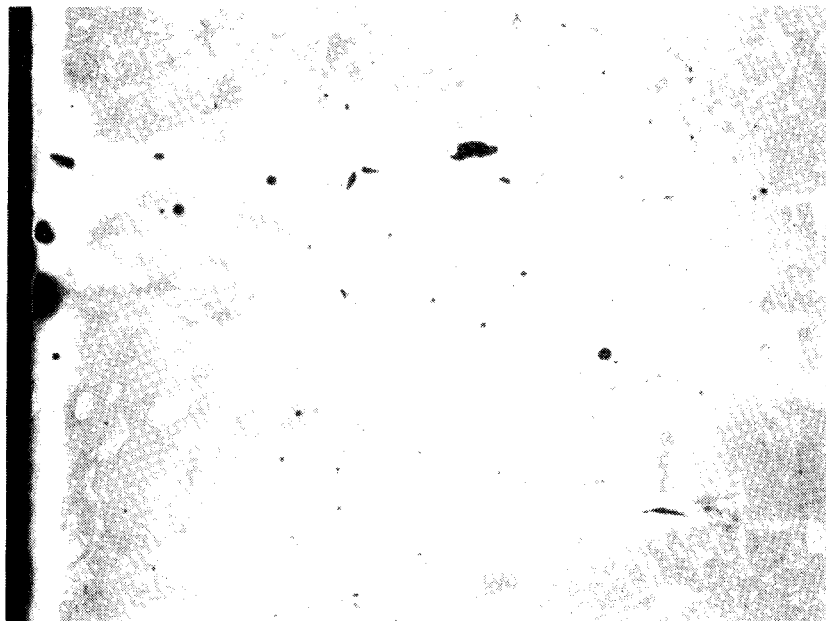
Figure 2  
Section plane

|| direction
