## Non-destructive testing of canister components and welds

This report summarises the development, during the period of 2009-2013, of non-destructive testing (NDT) techniques for inspecting canister components and welds. The basis for the development is the experiences from the manufacturing processes, the acceptance criteria defined in the design premises (SKB 2009) and the damage tolerance analyses as presented in the canister production report (SKB 2010) and its references. The acceptance criteria have in the beginning of 2014 been further refined (SKBdoc 1414374, 1414760, 1415307).

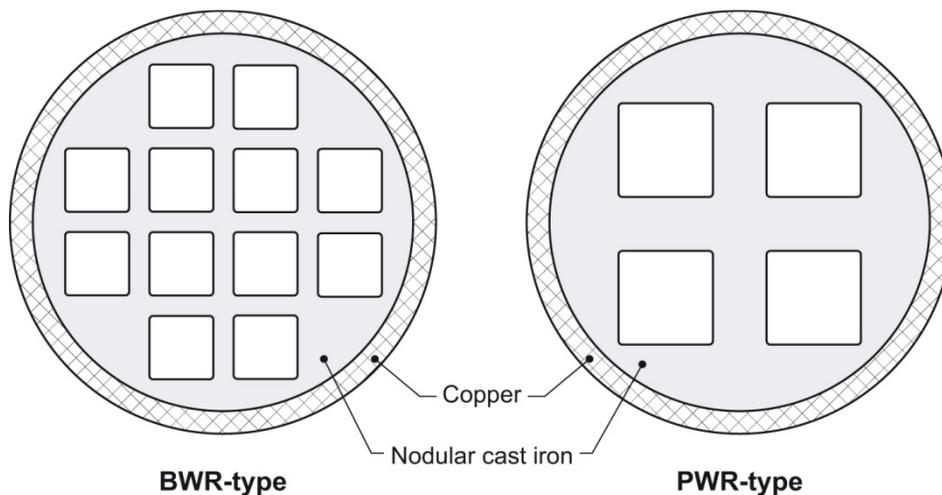
**Figure 3-2.** Basic differences between the BWR and PWR canister designs.

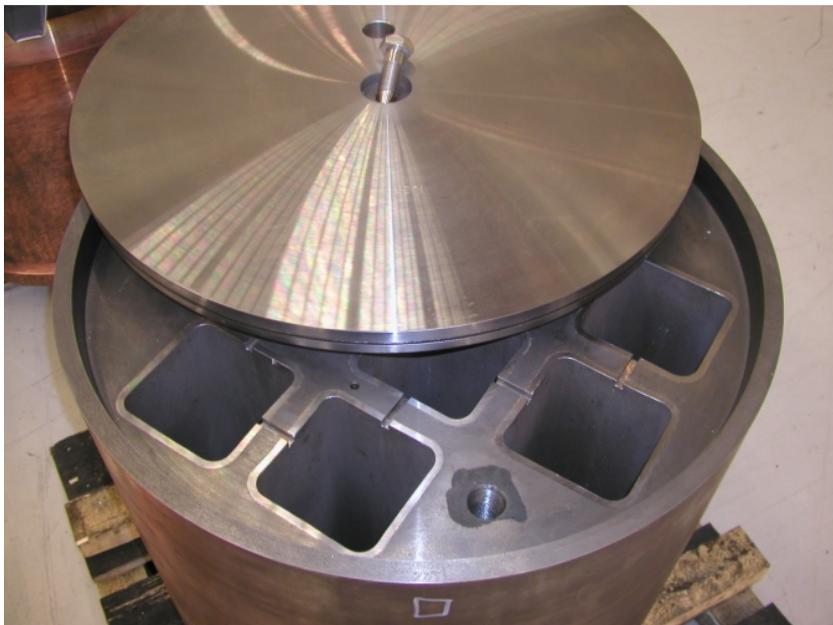
*Figure 3-5. BWR insert with steel lid.*

The steel lid (Figure 3-5) is manufactured from a conventional steel plate, which includes some associated parts such as the screw, gasket and valve for atmosphere replacement. The lid has a nominal thickness of 50 mm and a diameter of 910 mm (SKB 2010).

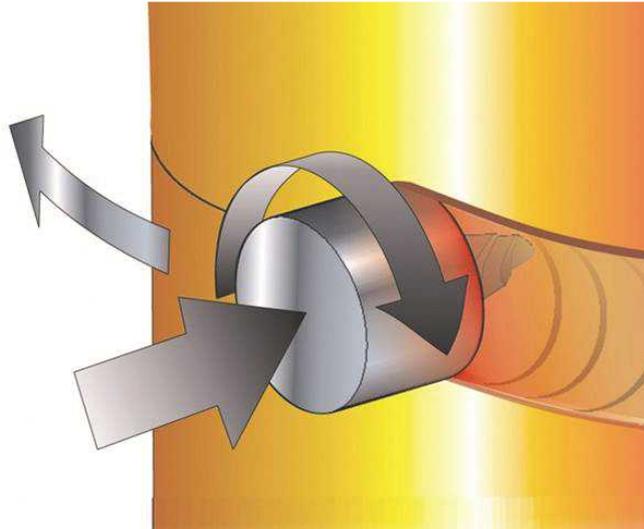
*Figure 3-8. Illustration of the welding process.*

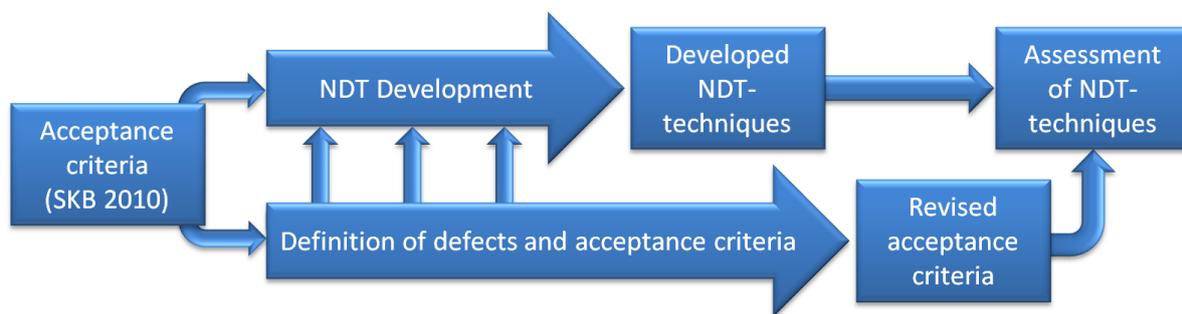
*Figure 4-1. Process for continuous development of NDT-techniques and acceptance criteria.*

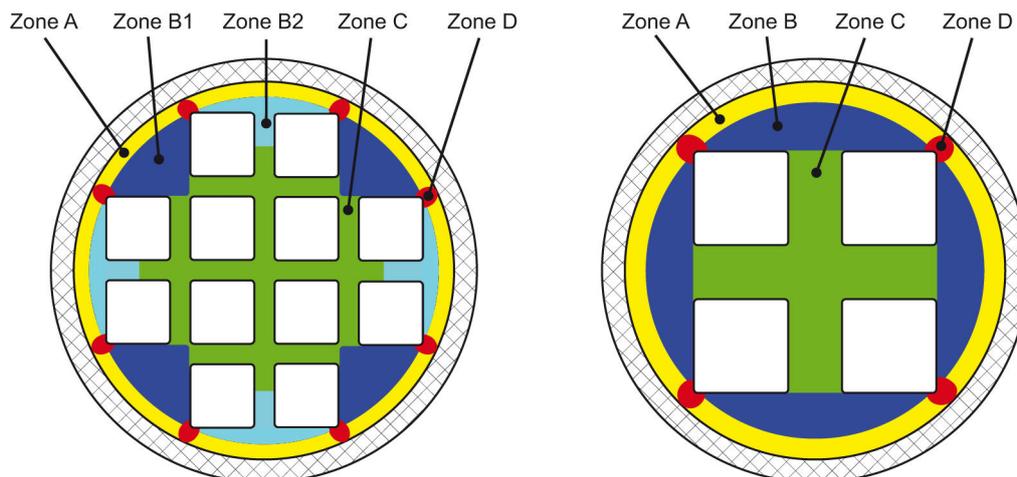
Figure 4-2. Zones in the inserts used for damage tolerance analysis.

The canister production report (SKB 2010) presented acceptance criteria for the isostatic and shear load case respectively. For the isostatic load case the BWR and PWR inserts were divided into different zones (Figure 4-2). Based on these zones, acceptance criteria for defects were created, see Table 4-1 and 4-2. For the shear load case acceptance criteria were defined for surface and internal defects, see Table 4-3.

Zone (Figure 4-2)	Defect depth/height (axial length in parenthesis), [mm]	
	BWR-insert	PWR-insert
A	37 (222)	53 (318)
B	NA	112 (672)
B1	65 (390)	NA
B2	50 (300)	NA
C	24 (144)	104 (624)
D	32 (192)	31 (186)

Zone (Figure 4-2)	Defect size (diameter) <sup>1)</sup> , [mm]	
	BWR-insert	PWR-insert
A	40	80
B	NA	100
B1	60	NA
B2	20	NA
C	20	100
D	20	20

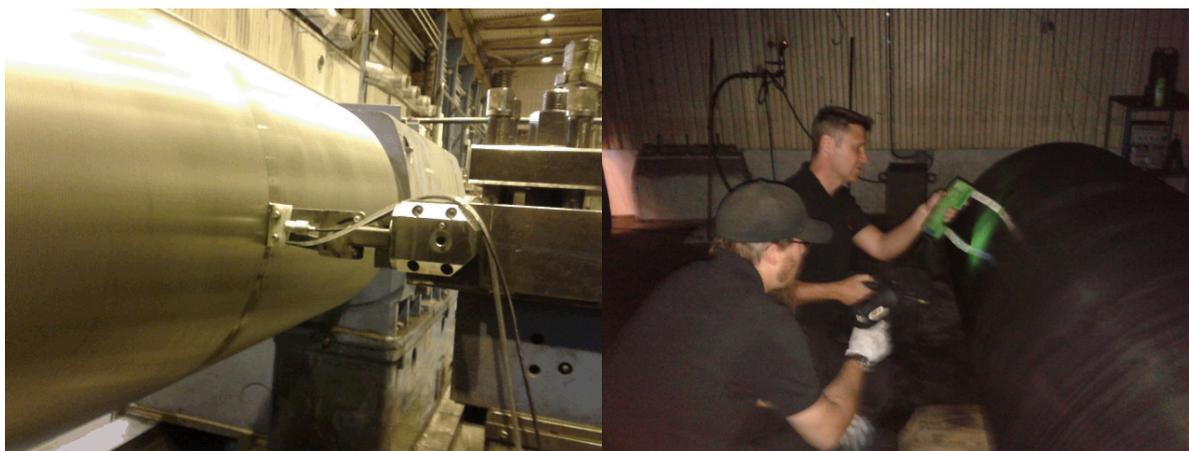
**Figure 6-7.** Ultrasonic and magnetic particle inspections of the inserts are performed by the supplier. The ultrasonic inspection (left) is automated using a turning machine as the manipulator; the cutting tool has been replaced with an ultrasonic probe that is fed with water as a couplant. The fluorescent magnetic particle inspection (right) is performed by magnetising each square decimetre of the insert in two orthogonal directions under UV lighting.

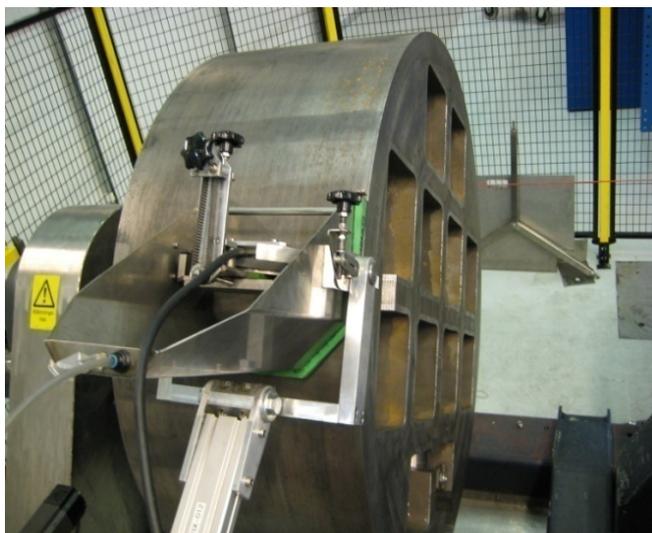
**Figure 6-8.** Linear array for local immersion inspection of the cast iron insert.

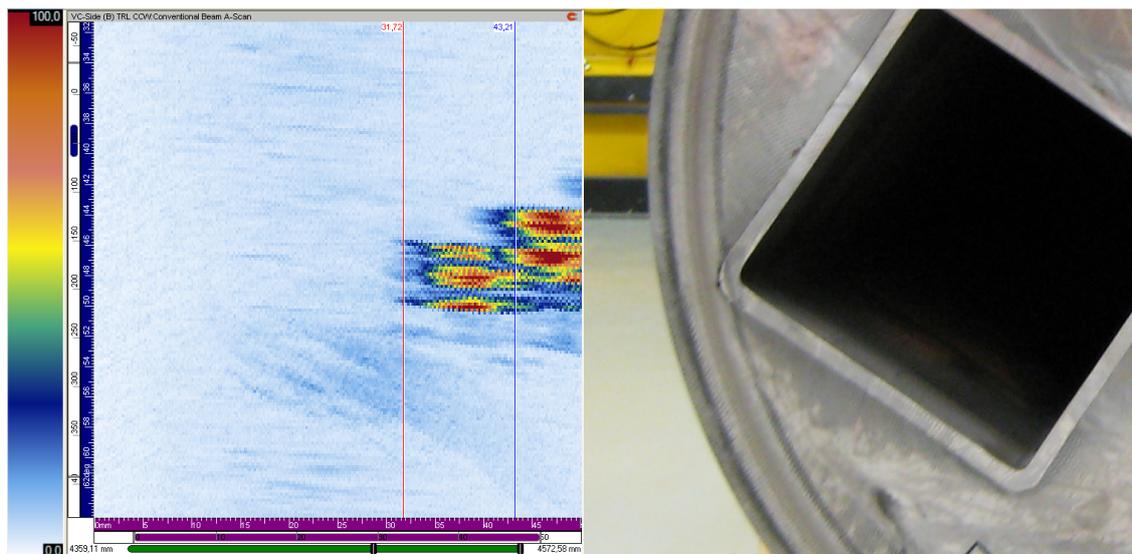
**Figure 6-14.** Ultrasonic B-scan (left), where the y-axis represents approximately 30° of the circumference, and the x-axis represents the inspection depth between 0 and 50 mm. The cross-section of the PWR-insert (right) is shown to present an overview of the inspection area.

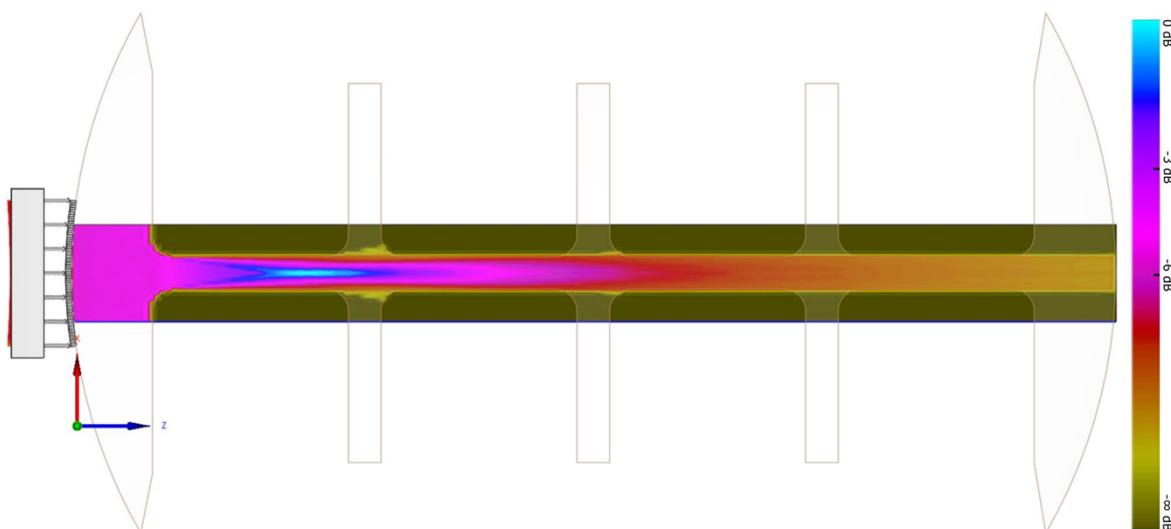
**Figure 6-24.** Civa simulation of the sound field for the transmitter beam in the through-transmission inspection of the centre pathway of the BWR insert.

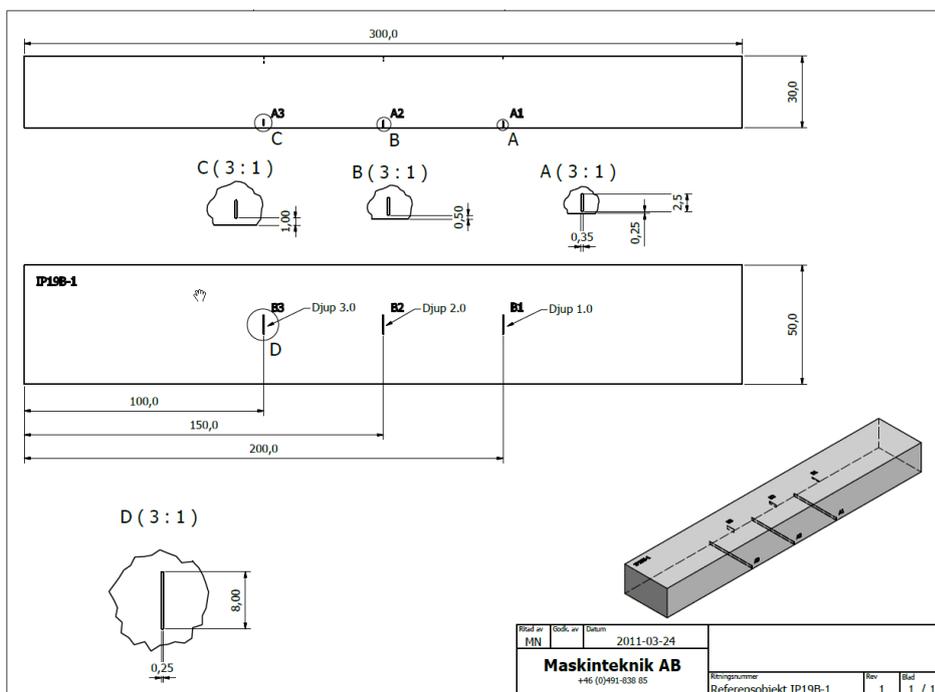
**Figure 6-26.** Reference object IP19B-1 made out of nodular cast iron. The EDM-notches are both surface breaking and with ligament.

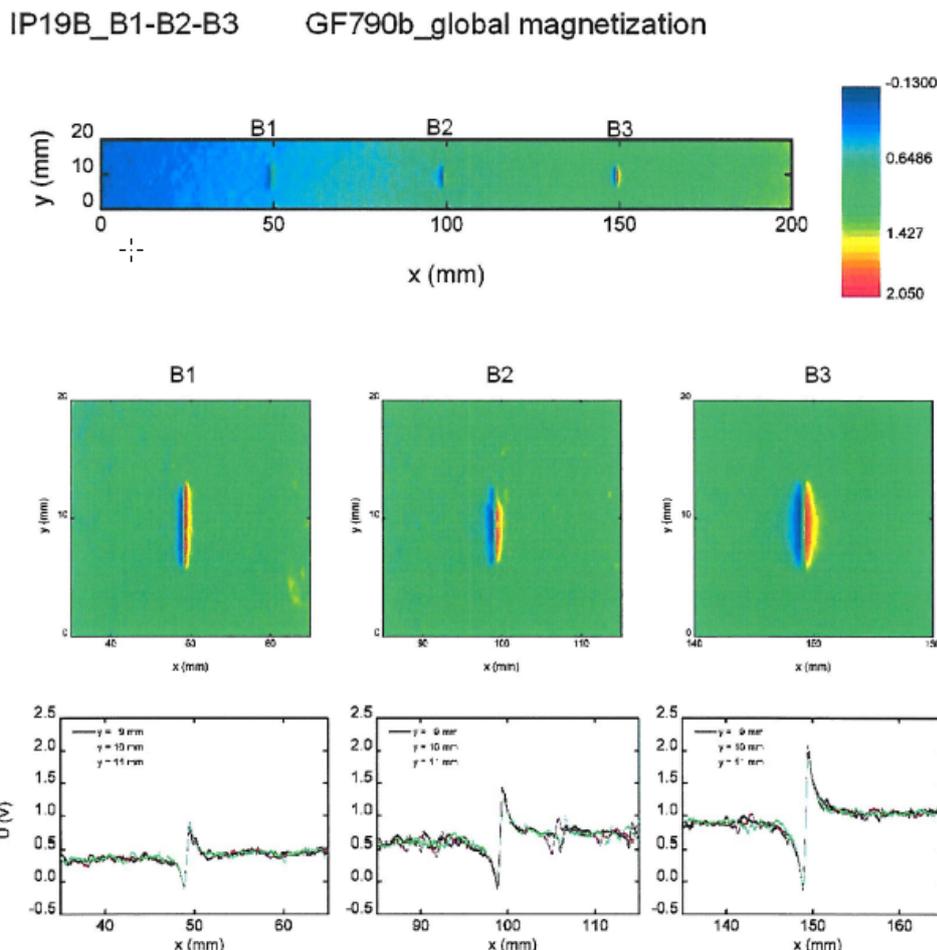
**Figure 6-27.** Indications from the surface-breaking EDM-notches on reference object IP19B-1 obtained by the magnetic flux leakage technique (MFL).

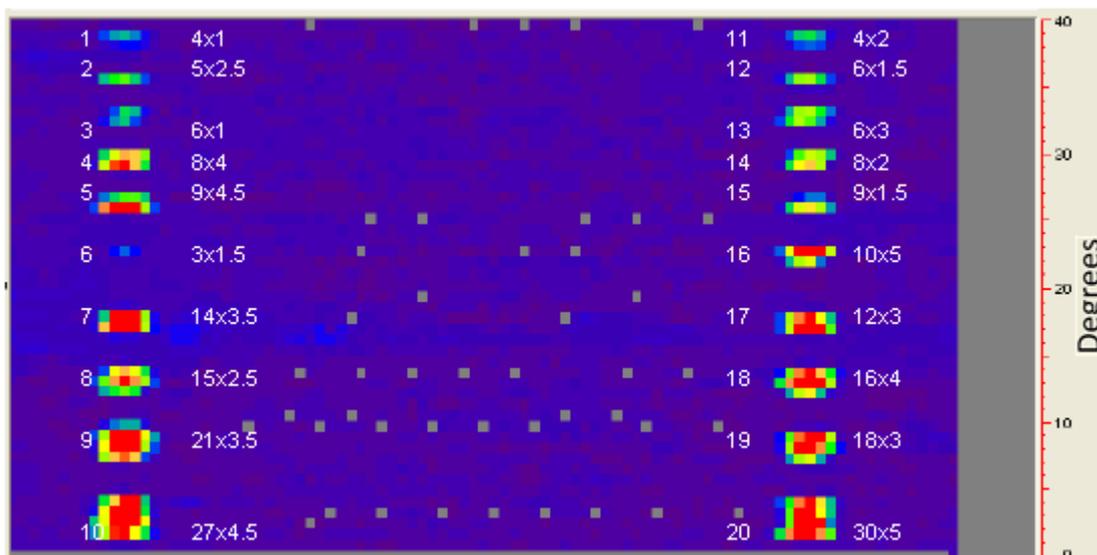
**Figure 6-30.** Eddy current inspection result from scanning reference object KLM162 containing surface-breaking elliptical EDM notches. The dimensions are presented in terms of length x depth. The grey pixels correspond to missing data, which are likely due to an encoder issue.

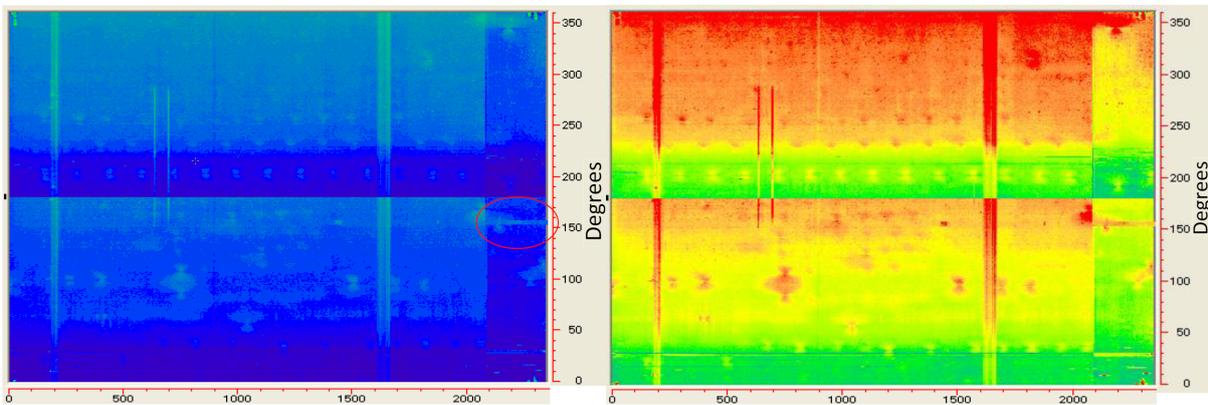
**Figure 6-31.** Eddy current inspection results from scanning a nearly 2.5-m-long section of an insert. The results are presented for a low gain (left) and a high gain (right).

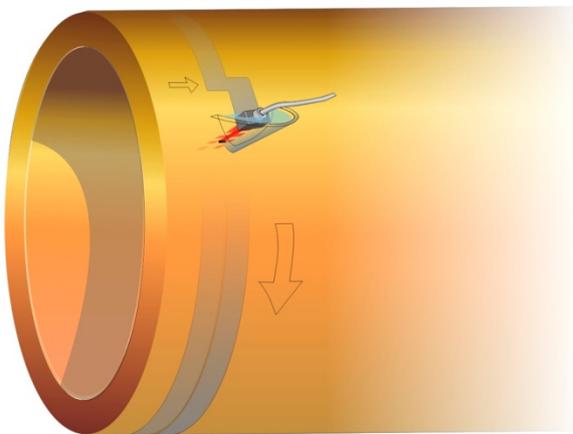
**Figure 6-36.** Scan pattern for the normal incidence ultrasonic inspection.

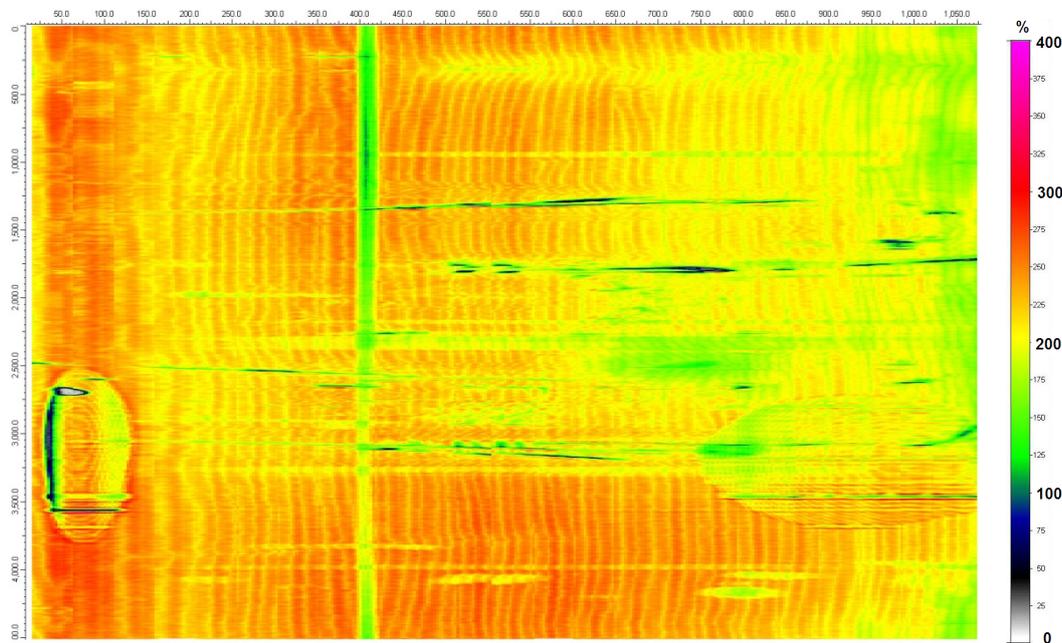
**Figure 6-38.** C-scan of the back wall echo amplitudes from ultrasonic inspection of the blocker in the manufacturing of copper tube T67. The x-axis represents the axial direction, and the y-axis represents the circumferential direction of the blocker. The deviating areas are due to surface damages or areas that not have been machined.

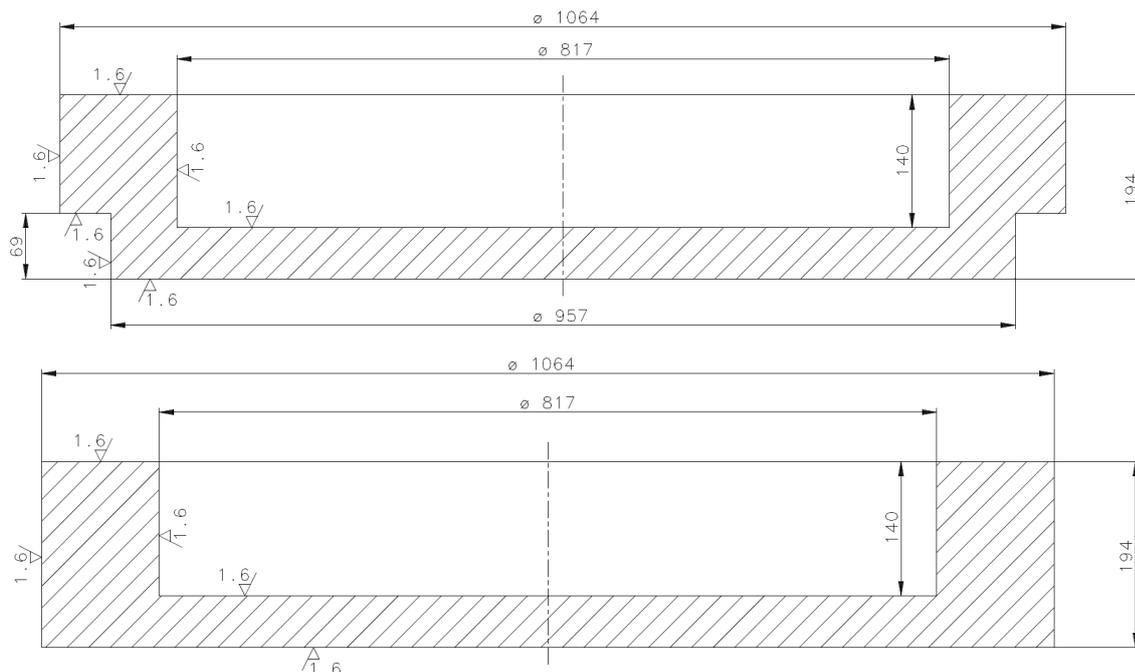
Figure 6-39. Design of the pre-machined lid: the previous design (top) and the new design (bottom).

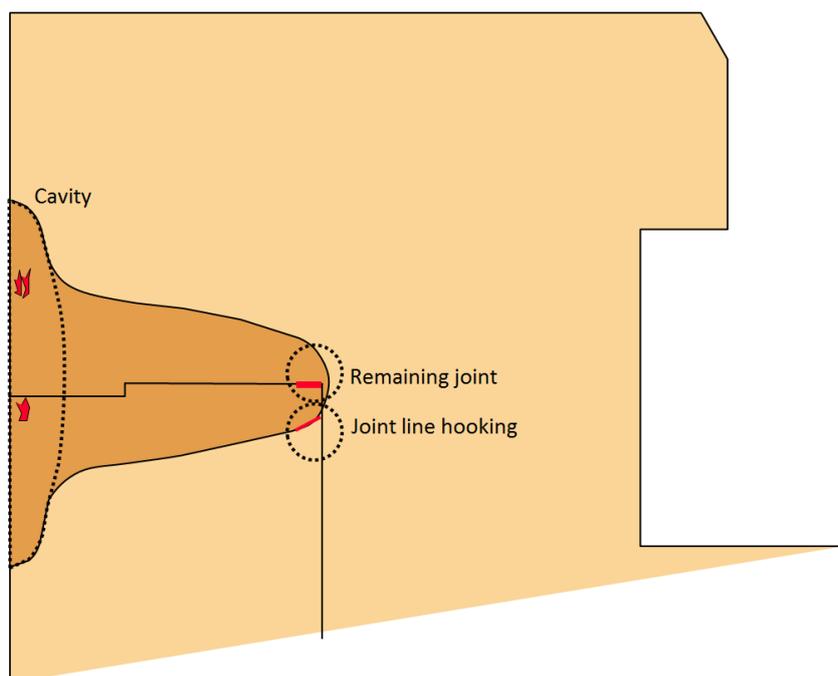
Figure 6-43. Schematic view of the friction stir weld.

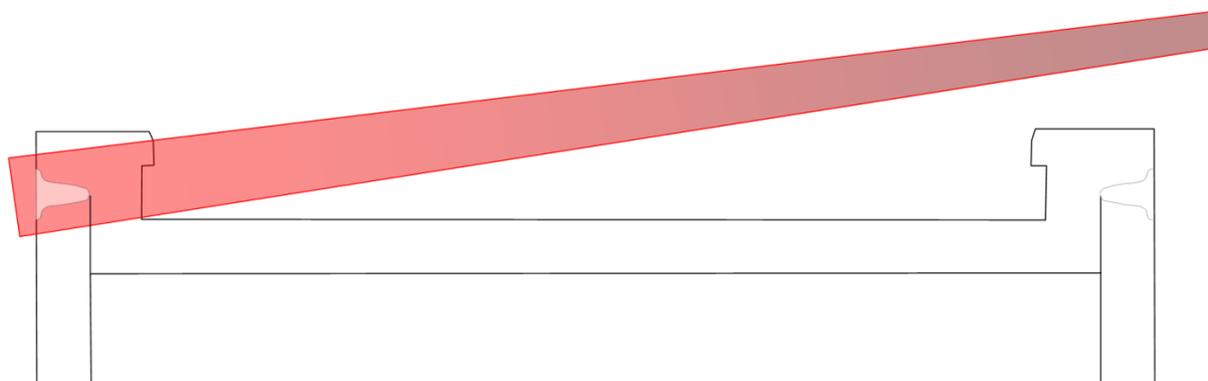
*Figure 6-46. Principle drawing showing the X-ray source on the right and the detector on the left.*

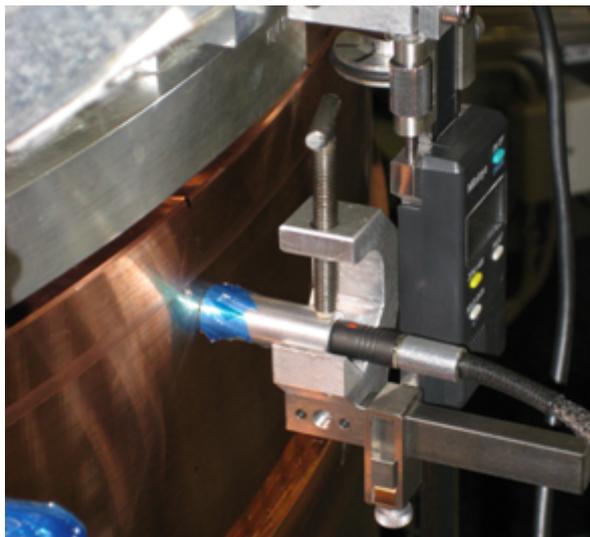
**Figure 6-47.** Conventional eddy current single probe, Leotest SKB MDF 12, attached to a primitive semi-automatic raster scanning manipulator used to inspect the envelope surface of a machined FSW weld.

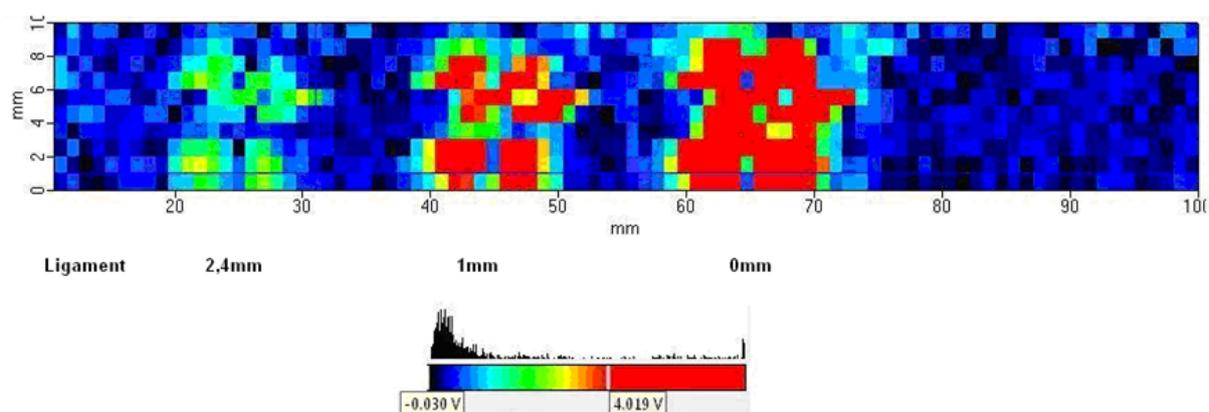
**Figure 6-48.** Eddy current inspection results with a conventional single probe, Leotest SKB MDF 12, on a reference copper block with three flat-bottom holes (FBHs) Ø2 mm and ligament sizes of 0, 1 and 2.4 mm. As the probe is composed of four coils in a square pattern, the indication of a single hole forms a similar square pattern.

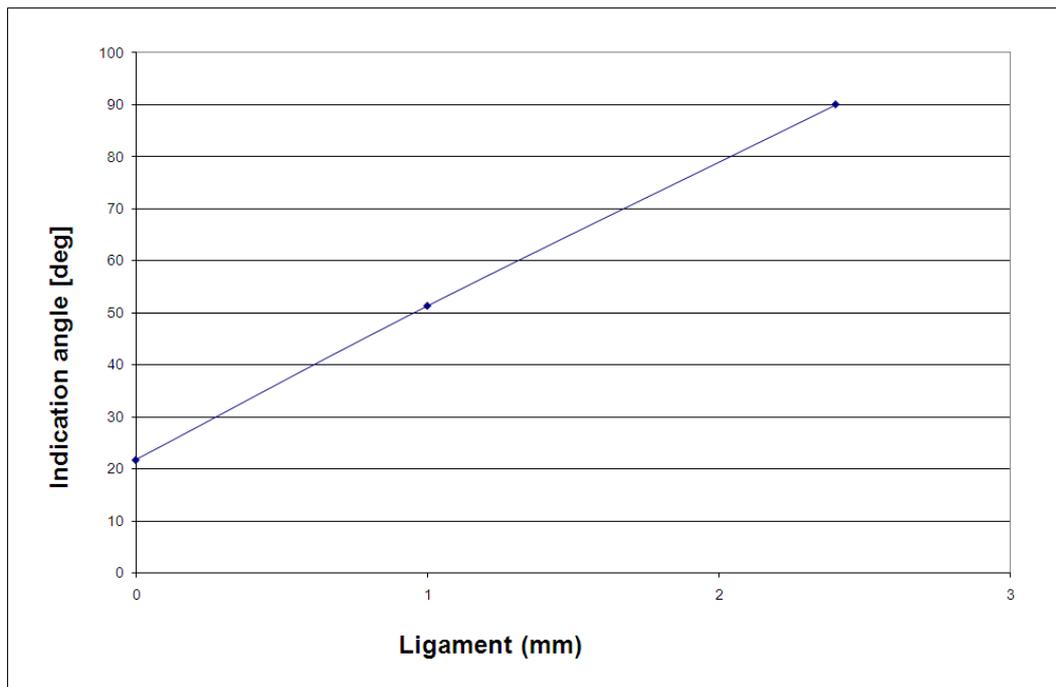
**Figure 6-49.** The relation between the ligament thickness of FBHs (Ø2 mm) and the phase shift of the corresponding indication obtained with the Leotest SKB MDF 12 probe.

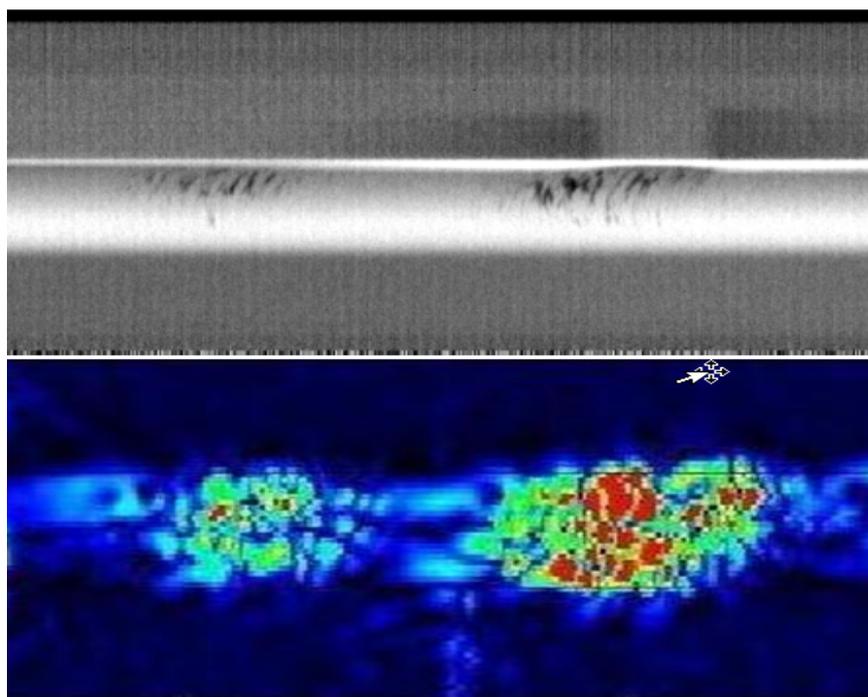
**Figure 6-50.** Result from the X-ray (top) and eddy current inspection (bottom) of a section of an FSW-weld containing two regions of cavities.

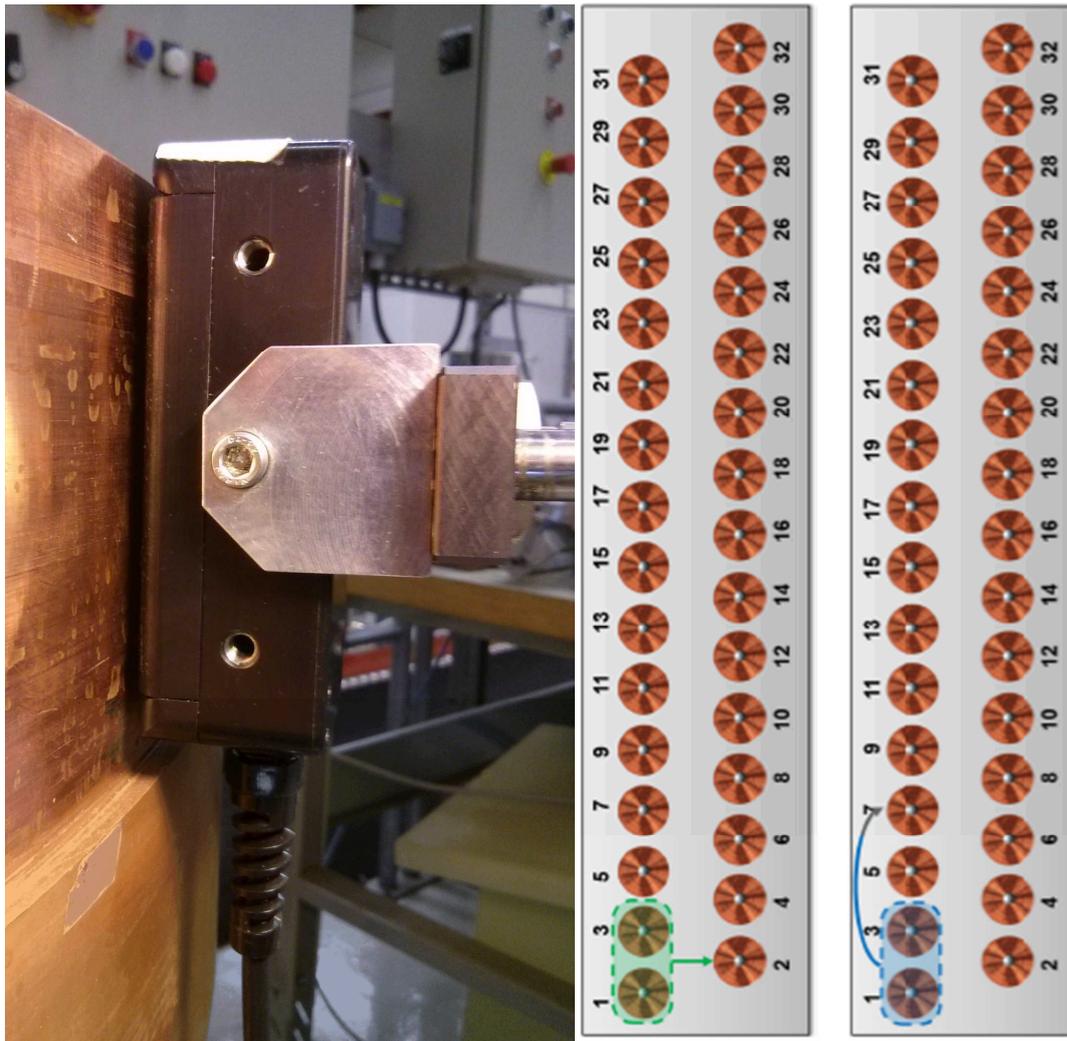
**Figure 6-51.** The array probe mounted for inspection (left) and the principal arrangement of the coils in the array pattern. In the middle, the transmitter/receiver configuration with two driver coils and one receiving coil is optimised for defects with a circumferential extension along the weld. On the right, the transmitter/receiver configuration is shown for detection of defects, with an extension transverse to the weld.

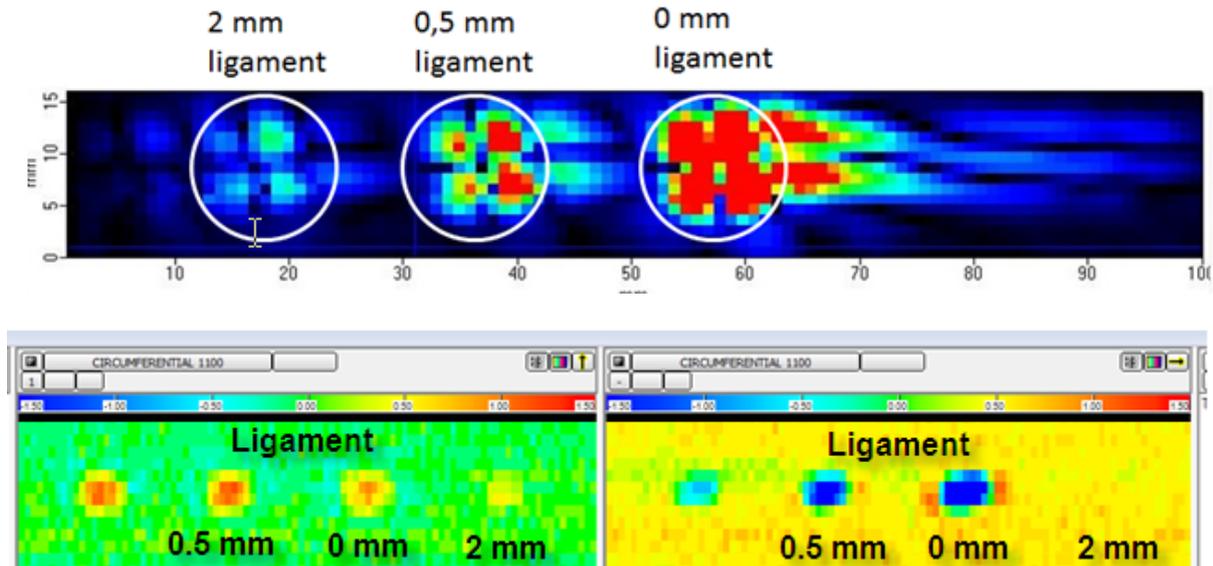
**Figure 6-52.** Results from the evaluation and comparison of a single probe and array probe approach on a copper reference block with FBHs ( $\text{\O}2\text{ mm}$ ) with different ligaments. The top image presents (single probe) the absolute signal deflection, while the bottom images present (array probe) the signal deflection in the vertical (left) and horizontal (right) directions in the probe impedance plane.

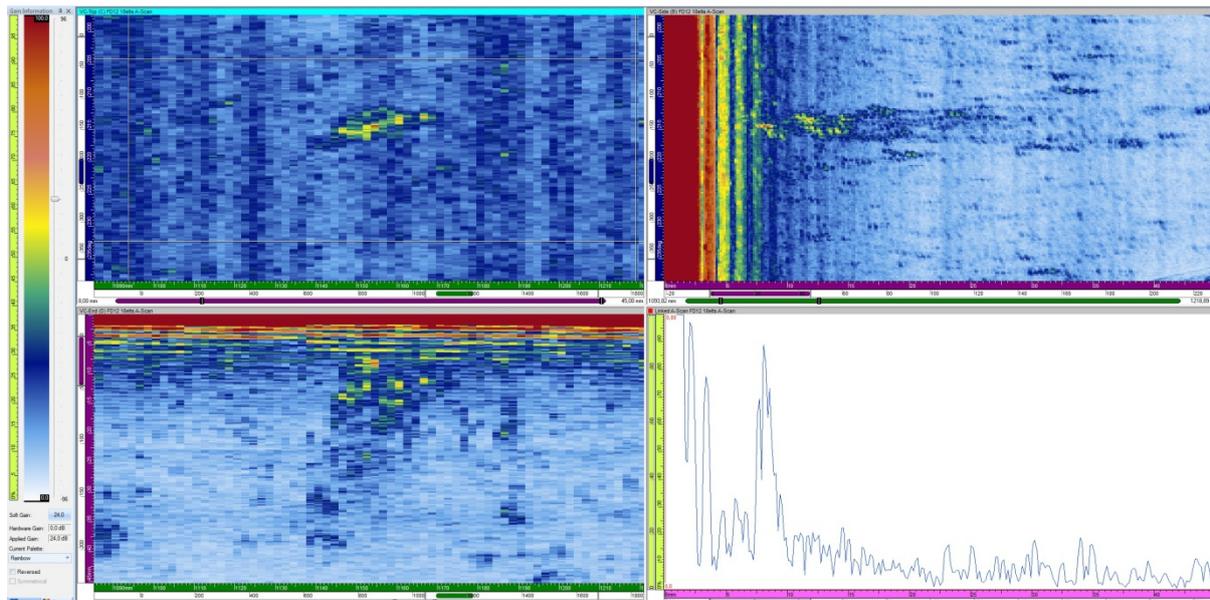
**Figure 7-1.** Results from phased array ultrasonic inspection (UT31) of a BWR insert area with porosity are shown as projections in three directions: a C-scan from the envelope surface (top left), a B-scan viewed from the end surface (top right) and a D-scan viewed along the axial direction (bottom left). The ultrasonic signal as a function of depth is shown in the A-scan (bottom right). The indication shows a SNR of ~5 (~14dB).

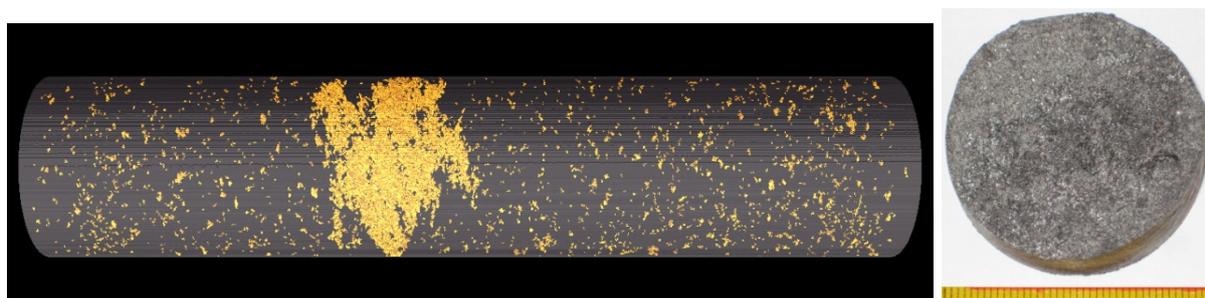
**Figure 7-2.** Characterisation of porosity indicated in Figure 7-1. Computed tomography (left) and fracture surface (right) images of a tensile test sample with a diameter of 40 mm.

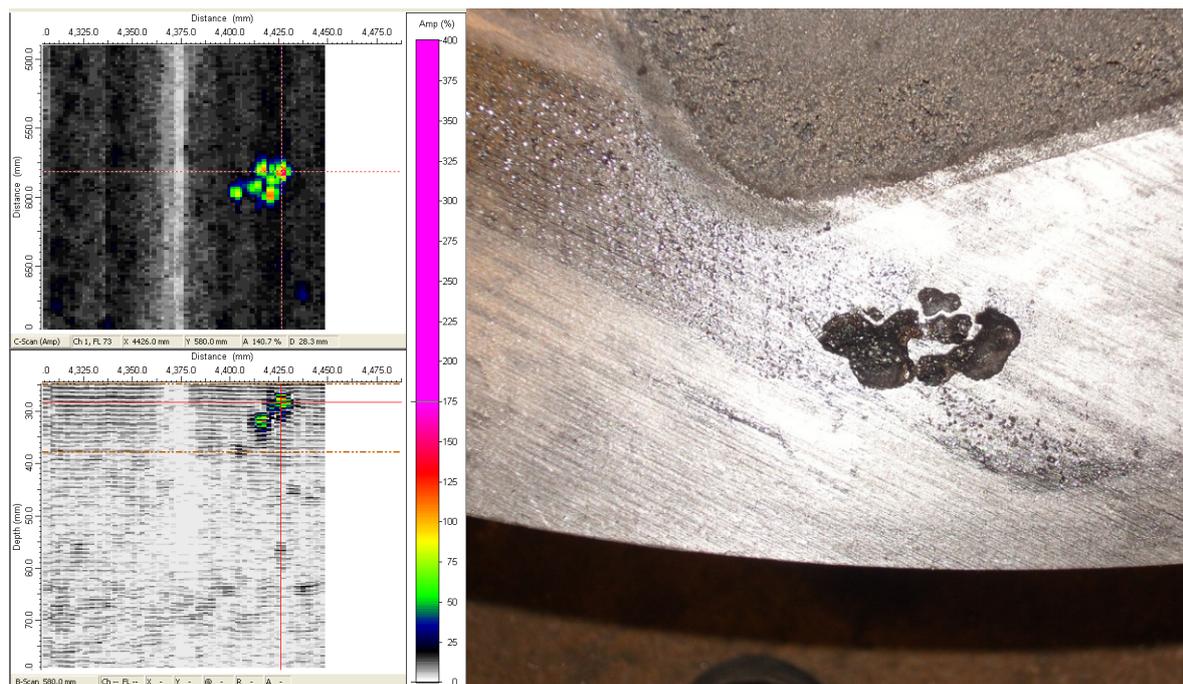
**Figure 7-3.** Results from the previous phased array ultrasonic inspection (UT31) of a blowhole. C-scan from the envelope surface (top left), a B-scan viewed along the axial direction (bottom left) and a photograph of the cut insert (right). The indication shows a SNR of  $\sim 10$  ( $\sim 20$ dB).

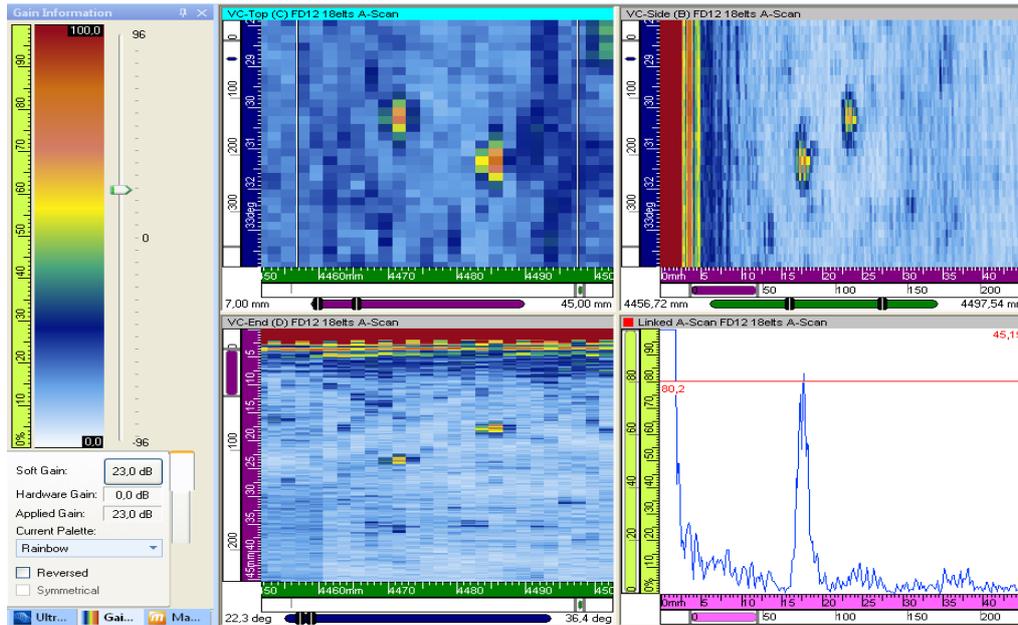
**Figure 7-4.** Point-like indication from phased array ultrasonic inspection (UT31). C-scan from the envelope surface (top left), B-scan viewed from the end surface (top right) and D-scan viewed along the axial direction (bottom left). The ultrasonic signal, for the right indication (in the C-scan), as a function of depth is shown in the A-scan (bottom right). The indication shows a SNR of ~8 (~18dB).

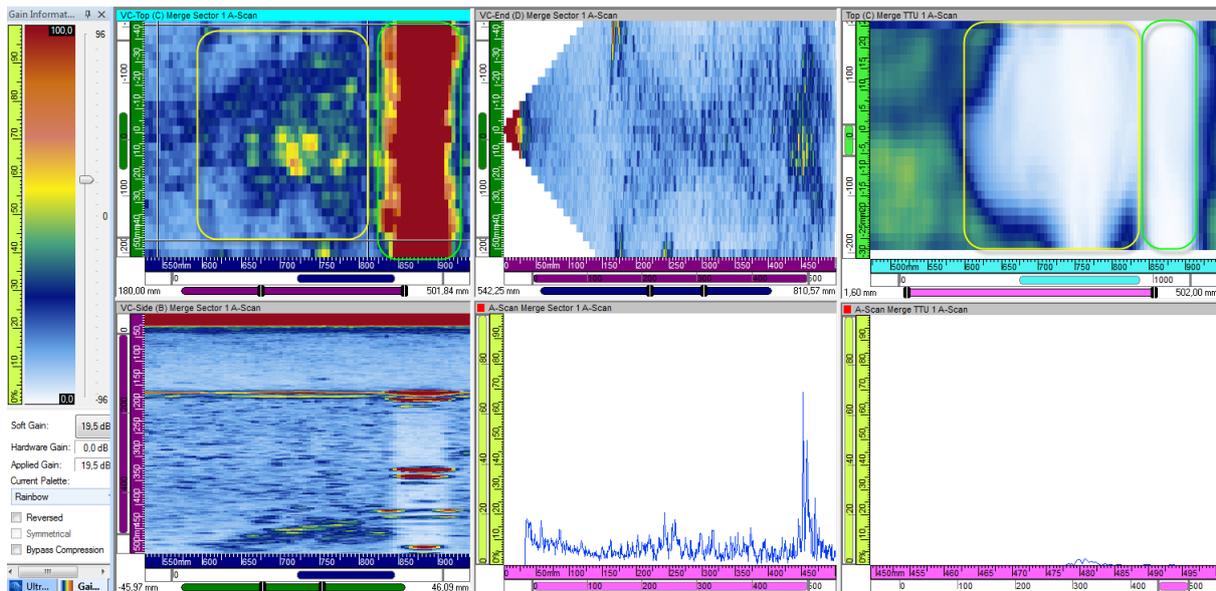
**Figure 7-5.** Results from phased array ultrasonic inspection (UT33) of a PWR insert area with porosity. C-scan from the envelope surface (top left), B-scan viewed from the end surface (top middle) and D-scan viewed along the axial direction (bottom left). The ultrasonic signal as a function of depth is shown in the A-scan (bottom middle). The right image shows the loss of signal (white areas) in transmission. The circled areas correspond to porosity (yellow) and a support plate (green). The indication shows a SNR of ~5 (~14dB) in pulse-echo and in transmission >10 (>20dB).

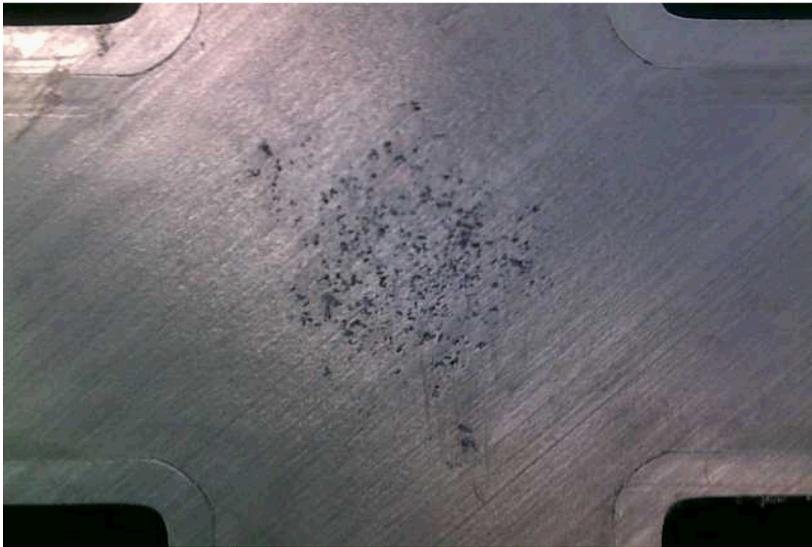
**Figure 7-6.** Photograph of the shrinkage pores indicated in Figure 7-5 between the fuel channels in a PWR insert.

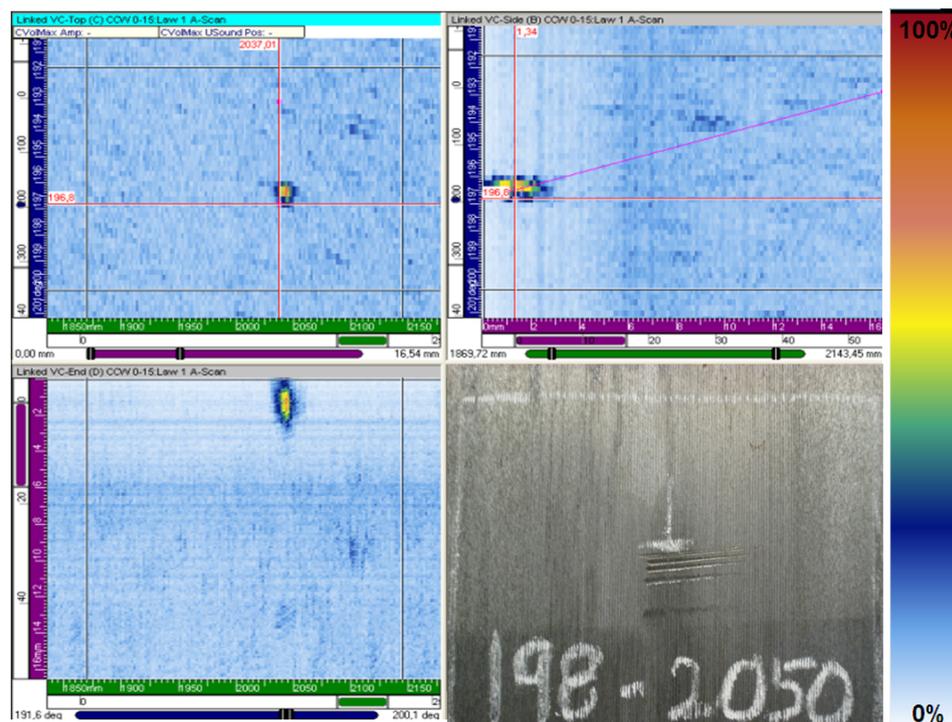
**Figure 7-8.** Results from the phased array ultrasonic inspection (UT34) in the circumferential direction of a surface defect indication. C-scan from the envelope surface (top left), B-scan viewed from the end surface (top right) and D-scan viewed along the axial direction (bottom left). To the right, at the bottom, a photograph of the surface marks is shown. The indication shows a SNR of >10 (>20dB).

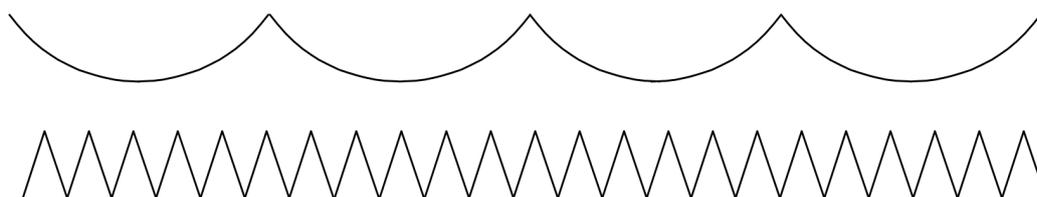
**Figure 7-9.** Sketch of a curved surface (top) and a saw-tooth-shaped surface (bottom).

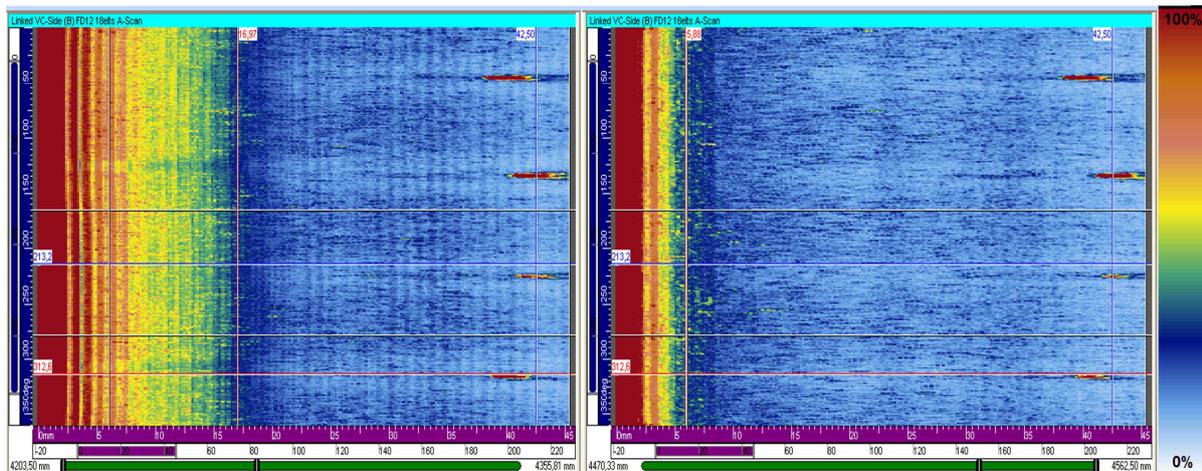
**Figure 7-10.** B-scan of the inspection of the PWR insert segments with different surface shapes. On the left, inspection of the original saw-tooth-shaped surface, and on the right, inspection of the new smooth surface.

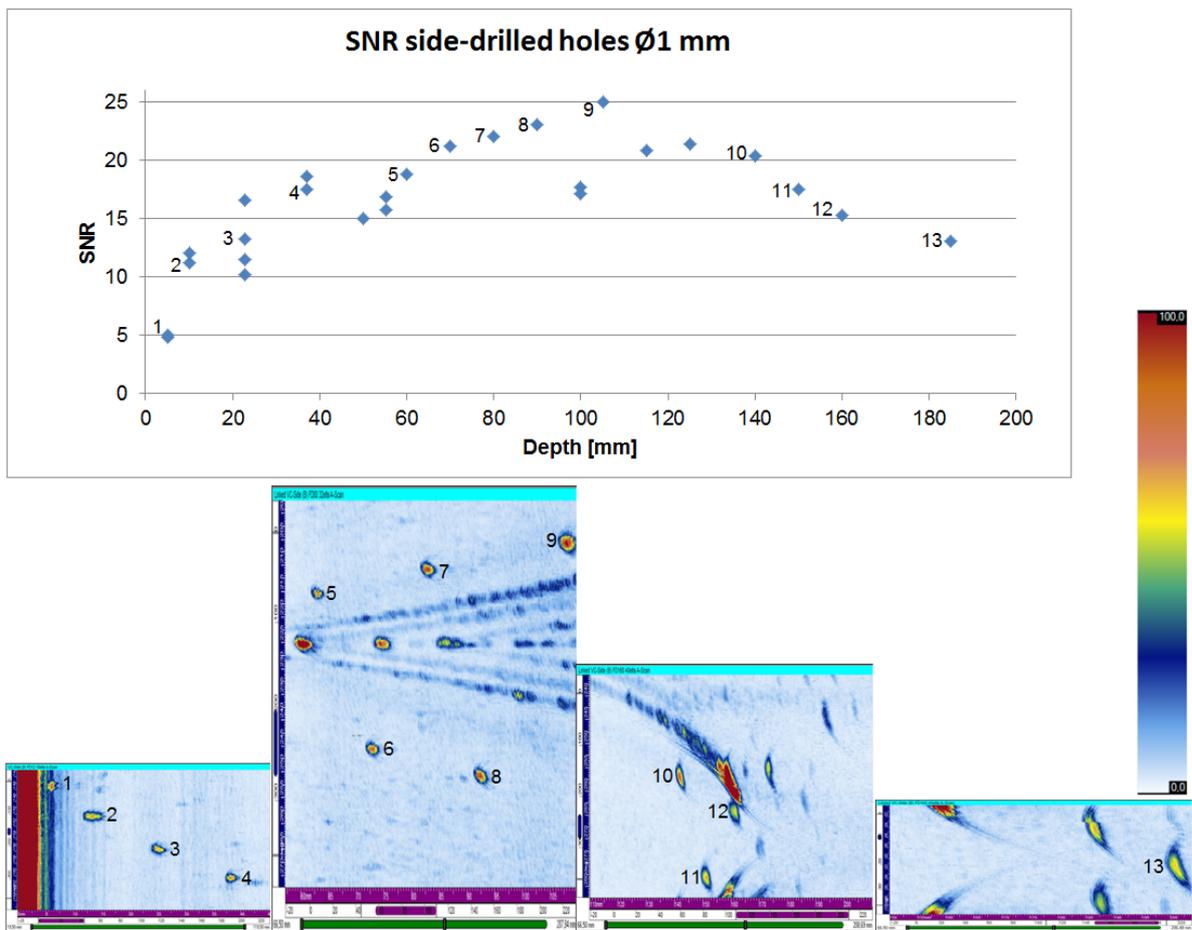
**Figure 7-13.** SNR for ultrasonic inspection (UT31) of side-drilled holes (Ø1 mm). The numbered data points in the diagram correspond to the ultrasonic signals in the B-scans showing the maximum amplitude in the circumferential (Y-axis) and radial (X-axis) direction.
