## Non-destructive testing of canister components and welds

This report summarises the development, during the period of 2009-2013, of non-destructive testing (NDT) techniques for inspecting canister components and welds. The basis for the development is the experiences from the manufacturing processes, the acceptance criteria defined in the design premises (SKB 2009) and the damage tolerance analyses as presented in the canister production report (SKB 2010) and its references. The acceptance criteria have in the beginning of 2014 been further refined (SKBdoc 1414374, 1414760, 1415307).

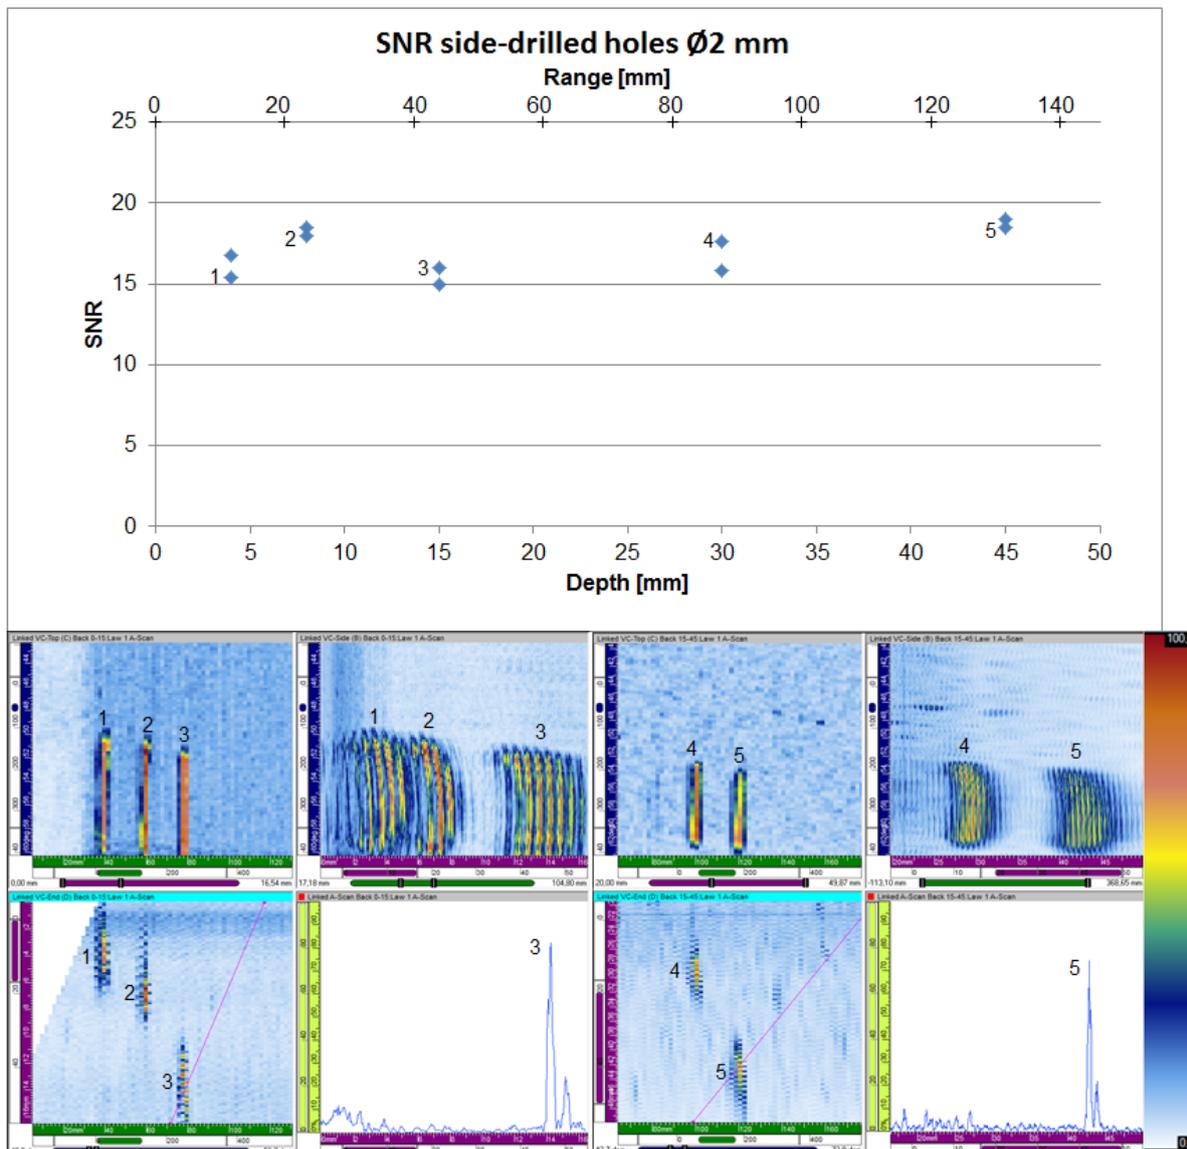
**Figure 7-14.** SNR for ultrasonic inspection (UT34) of side-drilled holes (Ø2 mm). The numbered data points in the diagram correspond to the ultrasonic signals in the views. The ultrasonic data are presented for two ultrasonic channels, axial inspection direction towards the bottom for the depth 0-15 mm and 15-50 mm respectively, each showing four ultrasonic views: C-scan (top left), B-scan (top right), D-scan (bottom left) and A-scan (bottom right). The axes are represented by colours as follows: circumferential axis (blue), axial axis (green) and radial (magenta).

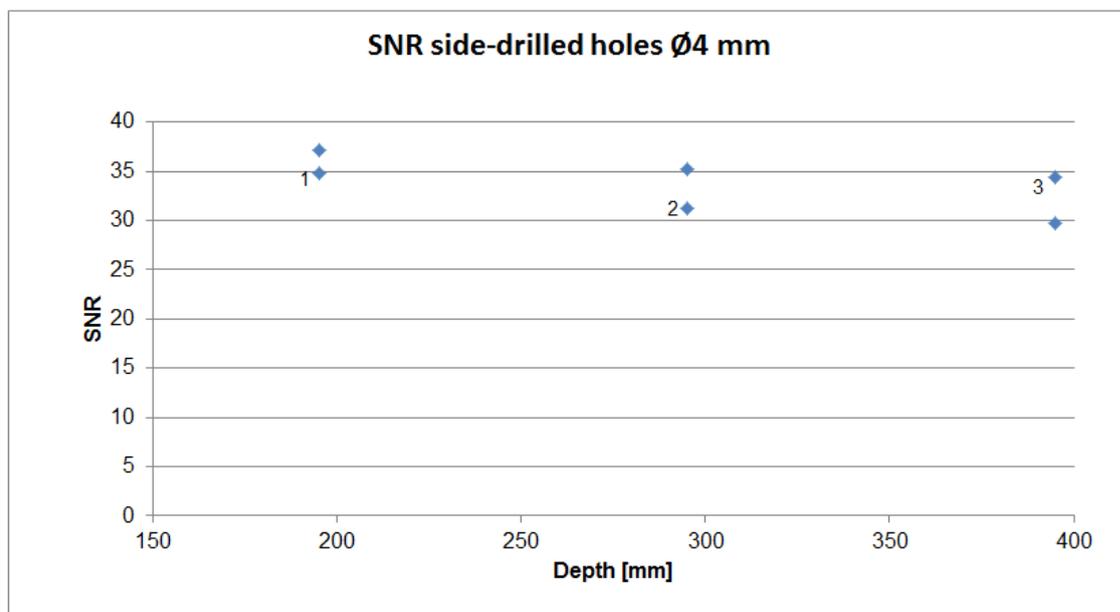
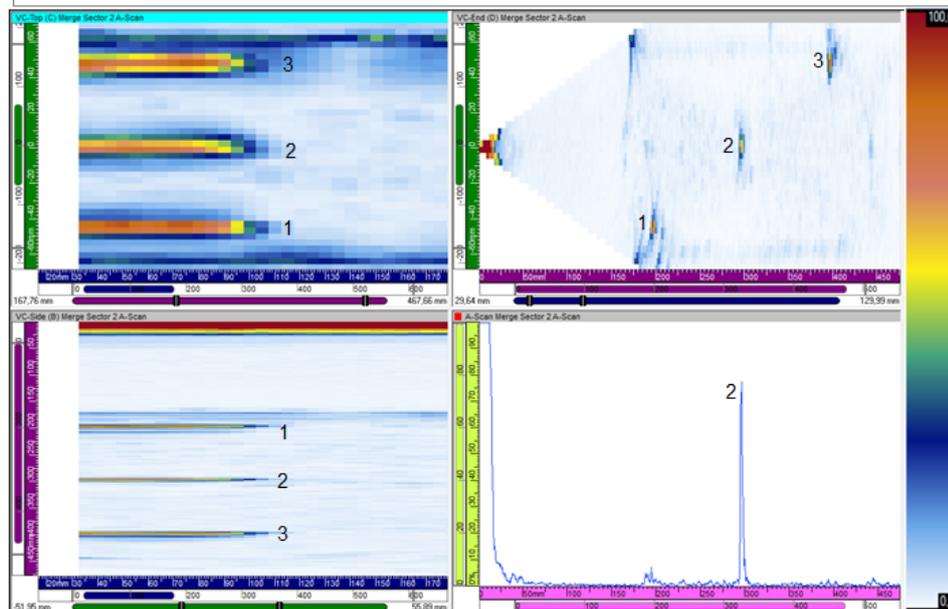
**Figure 7-15.** SNR for ultrasonic inspection (UT33) of side-drilled holes (Ø4 mm). The numbered data points in the diagram correspond to the ultrasonic signals in the views. The ultrasonic data are presented in four ultrasonic views: C-scan (top left), D-scan (top right), B-scan (bottom left) and A-scan (bottom right). The axes are represented by colours as follows: circumferential axis (blue), axial axis (green) and radial (magenta).

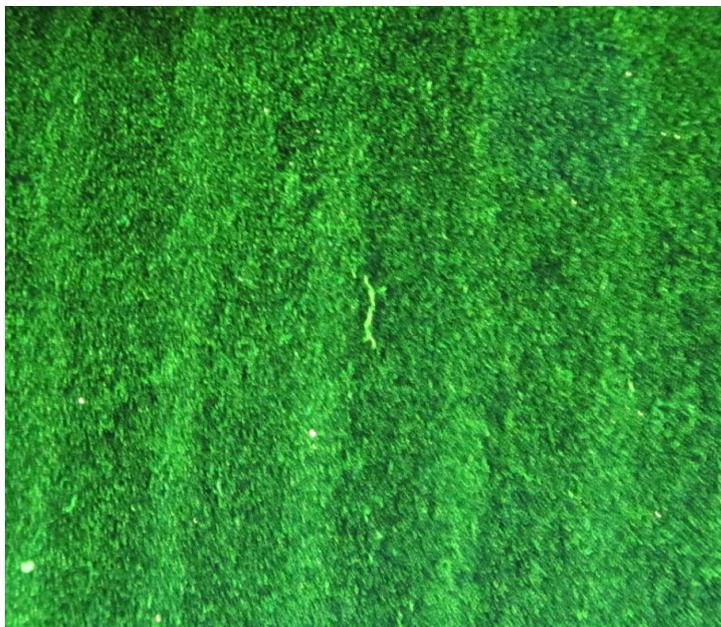
**Figure 7-16.** MT-1, a 3-mm linear indication obtained by magnetic particle inspection. The indication detected on the envelope surface of the insert is oriented in the circumferential direction. The five broader, weaker, non-relevant indications along the entire figure in the same vertical direction of the figure are caused by magnetic leakage fields related to the surface finish left by the turning operation.

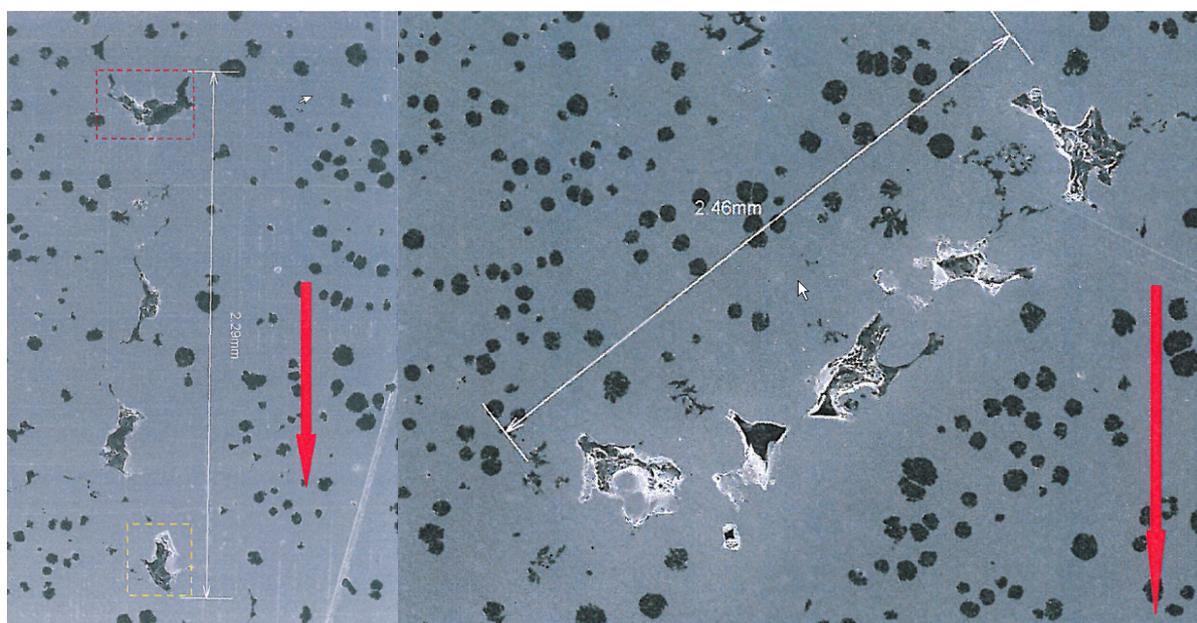
**Figure 7-17.** Analysis of an area coinciding with the position of the magnetic particle inspection indication, MT-1, which was detected on the envelope surface of the insert. The red arrow indicates a fixed, absolute orientation of the sample. The analysis indicates the presence of micro-porosity and degenerated graphite. The image on the left shows the defect analysed at the surface, and the image on the right shows the defect analysed at a depth of 0.4 mm. The coloured rectangles denote the locations selected for detailed analysis.

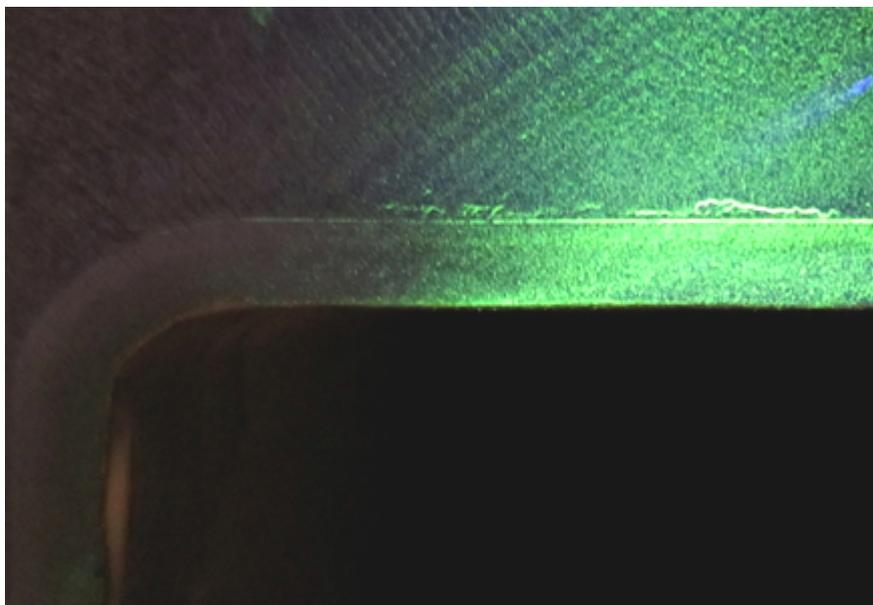
**Figure 7-18.** K2, linear indications obtained by magnetic particle inspection of the insert end surface along the interface between the casting and channel tube wall. The thickness of the channel tube steel wall is 12.5 mm.

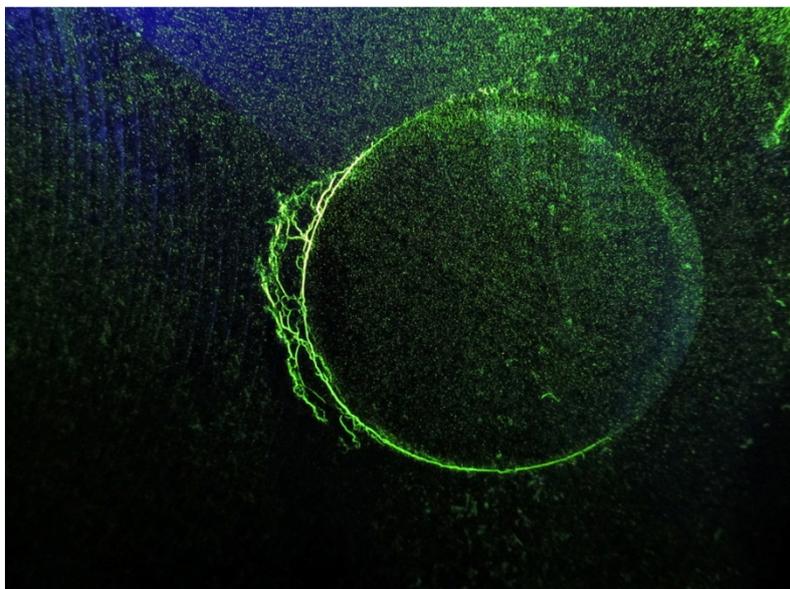
**Figure 7-20.** B1, linear indications obtained by magnetic particle inspection of the insert bottom end surface along the interface between the casting and cassette bottom round bar (M48 screw).

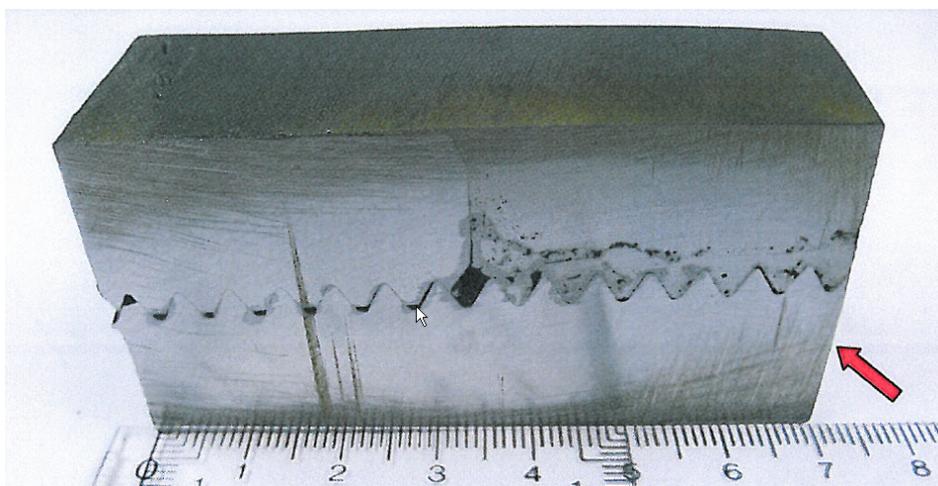
**Figure 7-21.** SEM-EDS analysis of an area coinciding with the position of the magnetic particle inspection indication B1 detected in connection and along with the interface between the casting and the cassette bottom round bar. The lower part of the sample depicted is the bar, the upper left part is the cassette bottom nut and the upper right part is the casted material. The analysis revealed the presence of inclusions of slag, which contained Mg, and quartz sand inclusions. The red arrow indicates the bottom surface of the insert inspected by magnetic particle testing.

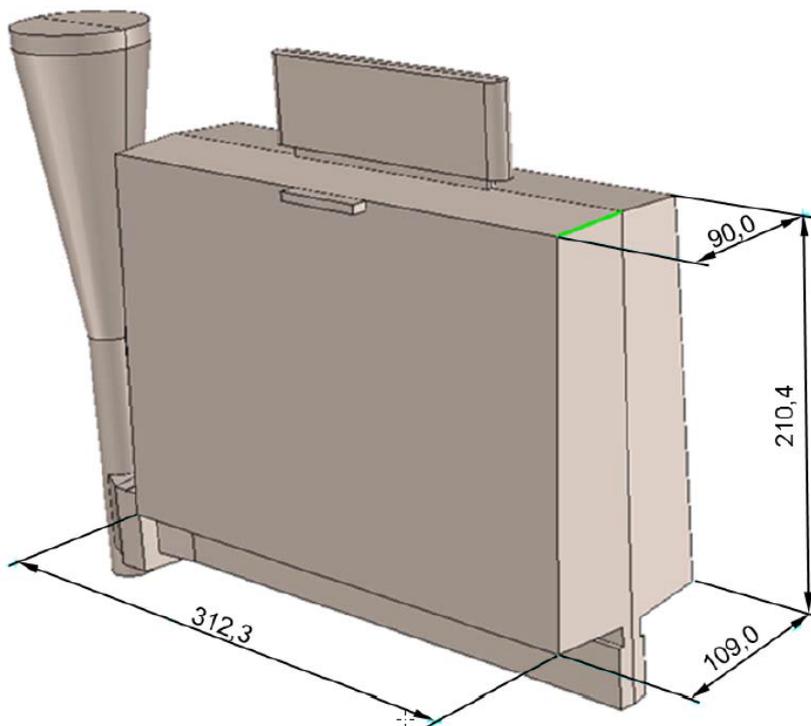
**Figure 7-22.** CAD model of the casting layout.

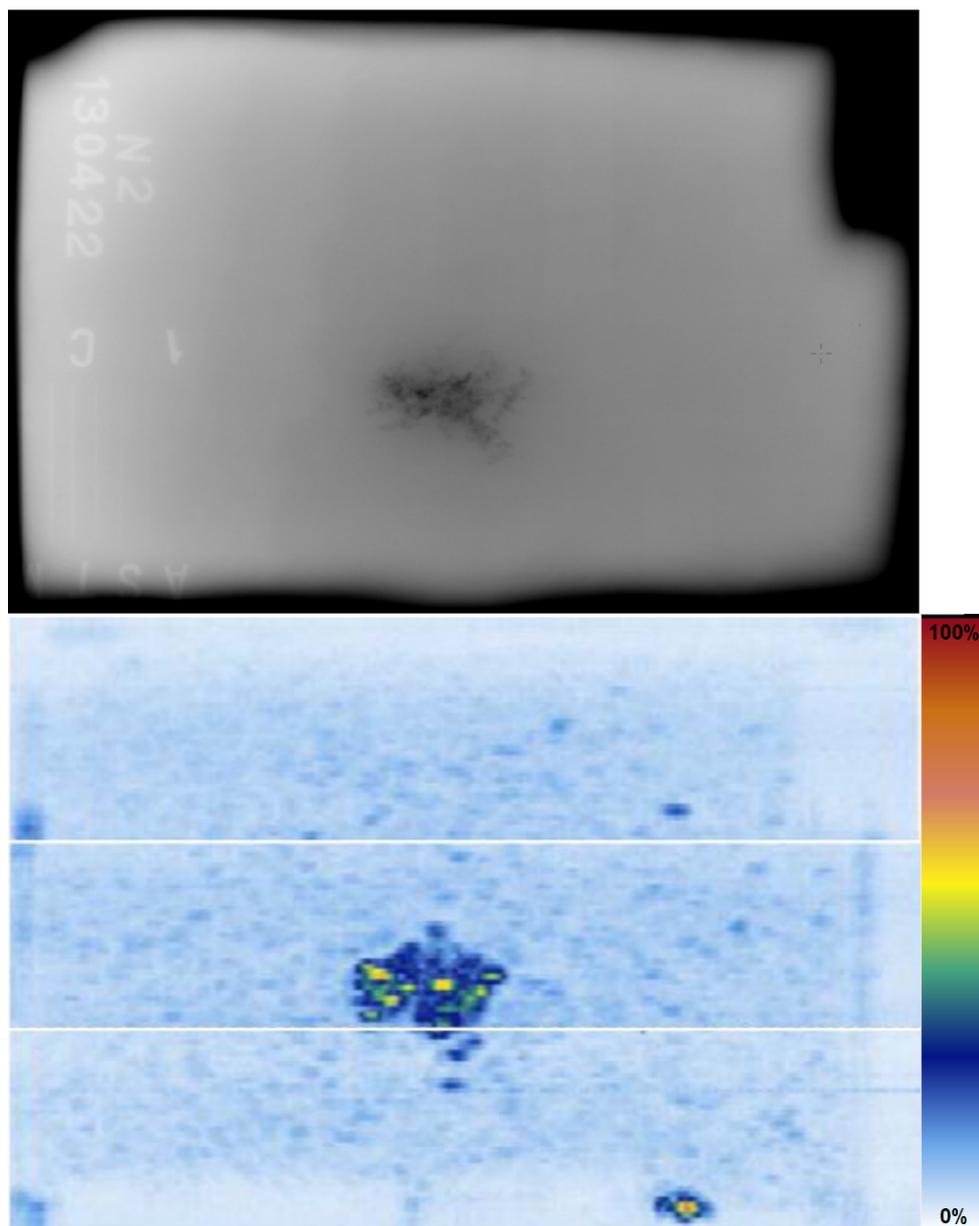
**Figure 7-23.** Results from radiographic film (top) and ultrasonic pulse-echo inspection (bottom) of a casting with internal indications, which are believed to originate from defects such as shrinkage and pore clusters. Note: the ultrasonic indication down to the right is a geometrical indication caused by lack of material at the side surface.

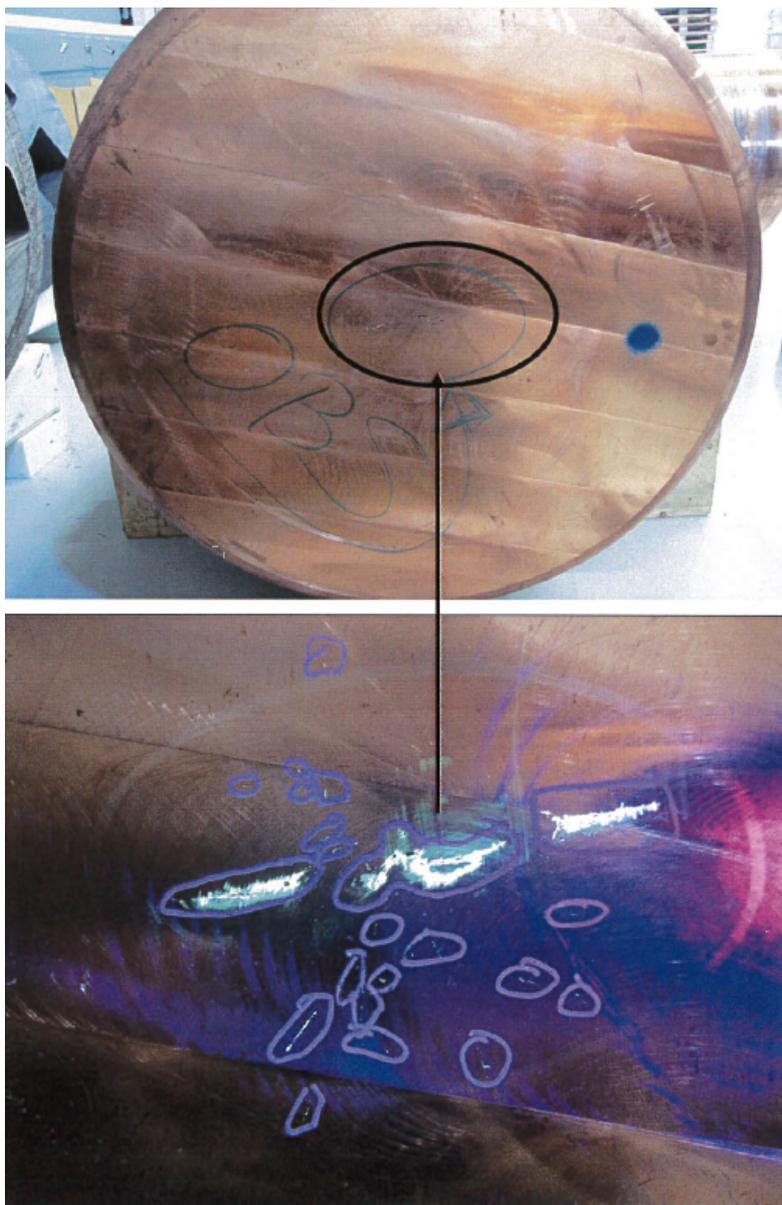
**Figure 7-24.** Penetrant inspection results for the copper tube ingot 268-2-1; the excess material at the ends of the ingot, which is susceptible to casting defects, was not removed. The penetrant results showed larger indications from, spider cracks in the centre of the ingot, and several surrounding, scattered, smaller indications. A close-up image of the detected, shrinkage-type defects is shown in Figure 7-25.

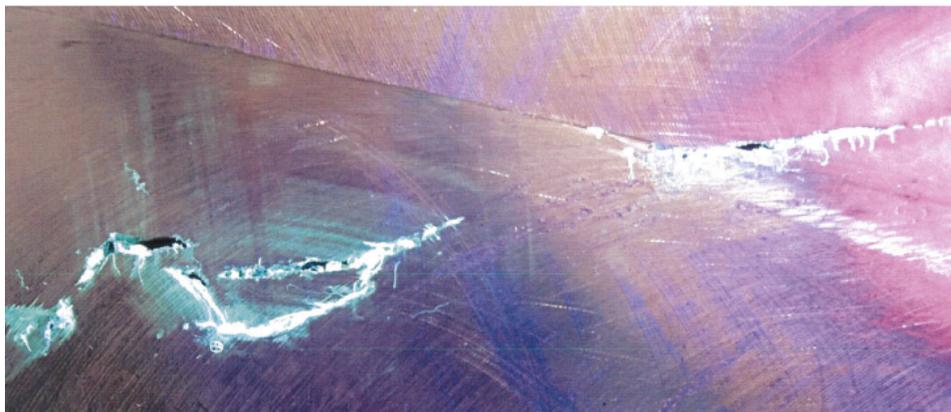
*Figure 7-25. Close-up image of the detected spider-crack defects shown in Figure 7-24.*

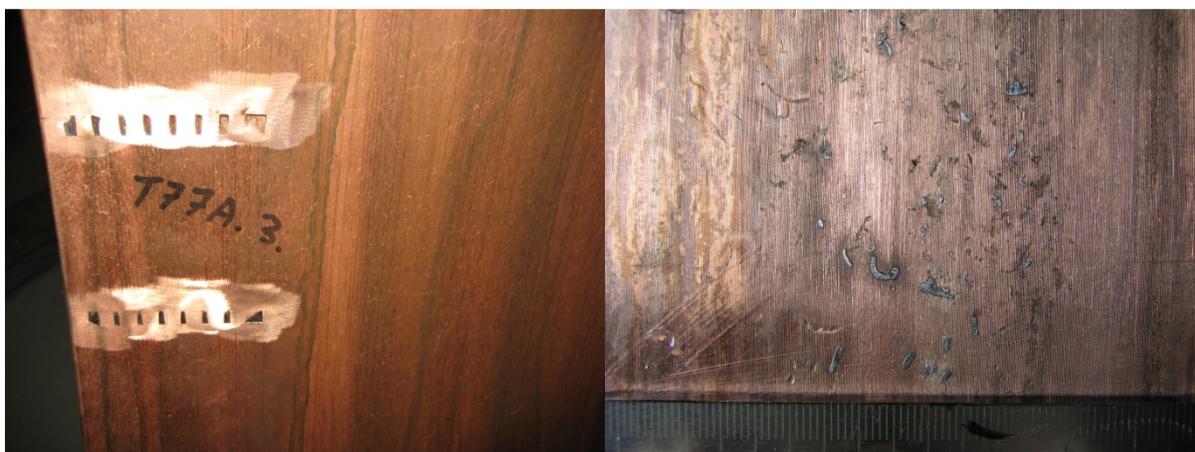
*Figure 7-26. Handling defects manifested as indentations on the inside of tube T77 (left) and foreign material on the outside of tube T43.*

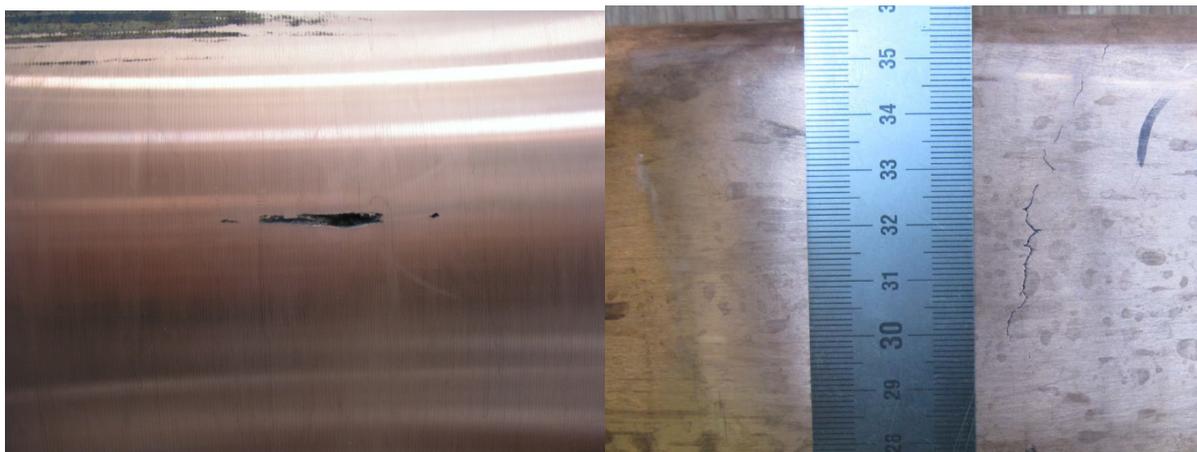
**Figure 7-27.** Manufacturing defects in copper tubes. The left image shows an axial scratch (T46) in an extruded tube and the right image shows a crack-like defect in a pierce-and-draw tube (T83).

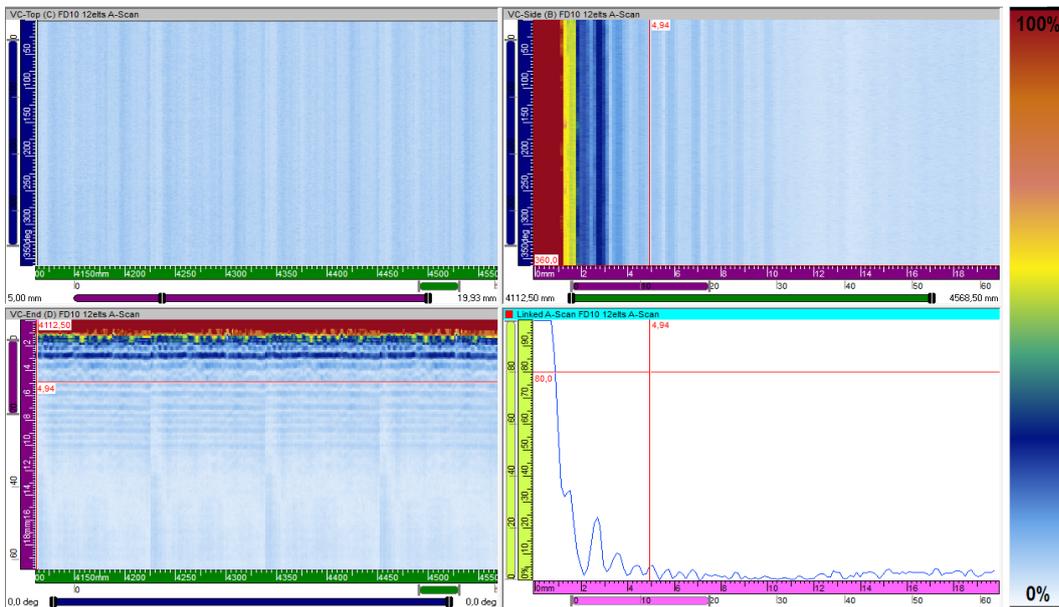
**Figure 7-29.** Ultrasonic Results from phased array ultrasonic inspection (UT11) of a copper tube area three directions: C-scan from the envelope surface (top left), B-scan viewed from the end surface (top right) and D-scan viewed along the axial direction (bottom left). The ultrasonic signal as a function of depth is shown in the A-scan (bottom right). The red cursor indicates the 5 mm that will be removed in the final machining and the reporting threshold applied.

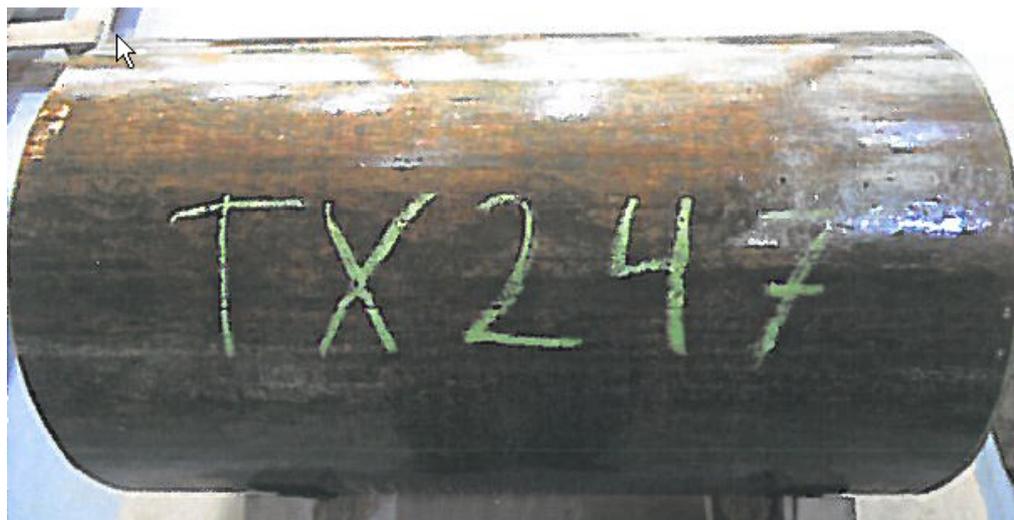
**Figure 7-30.** A copper lid ingot prior to fluorescent penetrant inspection with the envelope surface remaining as casted, whereas the end surfaces of the ingots were machined.

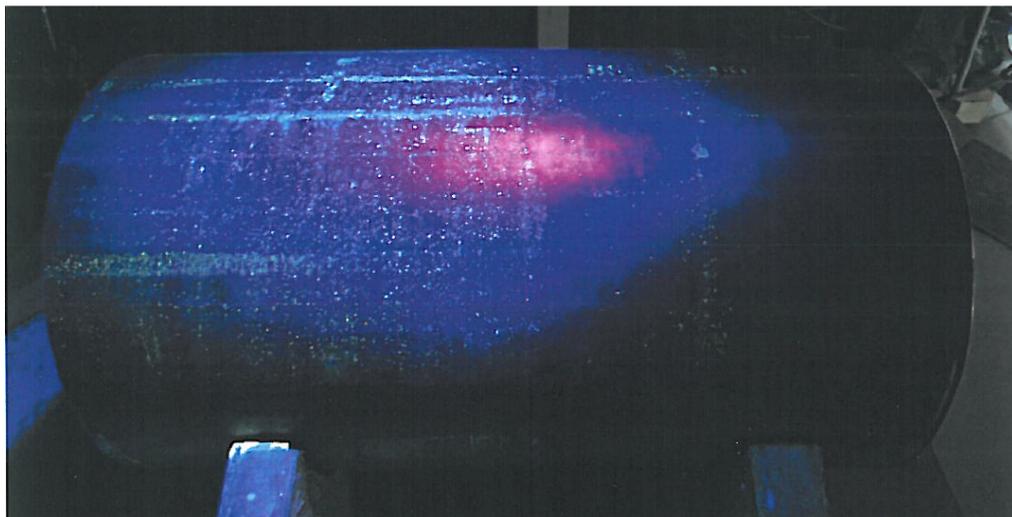
**Figure 7-31.** Penetrant inspection results for the envelope surface of a copper lid ingot, which shows a large number of non-significant indications caused by the rough as-cast surface.

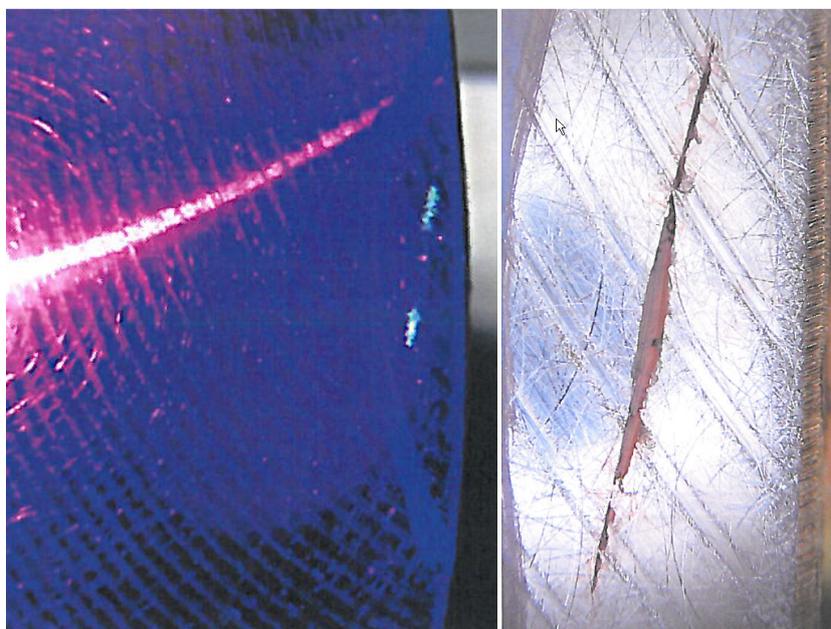
**Figure 7-32.** Penetrant inspection results for the end surface of a copper lid ingot showing an indication (left) caused by a sharp handling defect (right).

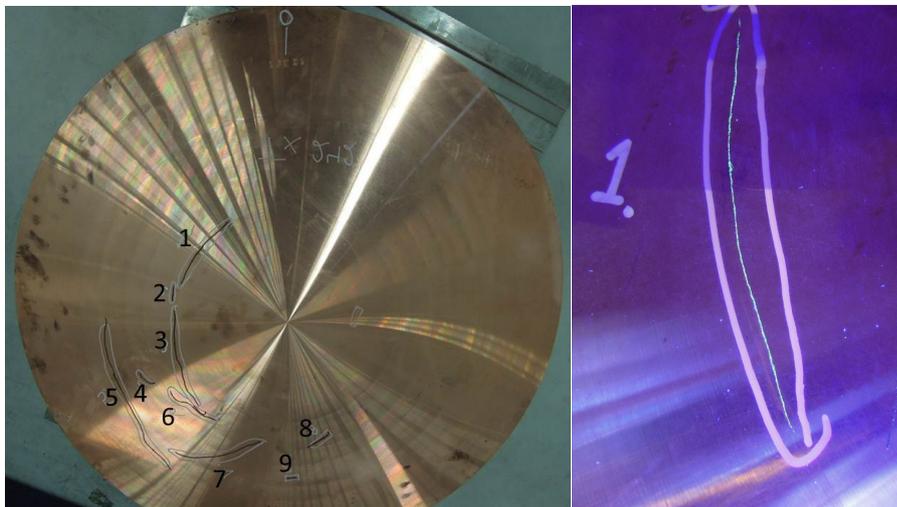
**Figure 7-33.** Results from fluorescent penetrant inspection of a lid (TX242) in the pre-machined state. Nine indications were detected on the bottom surface of the lid (left). The indication is circled in white, and the actual penetrant indication is highlighted by a black marker. All indications were linear and more or less circumferentially oriented. A section of indication number 1 is shown in the right image. The linear fluorescent indication is circled in white.

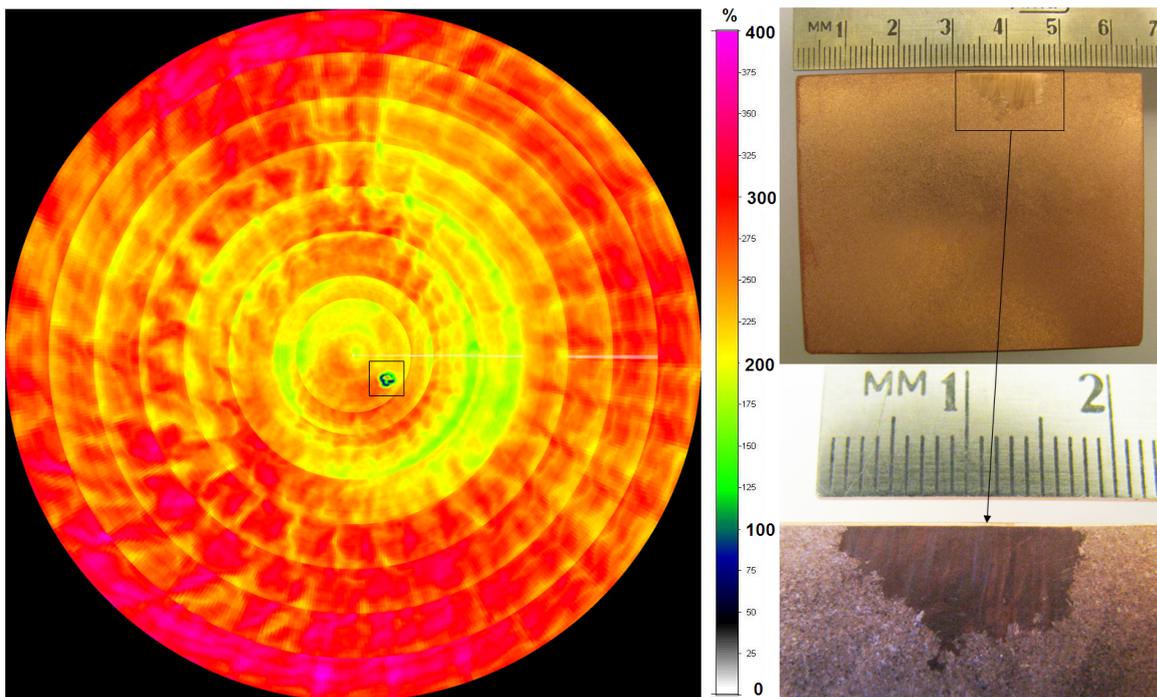
**Figure 7-35.** Ultrasonic back wall echo amplitude of the central part of lid TX215 (left) and the corresponding macrograph of the marked indication (right).

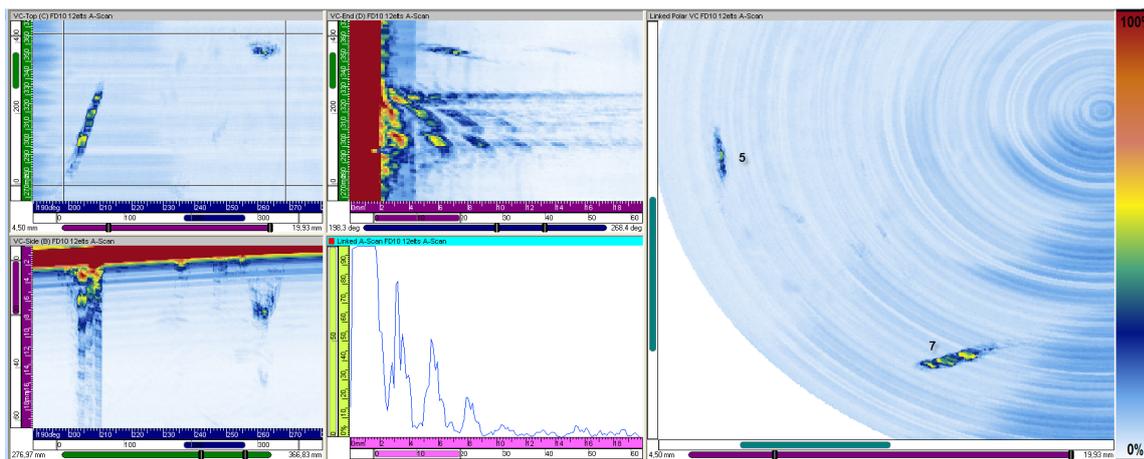
**Figure 7-37.** Ultrasonic results from indications 5 and 7 in Figure 7-36. The images on the top left, bottom left, and top middle show the C-scan, B-scan and D-scan, respectively, which correspond with the polar C-scan shown on the right, and the bottom middle image shows the A-scan for the maximum amplitude for indication number 7.

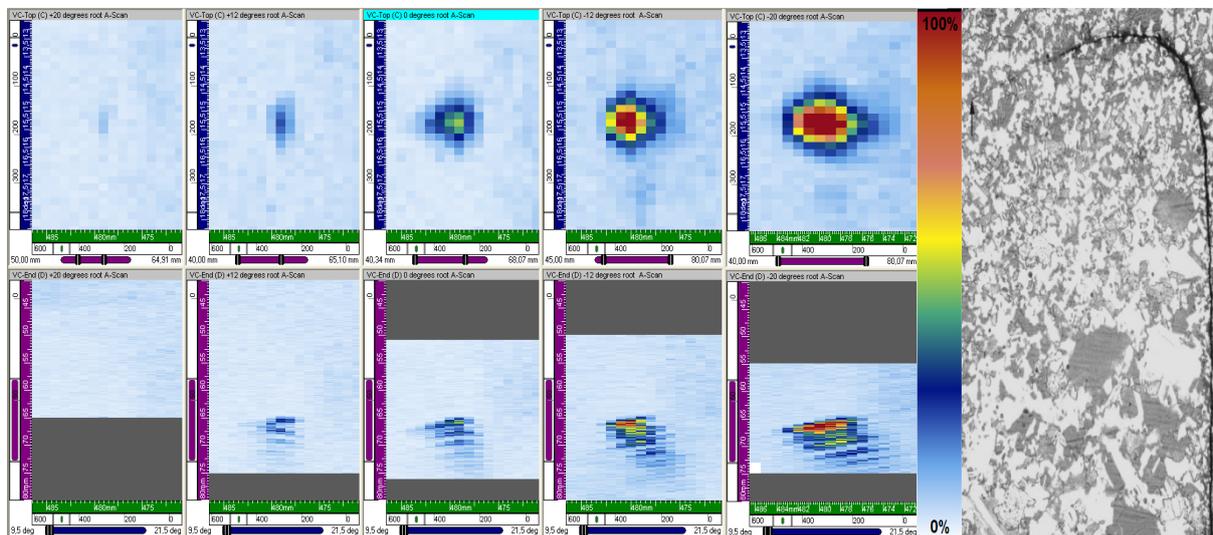
**Figure 7-38.** Results from inspection of a joint line hooking. The images on the left show, with the weld surface to the left, the C-scans (top) and B-scans (bottom) for inspection angles of  $20^\circ$ ,  $12^\circ$ ,  $0^\circ$ ,  $-12^\circ$  and  $-20^\circ$ . In the right image, a macrograph of a joint line hooking is shown.

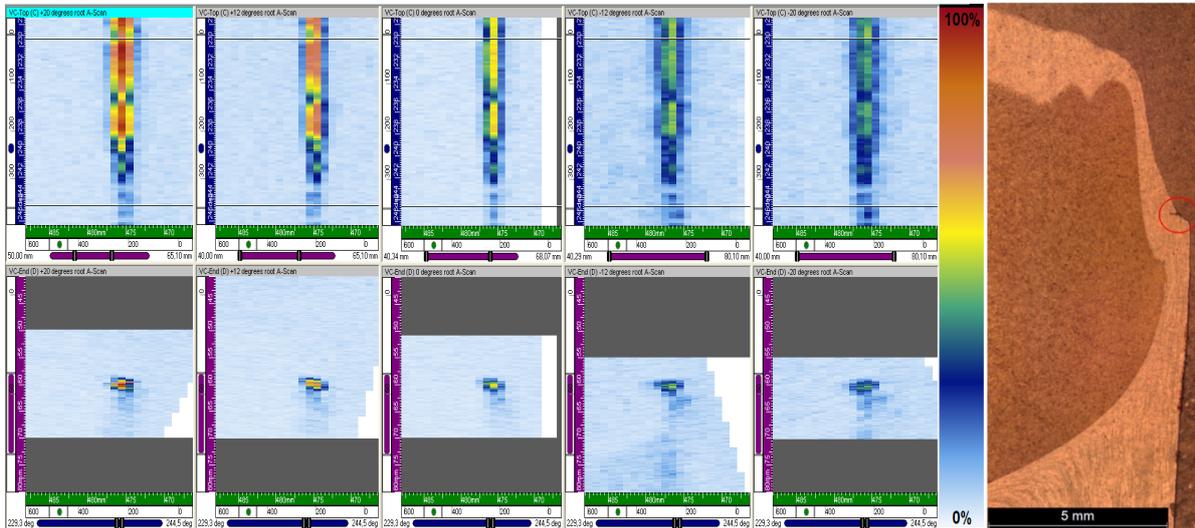
**Figure 7-39.** Results from inspection of a minor remaining joint. The images on the left show, with the weld surface to the left, the C-scans (top) and B-scans (bottom) for inspection angles of 20°, 12°, 0°, -12° and -20°. In the right image, a macrograph of a minor remaining joint is shown (circled in red).

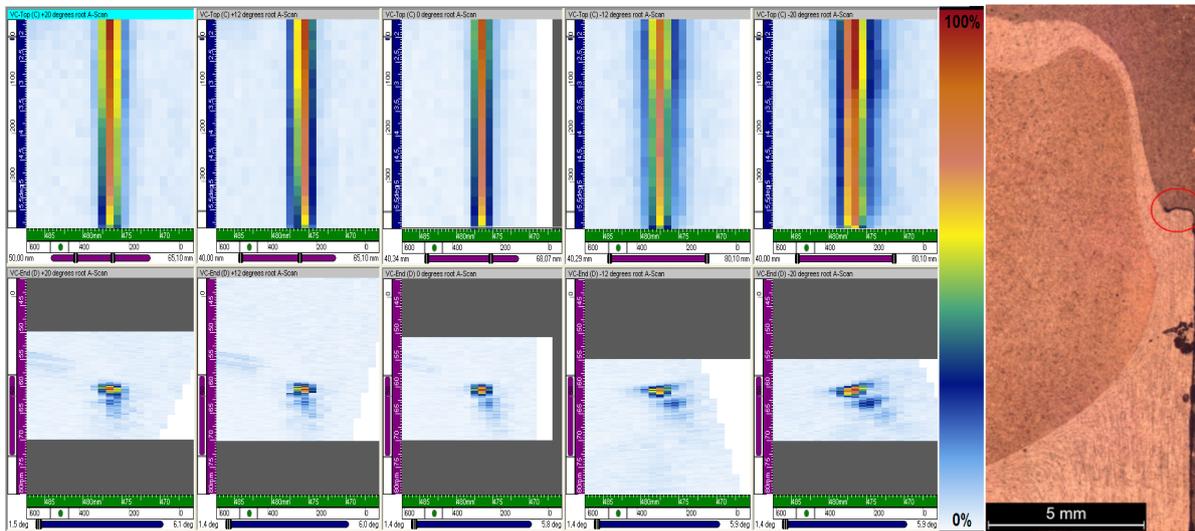
**Figure 7-40.** Results from inspection of a remaining joint. The images on the left show, with the weld surface to the left, the C-scans (top) and B-scans (bottom) for inspection angles of 20°, 12°, 0°, -12° and -20°. In the right image, a macrograph of a remaining joint is shown (circled in red).

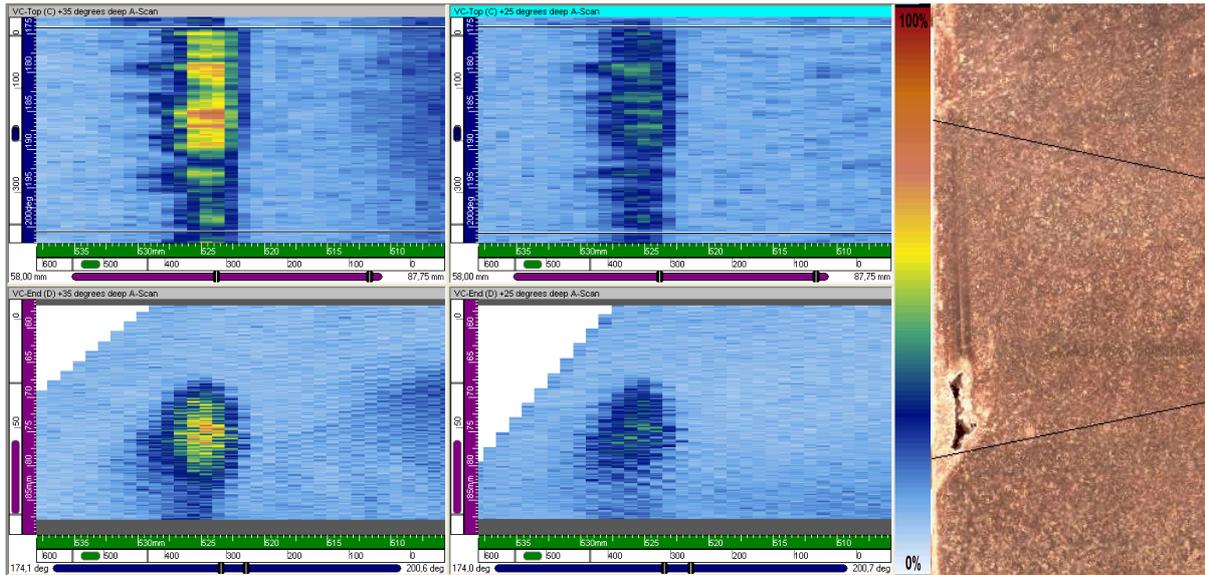
**Figure 7-41.** Results from inspection of a row of cavities. The images on the left show, with the weld surface to the left, the C-scans (top) and B-scans (bottom) for inspection angles of 35° (left) and 25° (right). In the right image, a macrograph of a cavity is shown.

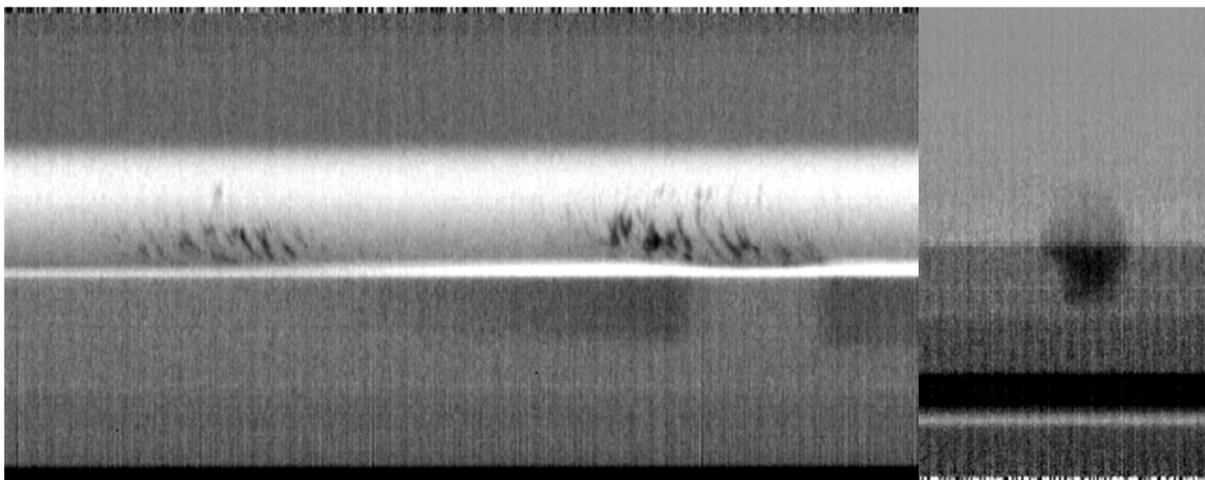
**Figure 7-42.** X-ray images of cavities (left) and a broken weld tool (right).

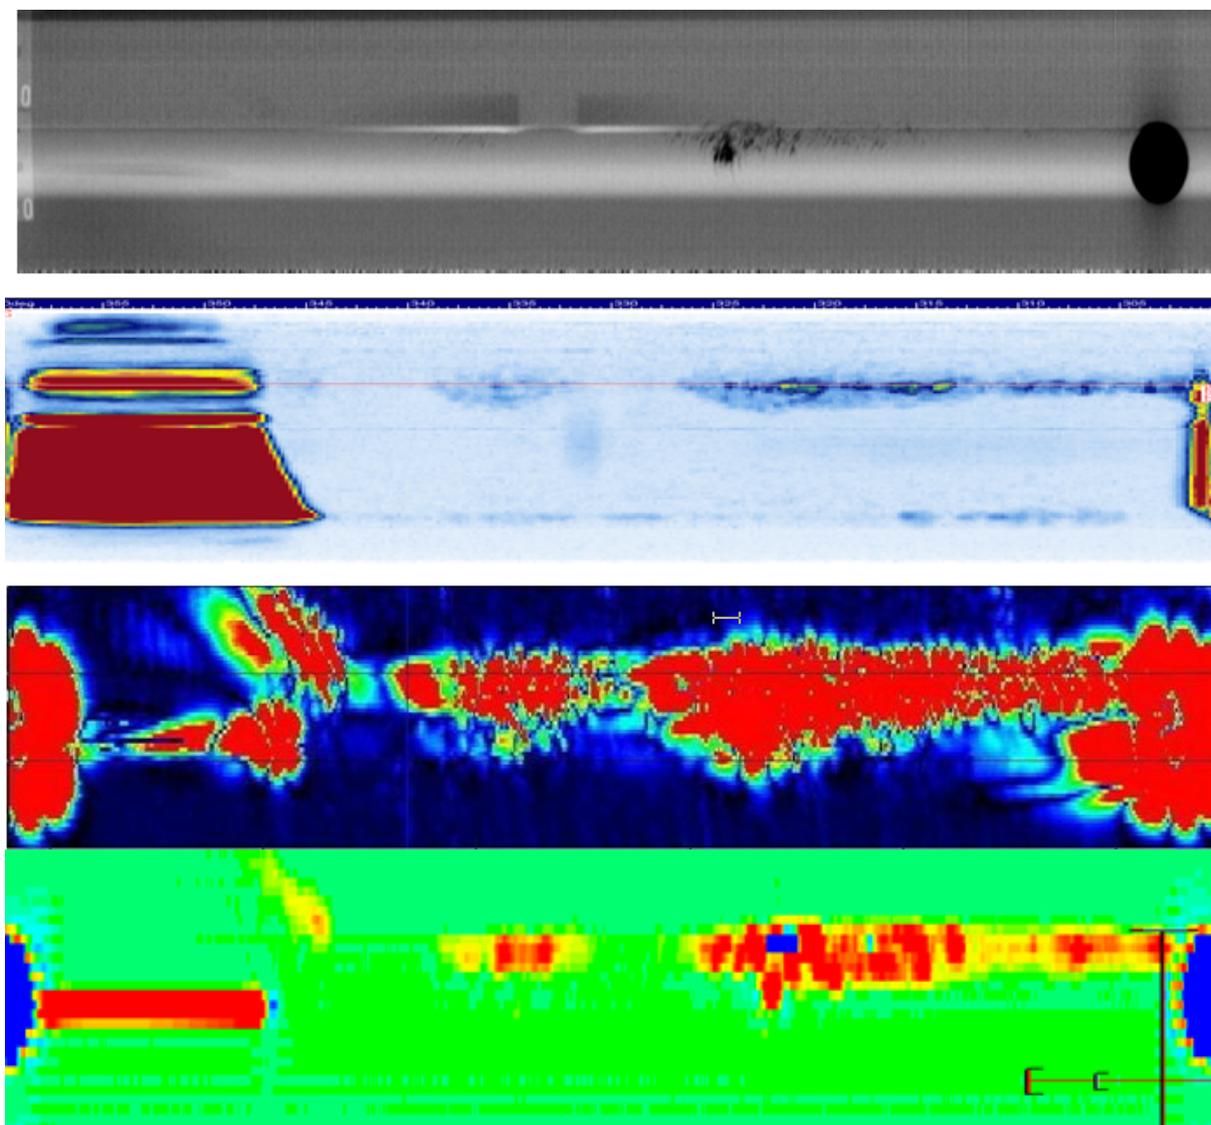
**Figure 7-43.** Non-destructive inspection results from a weld with a cavity-type defect. From top to bottom, the following are presented: X-ray, ultrasonic, single probe and array probe eddy current inspection results. The irrelevant indications on the far left were caused by a non-welded section, and those on the far right were caused by a welding tool exit hole that finished the welded section.

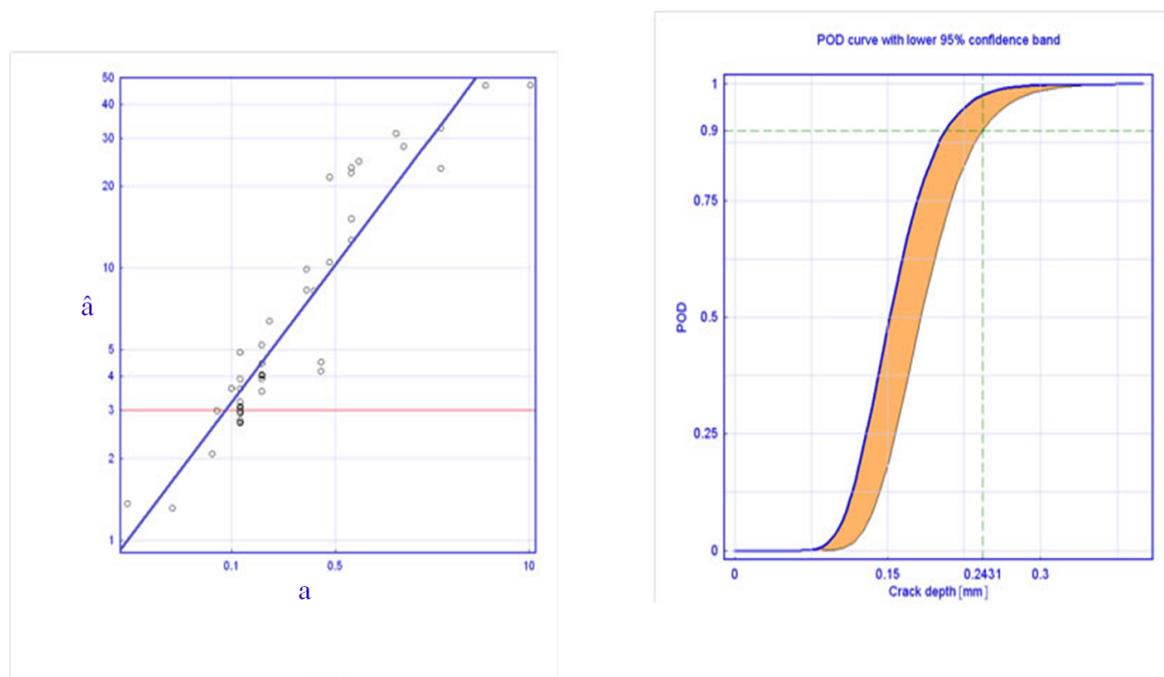
**Figure 8-1.** Typical signal response  $POD \hat{a}$  vs.  $a$  diagram (left) and the resulting  $POD$  curve as a function of defect parameter size (right).

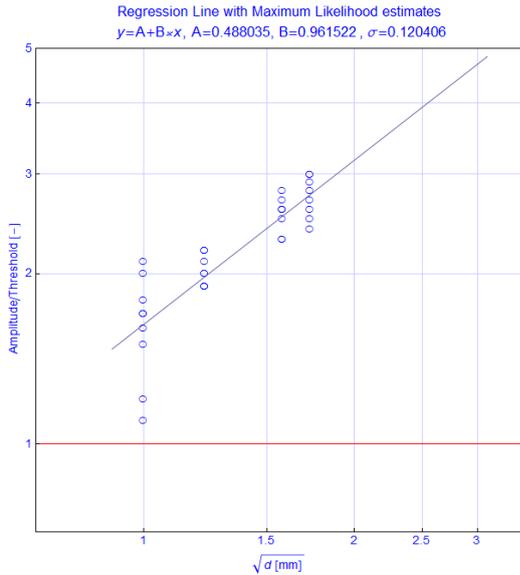
**Figure 8-3.**  $\hat{a}$  vs.  $a$  curve calculated for side-drilled holes (square root) for the depth range of 5-45 mm using the further developed normal incidence ultrasonic technique.
