Document ID 1434744	Version 2.0	Status Approved	Reg no	Page 1 (131)
Author Ulf Ronneteg Thomas Grybäck			Date 2015-02-04	
Reviewed by Lisette Åkerman (QA)			Reviewed date 2015-02-26	
Approved by Jan Sarnet			Approved date 2015-02-26

## Non-destructive testing of canister components and welds

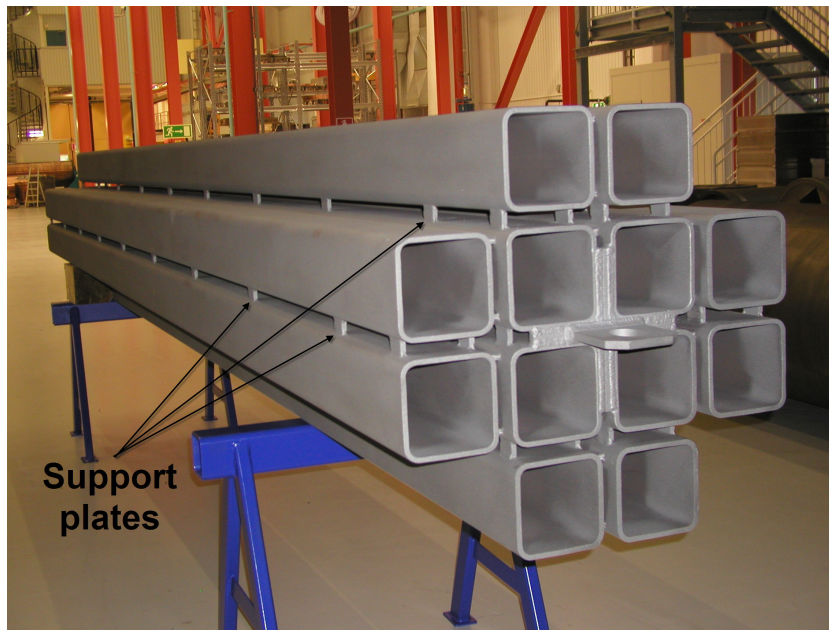
**Figure 3-3.** Steel cassette for the BWR insert.

The steel tube cassette (Figure 3-3) is formed by square steel tubes with thicknesses of 10 mm (BWR) and 12.5 mm (PWR) welded together. The distance between the fuel channels tubes, 30 mm for the BWR and 110 mm for the PWR, is maintained by steel plates (called support plates) positioned equidistantly vertically along the insert.

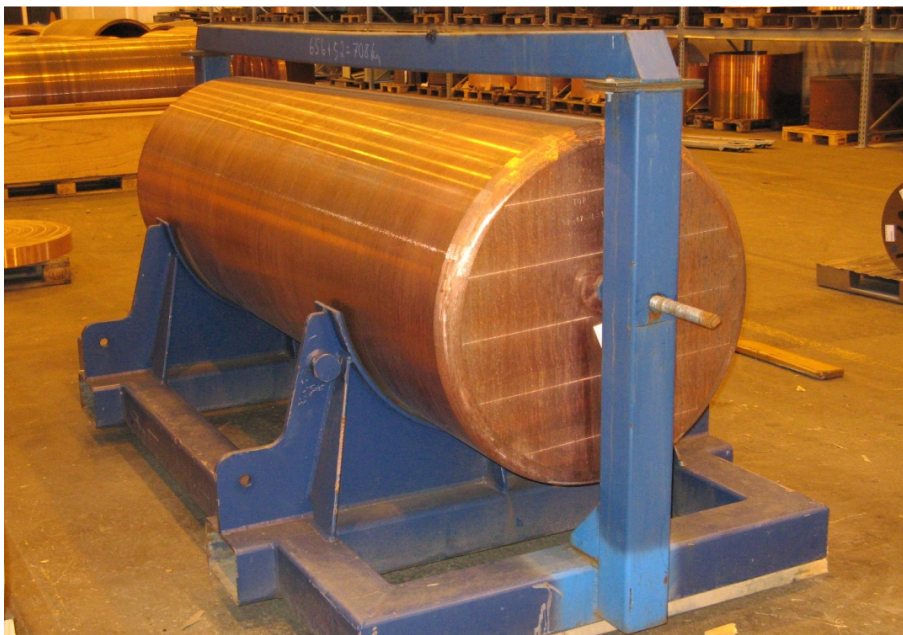
*Figure 3-6. Ingot used to manufacture tubes.*

The copper ingots are manufactured via semi-continuous casting, which creates cylindrical and solid ingots, as shown in Figure 3-6. After casting, the ingot is machined to a nominal diameter of 850 mm and a nominal weight of 12.4 tons for tube extrusion or 13.4 tons for the manufacture of tubes with an integrated base by the pierce-and-draw process.

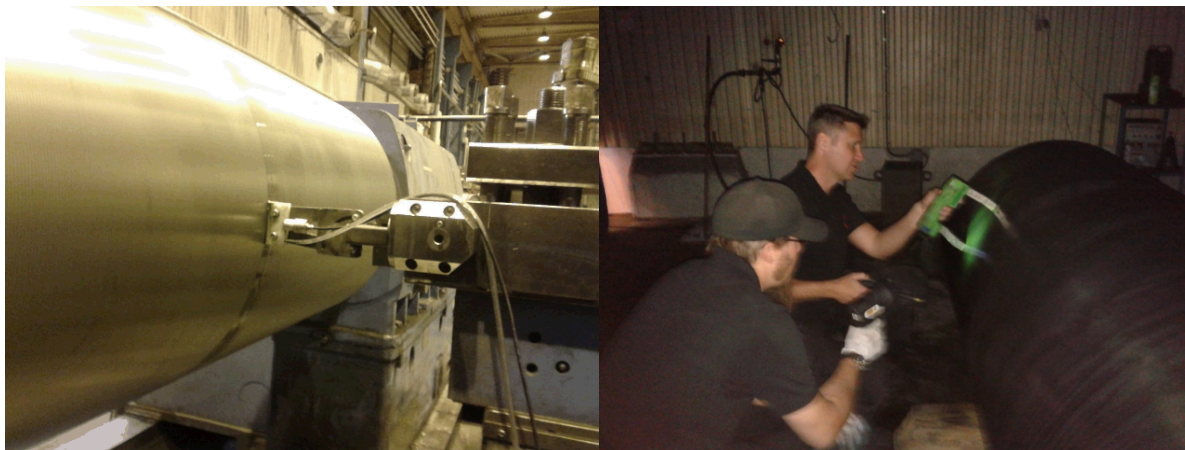
**Figure 6-7.** Ultrasonic and magnetic particle inspections of the inserts are performed by the supplier. The ultrasonic inspection (left) is automated using a turning machine as the manipulator; the cutting tool has been replaced with an ultrasonic probe that is fed with water as a couplant. The fluorescent magnetic particle inspection (right) is performed by magnetising each square decimetre of the insert in two orthogonal directions under UV lighting.

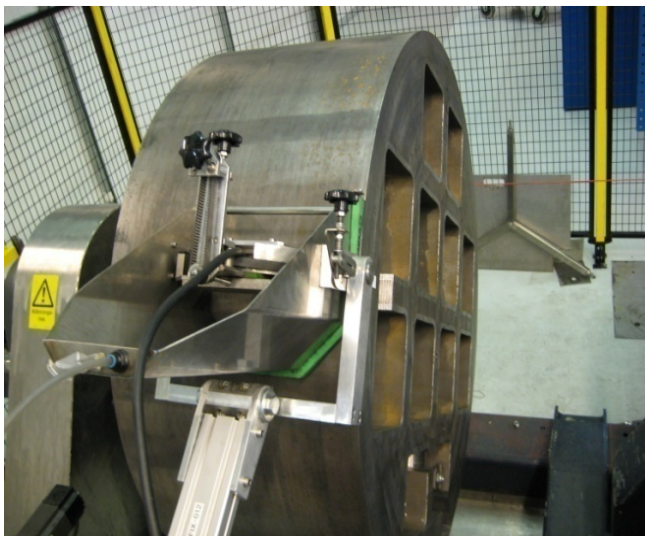
**Figure 6-8.** Linear array for local immersion inspection of the cast iron insert.

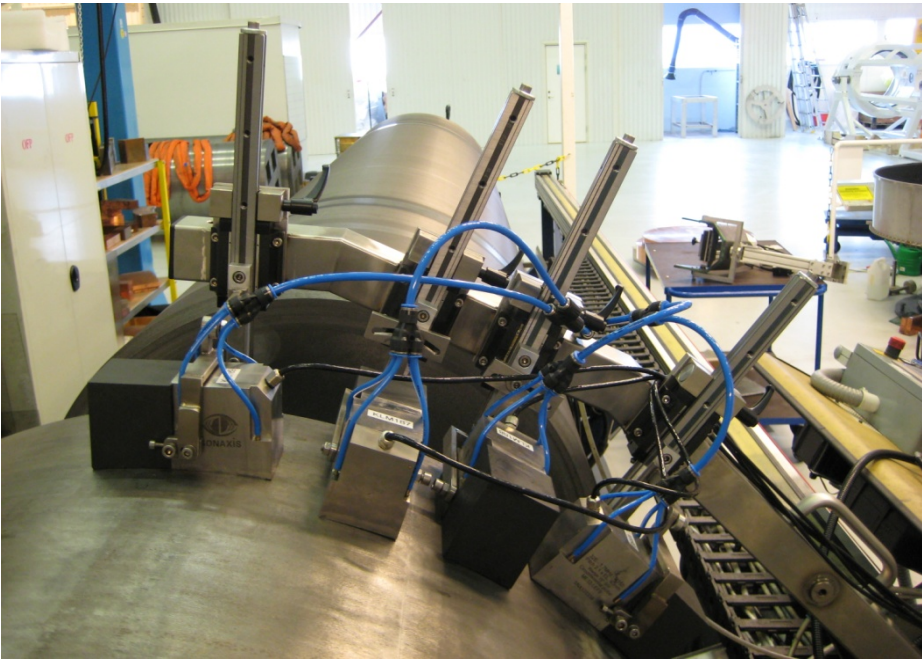
**Figure 6-19.** Fixture with four 32-element linear arrays (1.7 MHz) for ultrasonic testing of the outer five centimetres with shear waves and approximately 70° incident angle.

The next steps in the development of the inspection technique were to manufacture the curved linear arrays, two arrays adapted to the insert surface for inspection in the axial direction and two arrays for inspection in the circumferential direction, and to design and manufacture a fixture. The probes were manufactured with an integrated water irrigating system, for which the specifications are compiled in Table 6-3, and because the probes were rather heavy (half a kilo each), special attention was given to the design and manufacture of a rigid probe fixture (Figure 6-19).

Parameter	Value
Centre frequency	1.7 MHz
Number of elements	32
Nominal angle	70° shear wave
Passive focus	R 150 mm
Pitch between elements	2.1 mm
Passive aperture size	40 mm

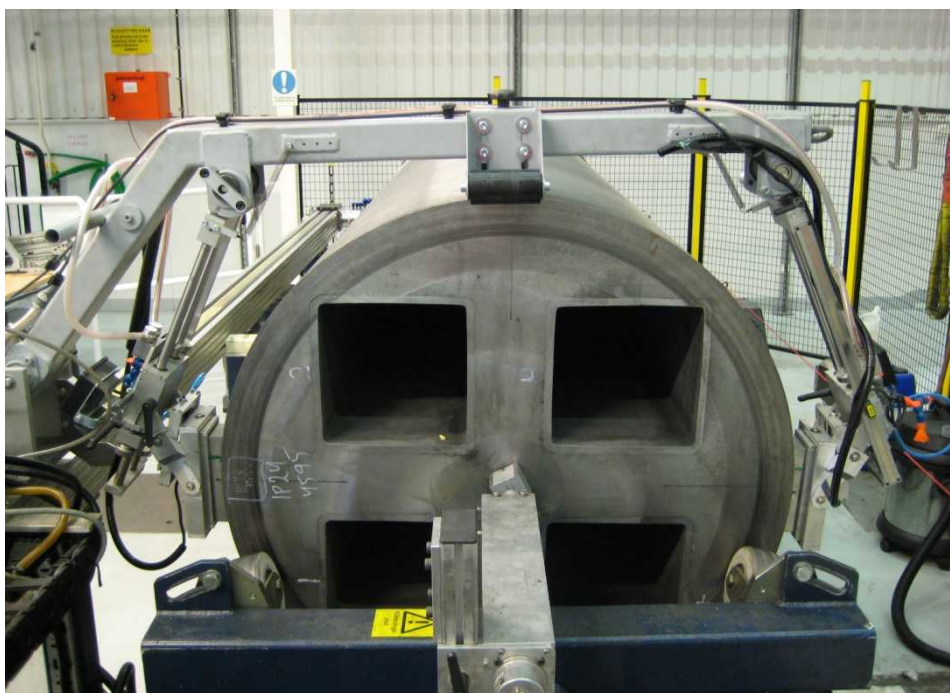
**Figure 6-23.** Ultrasonic testing of the volume between the channel tubes in a PWR insert using the Posiva probe fixture.

The next steps in developing the inspection technique were to manufacture the two curved linear arrays adapted to the insert surface and to modify the Posiva probe fixture (Figure 6-23). The probes were manufactured with an integrated water irrigation system, the specifications of which are compiled in Table 6-5. Finally, the inspection setup, which includes the fine-tuned focal laws, gain and gate settings etc., was defined, and instructions for full-scale inspection, which included data evaluation, were developed (UT33-PWR version 2.0). In Table 6-6, the primary phased array parameters used to inspect the central part of the PWR insert are summarised.

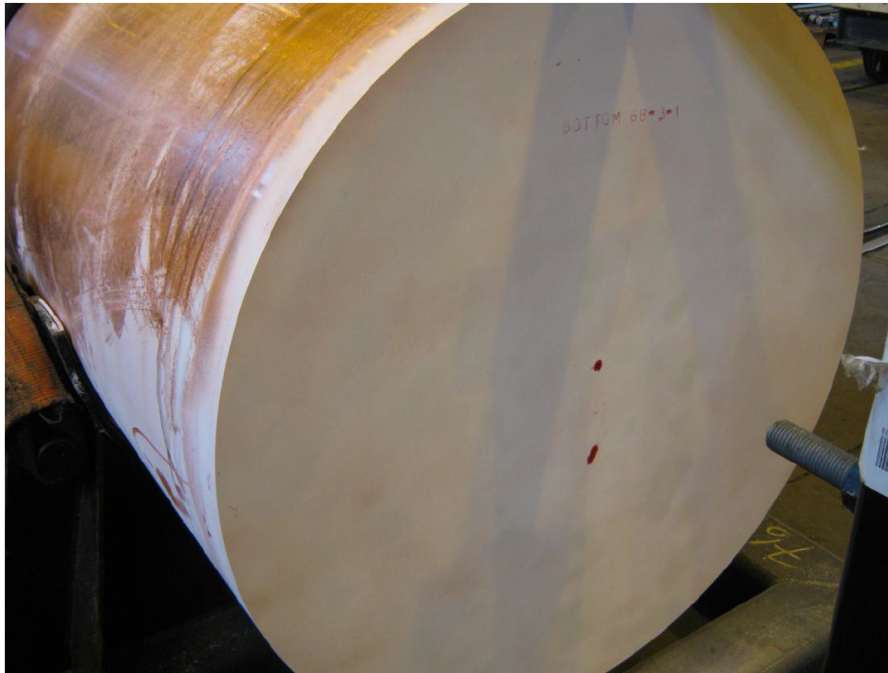
**Figure 6-35.** Dye penetrant inspection results on the end surface of a machined copper tube ingot. In the centre, two penetrant indications are visible.

Machined copper ingots, in addition to being visually inspected, are inspected using a dye penetrant according to international inspection procedures. Some sample results obtained from inspecting the envelope surface and end surface of a machined copper tube ingot are shown in Figures 6-34 and 6-35.

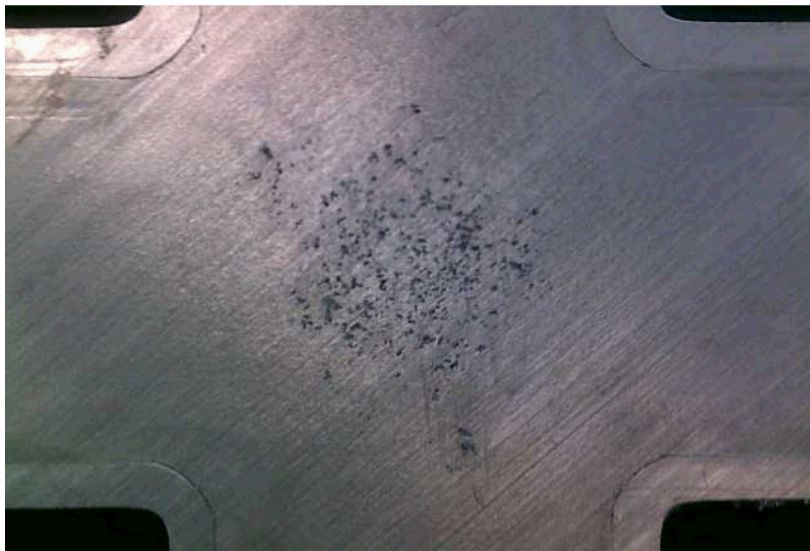
**Figure 7-6.** Photograph of the shrinkage pores indicated in Figure 7-5 between the fuel channels in a PWR insert.

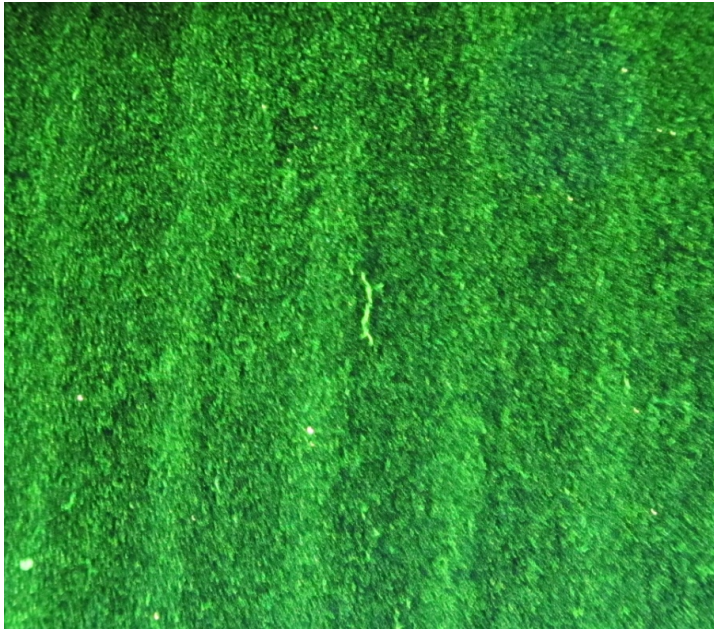
**Figure 7-16.** MT-1, a 3-mm linear indication obtained by magnetic particle inspection. The indication detected on the envelope surface of the insert is oriented in the circumferential direction. The five broader, weaker, non-relevant indications along the entire figure in the same vertical direction of the figure are caused by magnetic leakage fields related to the surface finish left by the turning operation.

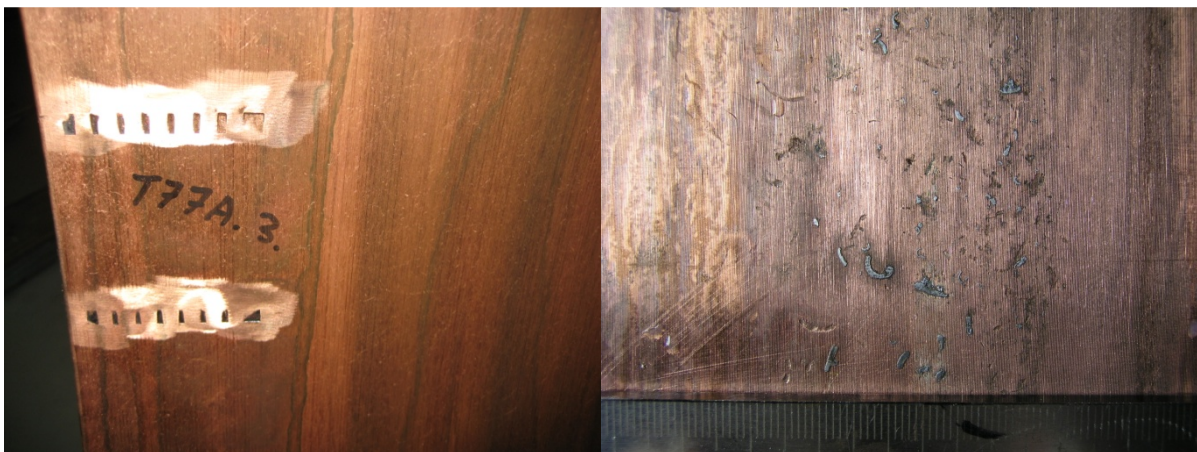
**Figure 7-26.** Handling defects manifested as indentations on the inside of tube T77 (left) and foreign material on the outside of tube T43.

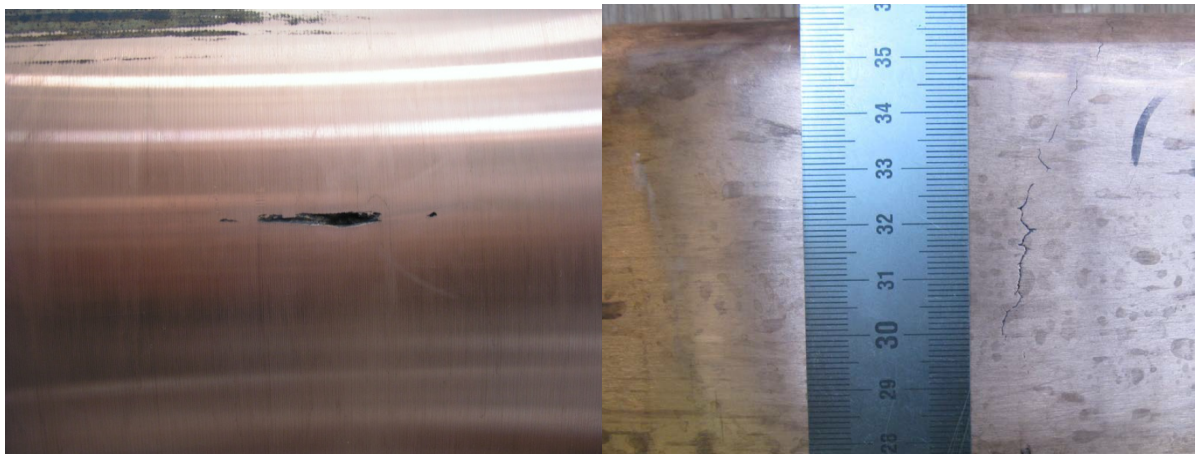
**Figure 7-27.** Manufacturing defects in copper tubes. The left image shows an axial scratch (T46) in an extruded tube and the right image shows a crack-like defect in a pierce-and-draw tube (T83).

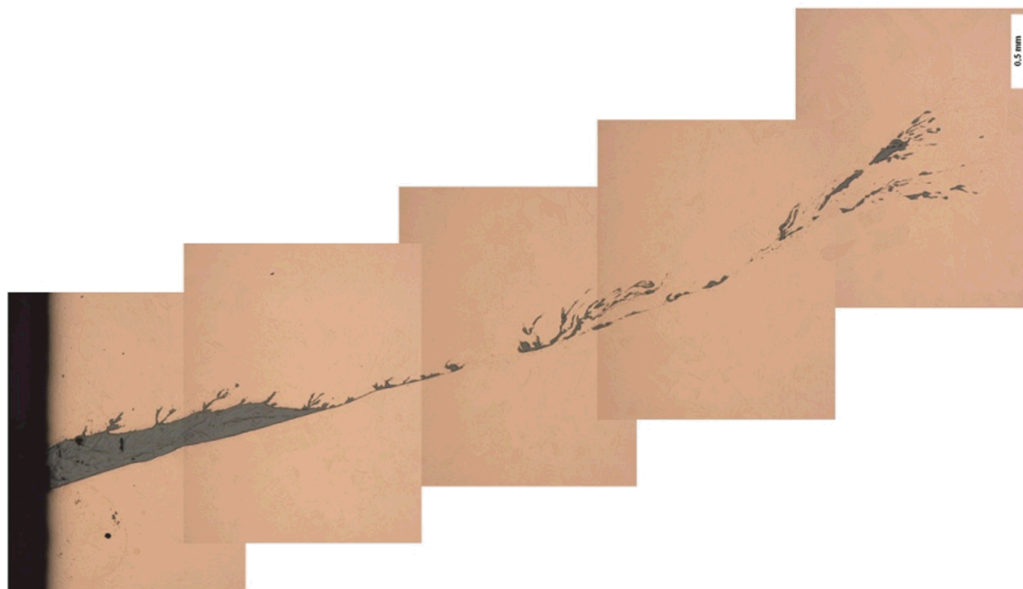
**Figure 7-34.** Metallographic cross-section of a forging lap extending from the bottom surface (left). The depth was measured to about 8 mm.

None of the aforementioned penetrant indications from the forging laps were cut for further metallographic examination. However, on a previously manufactured lid, a forging lap was visually detected and afterwards verified by eddy current inspection. This forging lap was cut, and metallographic examination revealed a defect that extended down to a depth of 8 mm. The metallographic cross-section of the forging lap is shown in Figure 7-34.
