R-15-11

Further metallographic analysis of MiniCan SCC test specimens

Suzanne Aggarwal
Venugopal Addepalli
Nicholas Smart

Suzanne Aggarwal, Venugopal Addepalli, Nicholas Smart
Amec Foster Wheeler

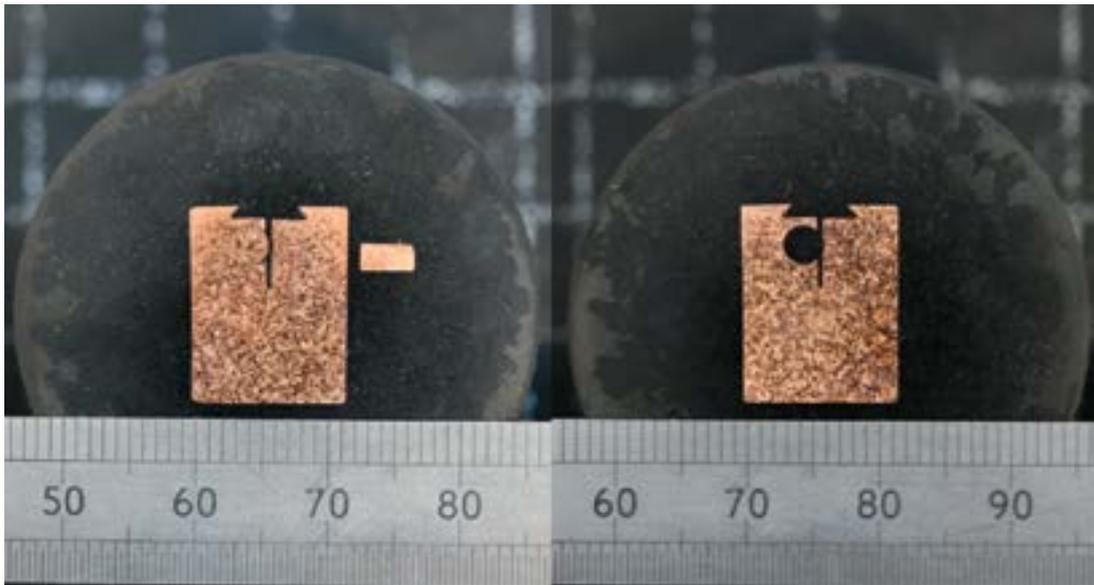
Figure 3-1 shows the WOL specimens before they were removed from the Bakelite mounts and Figure 3-2 shows the opened WOL specimens; there was a range of discoloration on the notch and pre-crack area, along with fresh shiny surfaces on the fast fracture areas. The pre-crack region is evident from the thumbnail shapes emanating from the notch created in the WOLs. WOL B sections appear to have a much darker deposit on the surface of the pre-crack region.

Figure 3-1. WOL A (LHS) and WOL B (RHS) prior to being cut out of Bakelite.

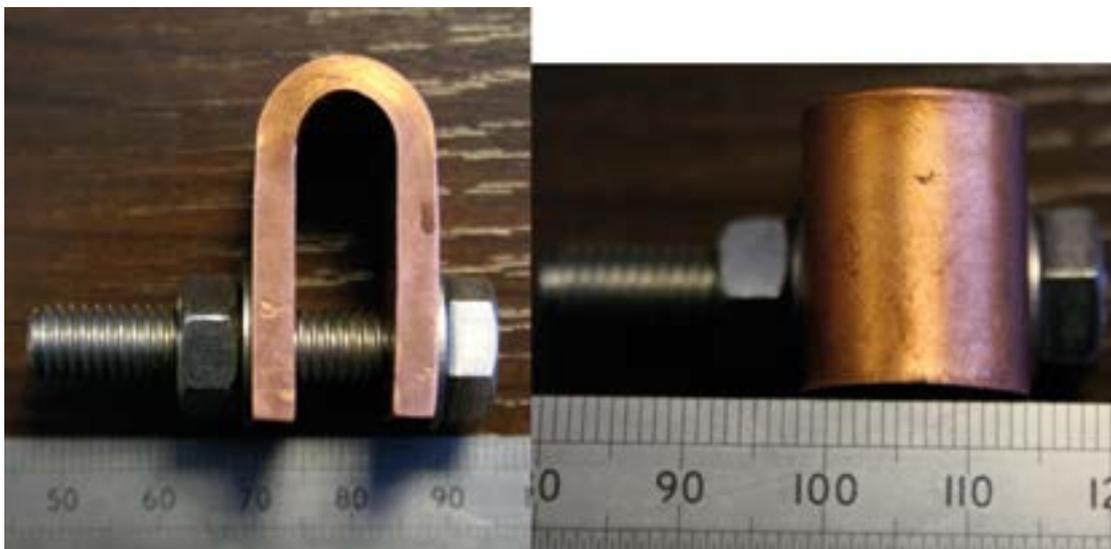
In order to determine, and possibly distinguish between, the effects of in situ exposure in the MiniCan test and the effects of mechanical stress (if any) during preparation (i.e. bending) of the U-bend specimens, a strip of copper of similar dimensions (0.5 mm thicker) was bent into a U-bend using the curvature of the tested U-bends as a template (Figure 3-15). The copper strip was bent around a former, with no external heat applied, then bolted in tension. This procedure was carried out using the same approach as that used for the U-bend specimens that had been prepared in 2006 and used in the in situ test. The aim of comparing an untested U-bend with the tested U-bends was to determine whether any surface features could be attributed to the mechanical forming of the U-bend. Although it is not clearly evident, there appears to be an “orange peel” effect on the surface of the untested U-bend (Figure 3-15). An orange peel effect is clearly visible on U-bend specimens 95UG and 94UG (Figures 3-16 and 3-17). Further evidence of the orange peel effect is presented in the following section.

Figure 3-15. Side view and top view of untested U-bend copper specimen created for comparative analysis.

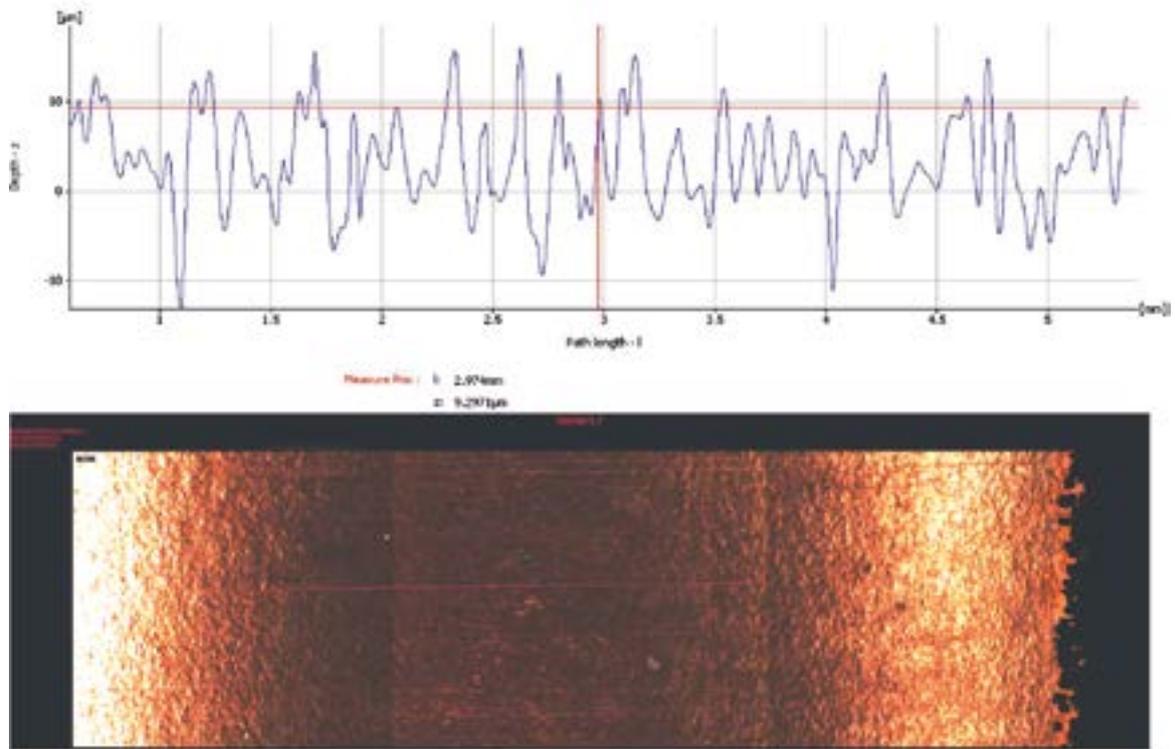
The apex values of the surface roughness of the untreated U-bend compared with the tested U-bends from the MiniCan experiment show that the surface condition had been altered by general corrosion (assuming the specimens deformed in a similar manner). This is shown by comparing the specimen slices from 94UG and 95UG with the untreated U-bend Ra values. Surface roughness values were taken across approximately the same lengths across each specimen slice and over a length of at least five repeating unit lengths, in accordance with ISO standard practice for surface roughness measurements (ISO 1302:2002, ISO 4287:1997).

Figure 3-18. Surface roughness and optical microscopy image of apex of untested U-bend.

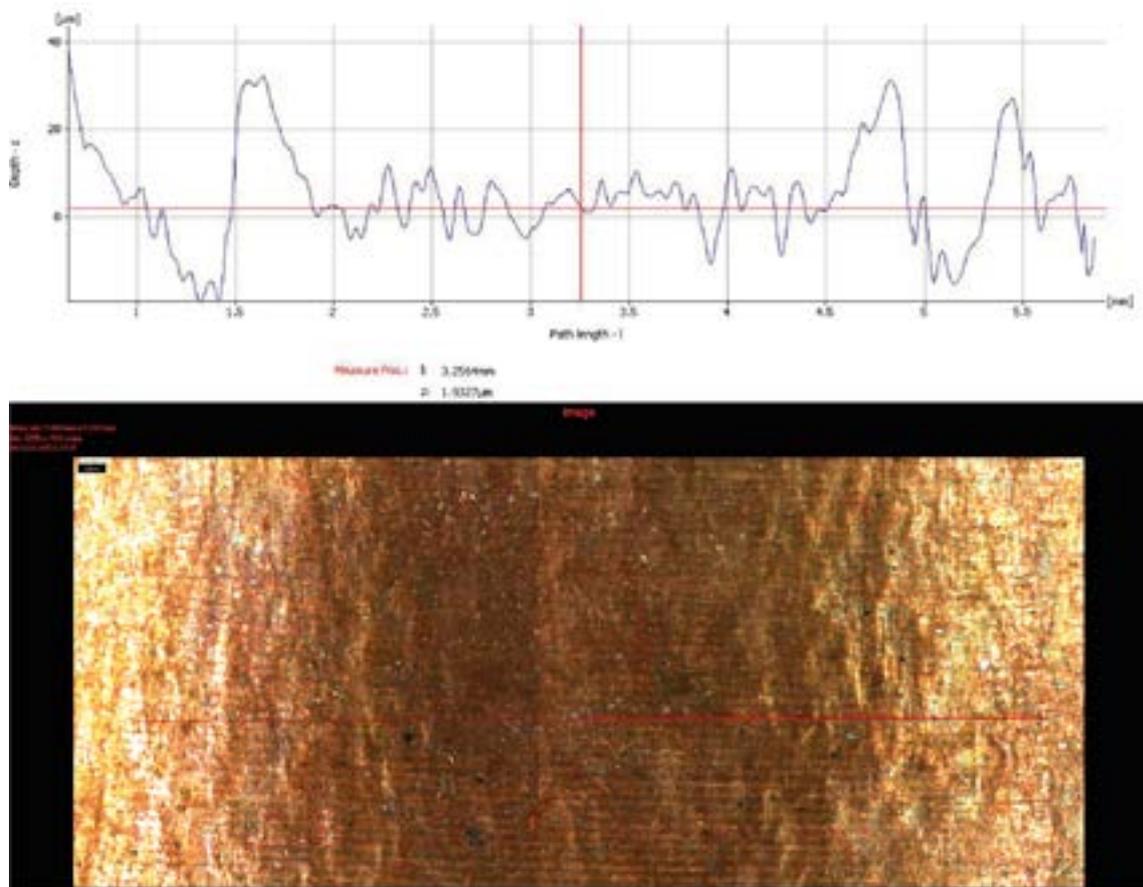
Figure 3-19. Surface roughness and optical microscopy image of apex of 94UG: unmounted slice.

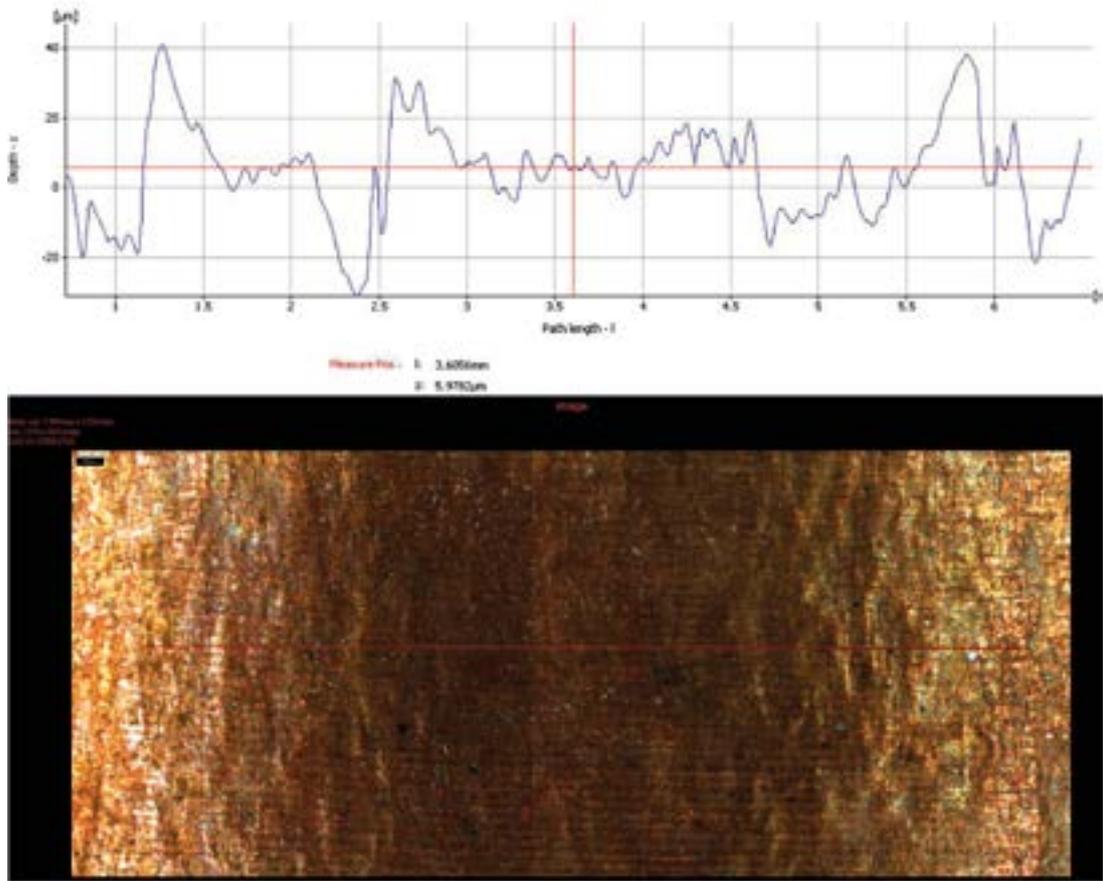
Figure 3-20. Surface roughness and optical microscopy image of apex of 94UG: bottom slice.

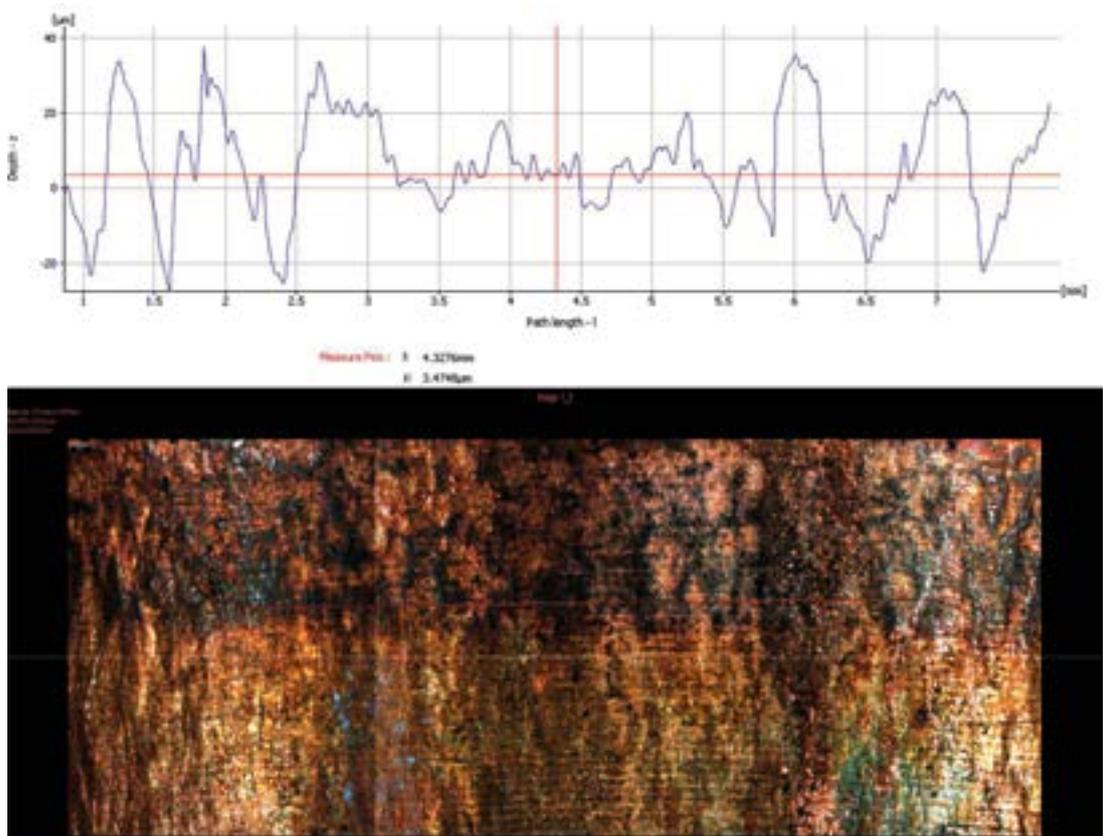
Figure 3-21. Surface roughness and optical microscopy image of apex of 94UG: top slice.

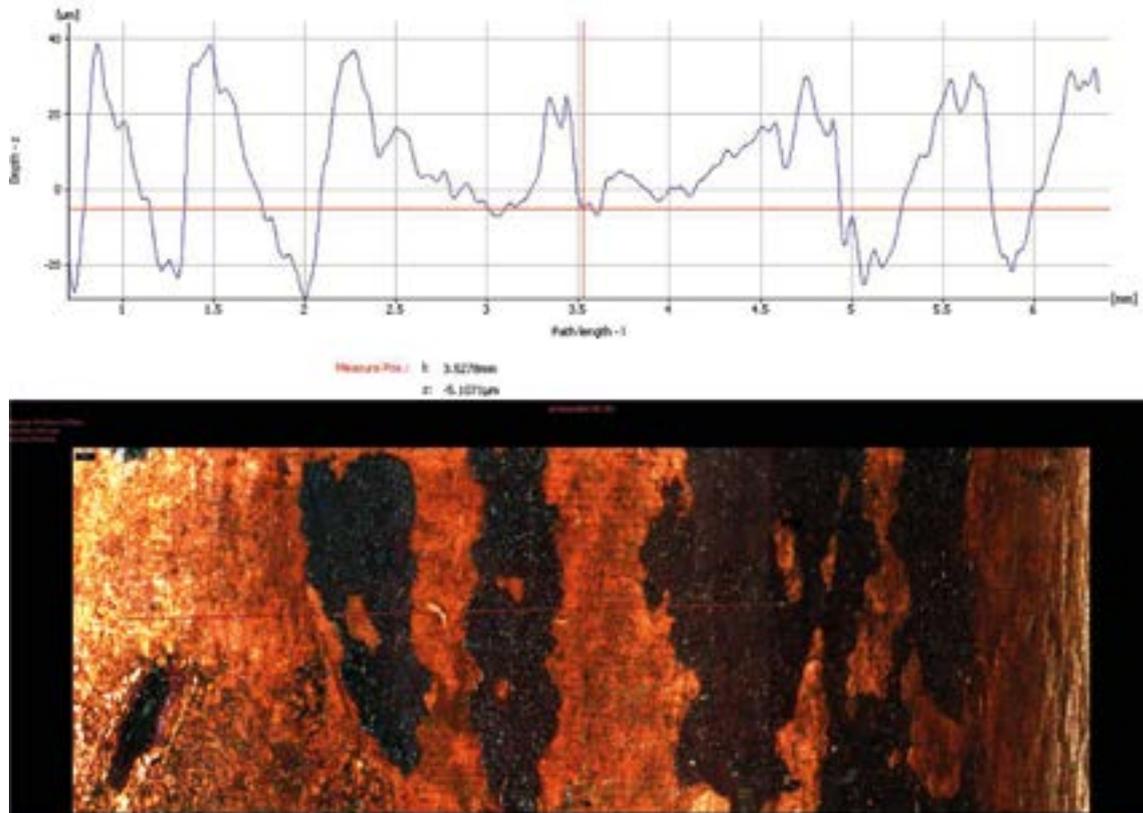
Figure 3-22. Surface roughness and optical microscopy image of apex of 95UG: unmounted slice.

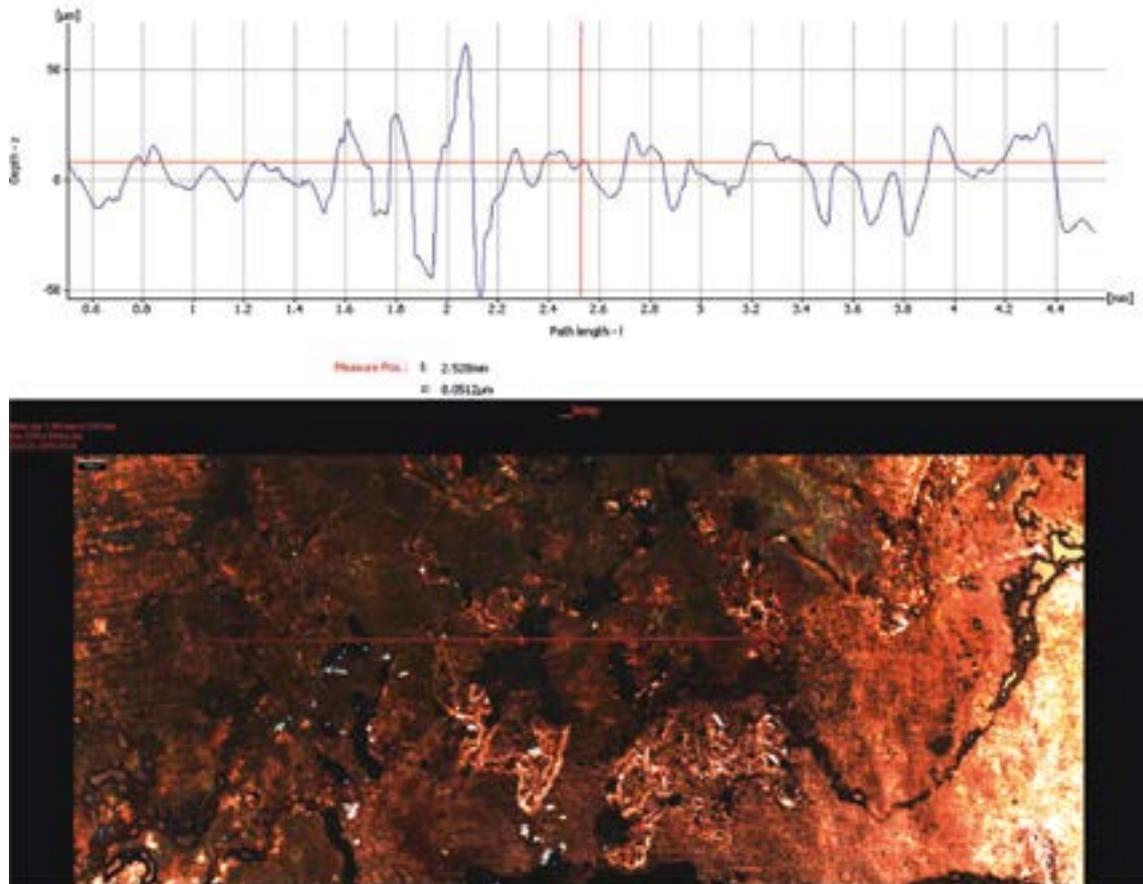
Figure 3-23. Surface roughness and optical microscopy image of apex of 95UG: bottom slice.

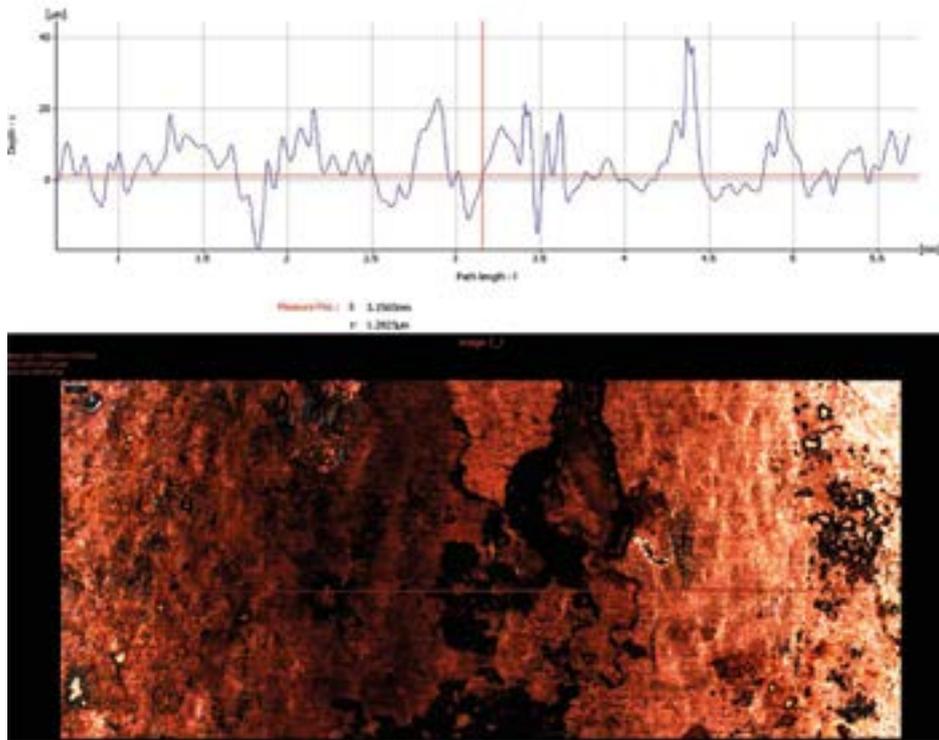
Figure 3-24. Surface roughness and optical microscopy image of apex of 95UG: top slice.

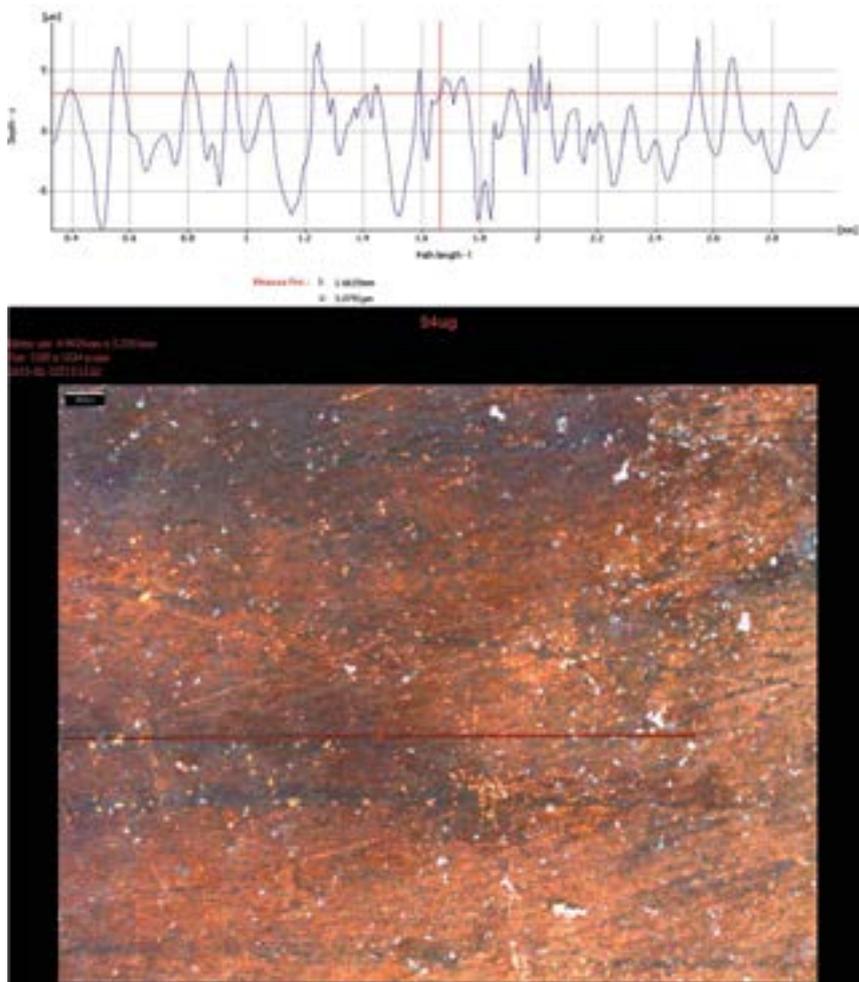
Figure 3-25. Surface roughness and optical microscopy image of 94UG: flat end of U bend.

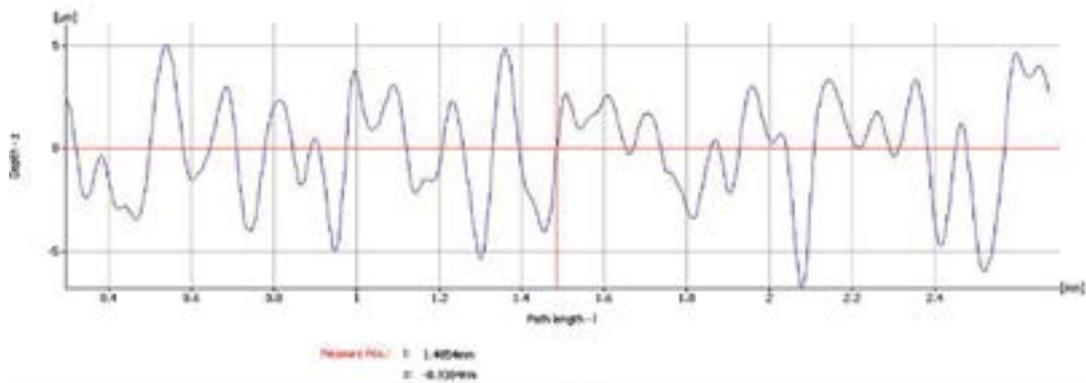
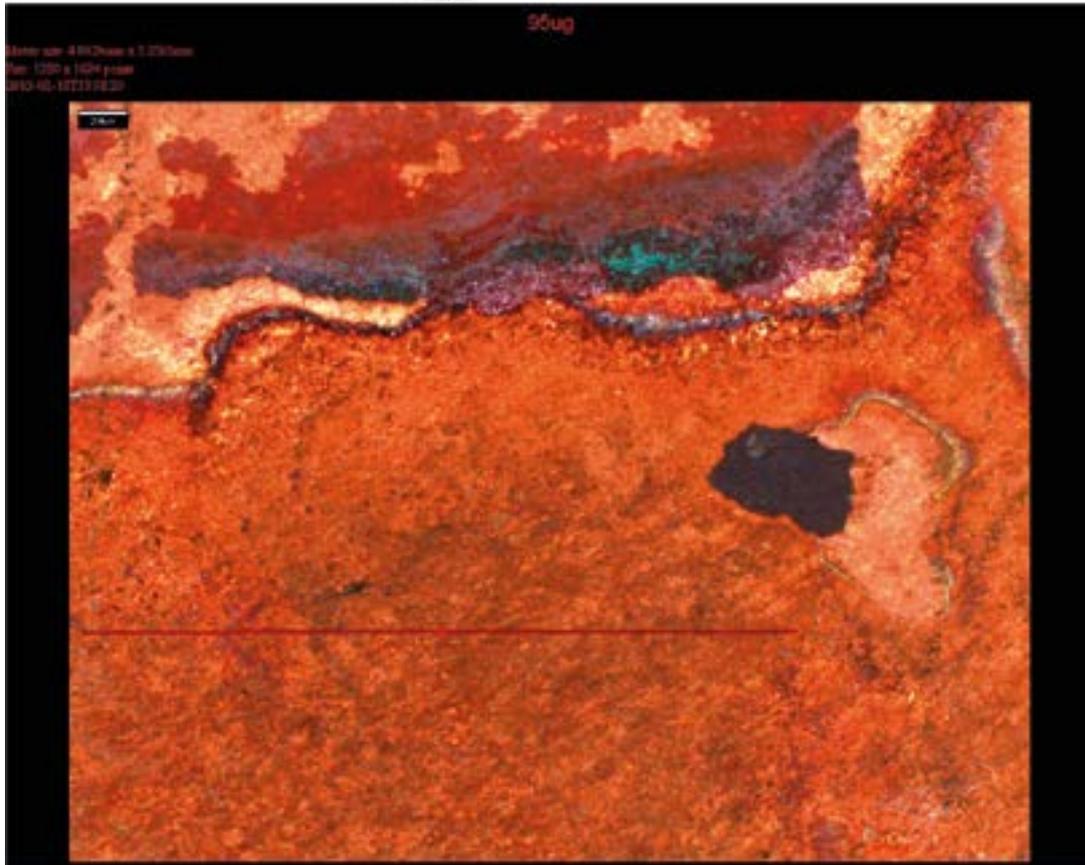
Figure 3-26. Surface roughness and optical microscopy image of 95UG: flat end of U-bend.

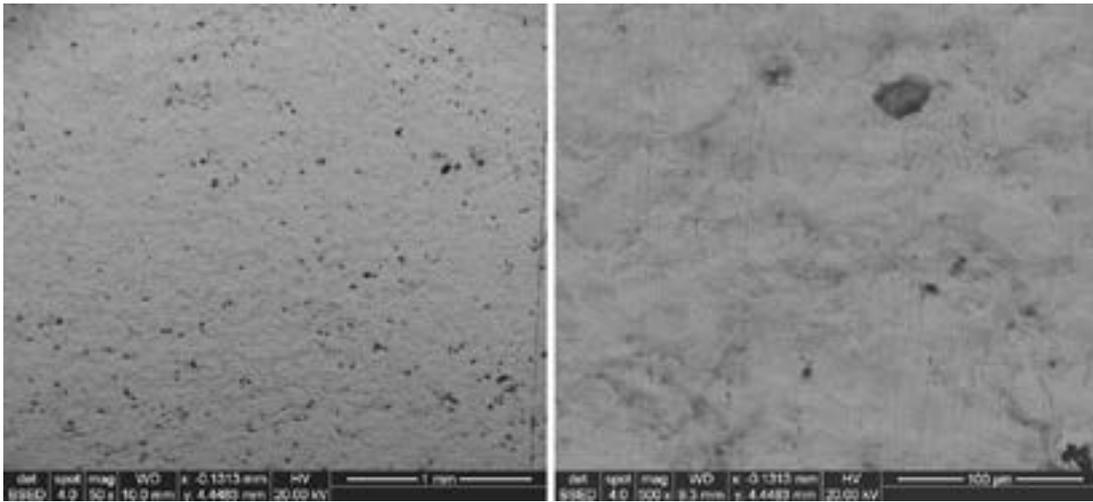
Figure 3-27 and Figure 3-28 show increasing magnification micrographs of the untested U-bend surface condition. It can be clearly seen in the higher magnification images that there are strain-directional striations and non-uniform surface features. These images are in agreement with the images above, showing non-uniform mechanical deformation of the apex of the U-bends.

Figure 3-27. SEM images at $\times 50$ and $\times 500$ of untested U-bend.

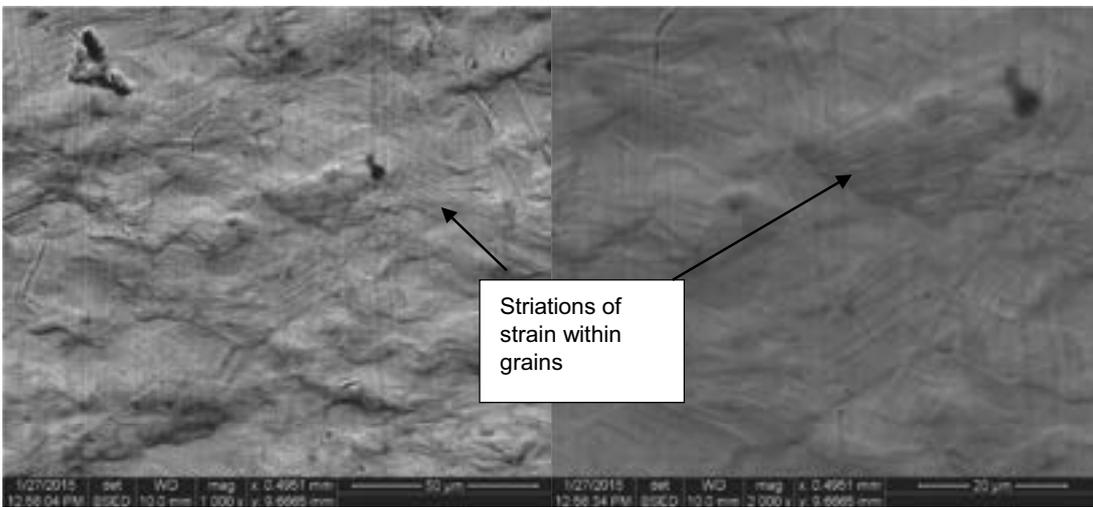
Figure 3-28. $\times 1000$ and $\times 2000$ magnification backscattered electron detector (BSED) images of untested U-bend with curvature from top of image to bottom.

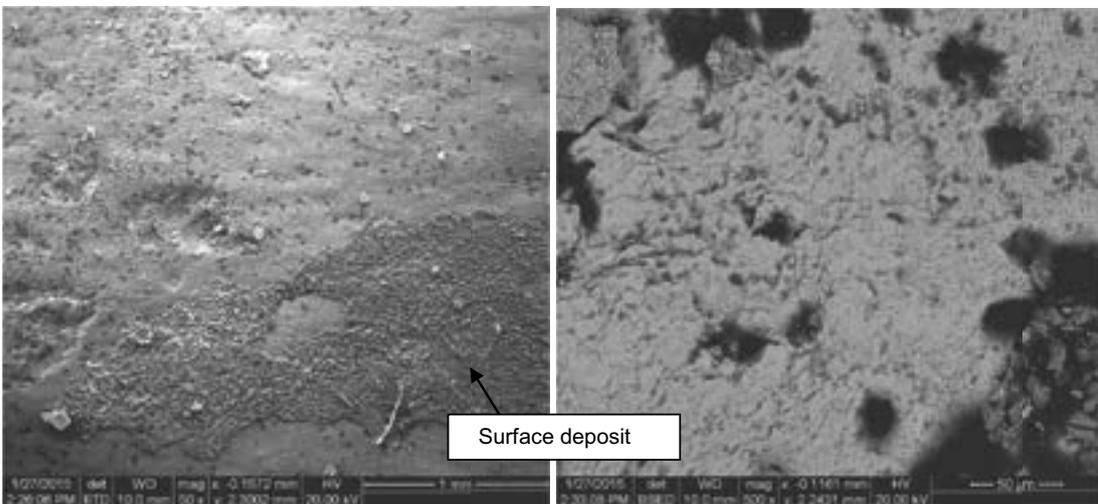
Figure 3-29 to Figure 3-38 are SEM images of the tested U-bends, all showing evidence of surface deposition. Table 3-4 and Figure 3-29 show the results of EDX analyses at three different positions on the surface of a tested U-bend specimen whose elemental composition was characterised using EDX. All three positions showed the presence of carbon, oxygen, calcium and copper in varying proportions. This suggests that there was a general surface deposit that was oxygen-rich, possibly a calcium-copper carbonate. The pit size range seen on the surface was up to a maximum of ~20 μm diameter.

Figure 3-34. $\times 50$ and $\times 500$ magnification SEM images of 95UG unmounted slice with curvature of U bend from top of image to bottom.

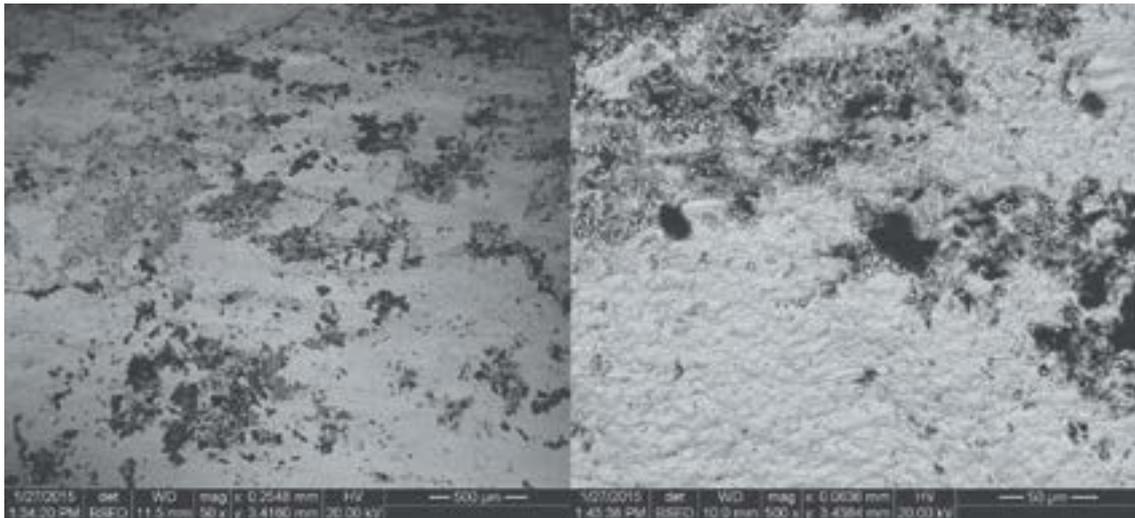
Figure 3-37. $\times 50$ and $\times 500$ magnification SEM images of 95UG top slice with curvature of U-bend from top of image to bottom.

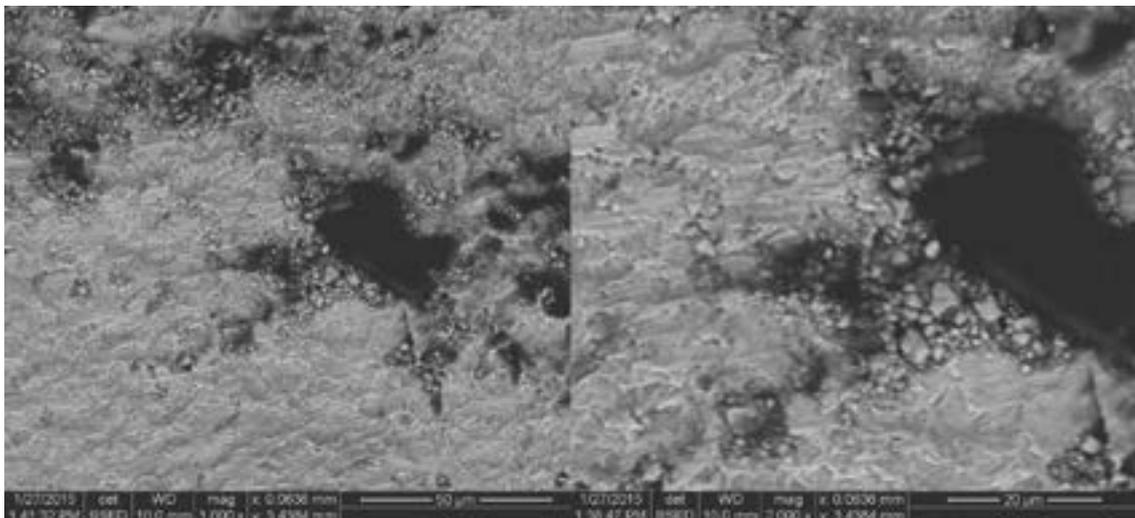
Figure 3-38. $\times 1000$ and $\times 2000$ magnification SEM images of 95UG top slice U bend with curvature from top of image to bottom.
