# Investigation of defects in manufacturing of copper tubes

Ralph Nyström  
Håkan Lundbäck  
Swerea MEFOS

October, 2013

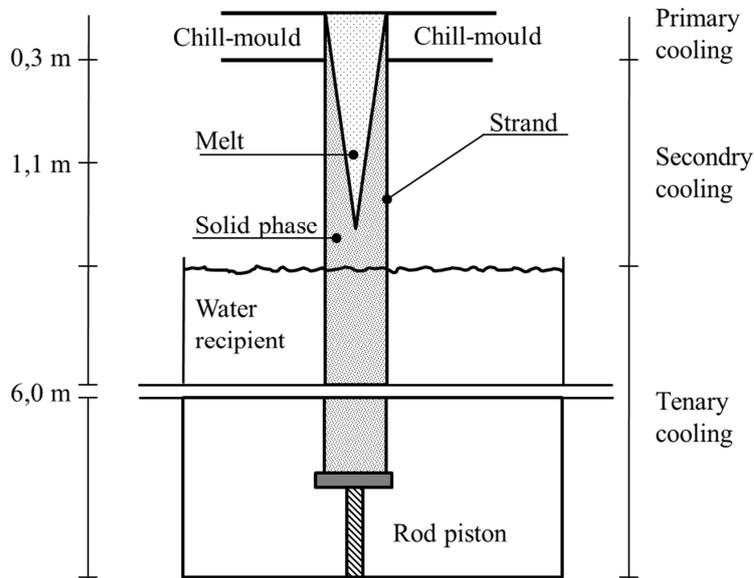
the relevant process parameters are accurately controlled according to pre-set values. The chill-mould oscillates affecting the heat transfer and the friction properties. Further, a casting flux is added to protect the top surface. The flux affects the heat transfer and the friction properties between the cast shell and the mould. Figure 2-1 shows a principle sketch of the casting machine with the different cooling zones according to Fredriksson and Åkerlind (2006).

*Figure 2-1. Materials processing during casting. Fredriksson and Åkerlind (2006).*

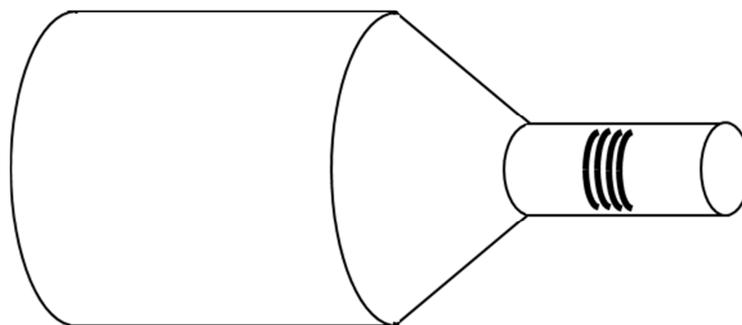
Cracks in the surface can arise from roughened surface to repetitive transverse cracking called - Fir-Tree Cracking, see Figure 3-1. This type of cracking is proposed to be generated due to longitudinal tensile stresses generated as the extrusion passes through the die.

**Figure 3-1.** Surface cracks from heavy die friction and high temperature in extrusion.

In hot extrusion, this form of cracking is often inter granular and is associated with Hot Shortness. The discontinuities are formed as Circumferential Surface Cracks. The most common reason in this case is too high ram speed for the extrusion temperature. At lower temperature, sticking in the die land and the sudden building up of pressure and then brake away will cause transverse cracking.

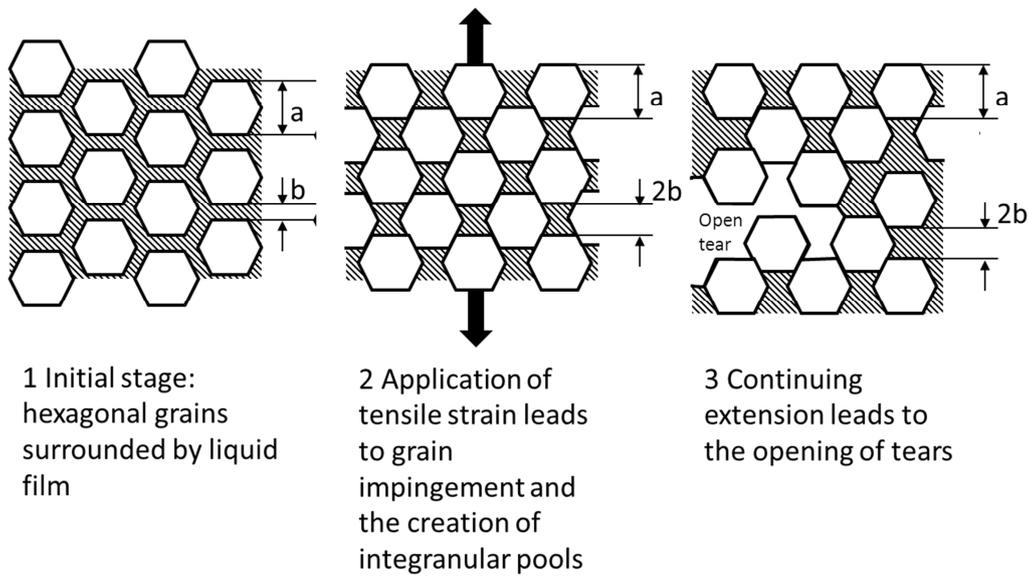
**Figure 3-2.** Hot Tearing mechanism proposed by Rappaz et al. (2003).

The mechanism of hot tearing has been extensively investigated by Sigworth (1999) and Arnberg and Mo (2008). It is commonly believed that hot tears start to develop in the mushy zone at solid fractions close to 1, and the phenomenon is associated with excessive thermally induced deformations caused by the non-uniform cooling contraction of the casting and inadequate inter dendritic melt feeding of the solidification shrinkage. More specifically, at the later stages of solidification, the dendritic network grows to an extent whereby it has sufficient strength to transmit thermal contractions, and tensile stresses will build up in a restrained casting that is not free to contract. Because the grain boundaries are still covered by a thin liquid layer, the material is still weak, and melt feeding to compensate for the solidification shrinkage is simultaneously taking place. Various investigators have explained hot tearing as a too-severe thermally induced deformation and/or an inadequate melt feeding of the solidification shrinkage. In addition to being controlled by these two macro mechanisms, a series of microscopic effects and phenomena play a significant role in hot tearing susceptibility, such as grain morphology, dendrite bridging (coalescence) (Rappaz et al. 2003) the local interplay between the coalescing dendrites and the localized liquid feeding (Vernède et al. 2006) and the alloy composition, including the effect of various trace elements.

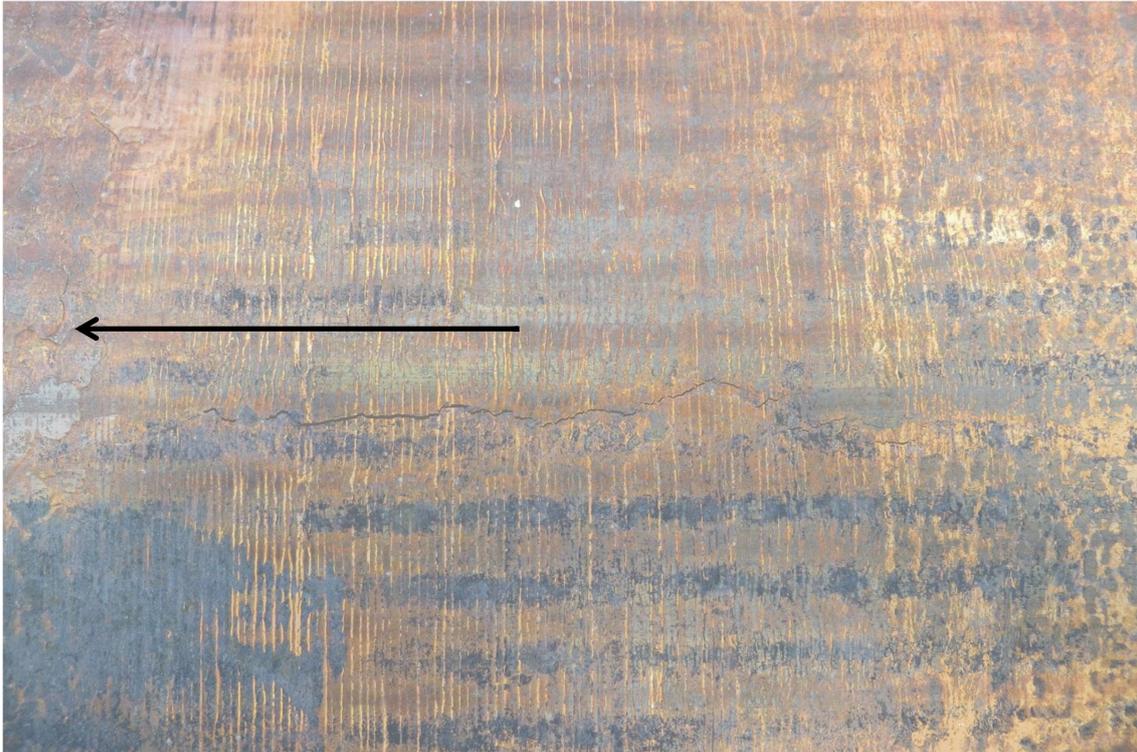
On the ingot surface Cold Laps could be observed as shown on the left side of Figure 4-1. Cold laps will occur when the solidified ingot shell has shrunk away from the mould wall making a gap that allows liquid copper to flow in between the solidified shell and the mould wall. It is assumed that the depth of this type of surface discontinuity is very shallow and the no sharp edges are observed. These discontinuities are likely to be removed in the turning operation that is performed after casting.

Luvata explained that the detected surface cracks are longitudinal Thermally Induced Cracks which will have a depth in the range 2-10 mm after the first turning. Typically the initial turning removes approximately 10 mm of the surface. According to Luvata these surfaces cracks are formed due to uneven heat transfer between the solidified shell and the copper mould and will be detected by ocular and die penetrant inspection and removed by turning or grinding. Figure 4-1 shows a photo of the ingot surface with a thermally induced crack. The length of the crack is approximately 100 mm.

**Figure 4-1.** Ingot surface with a longitudinal Thermally Induced crack. Length: approximately 100 mm. An area with cold laps is indicated with the arrow.

The supplier of ingots has detected surface cracks often visible for a naked eye. These cracks are longitudinally thermally induced cracks which will have a depth in the range 2-10 mm after the first turning. These surfaces cracks are said to be formed due to uneven heat transfer between the solidified shell and the copper mould and will be detected by ocular and die penetrant inspection. By turning the ingots after casting and removing some 10 mm from the barrel surface the eventual surface cracks can be further reduced. Further development of the route using dye penetrant testing and local grinding may give opportunities for a total crack free barrel surface.

According to information from this investigation it is anticipated that it will be technically possible to specify and perform a process route for production and inspection of ingots with practically defect free barrel surfaces. The ingots could be machined and then dye penetrant tested. Any existing longitudinal sharp thermal cracks could be removed by local grinding.

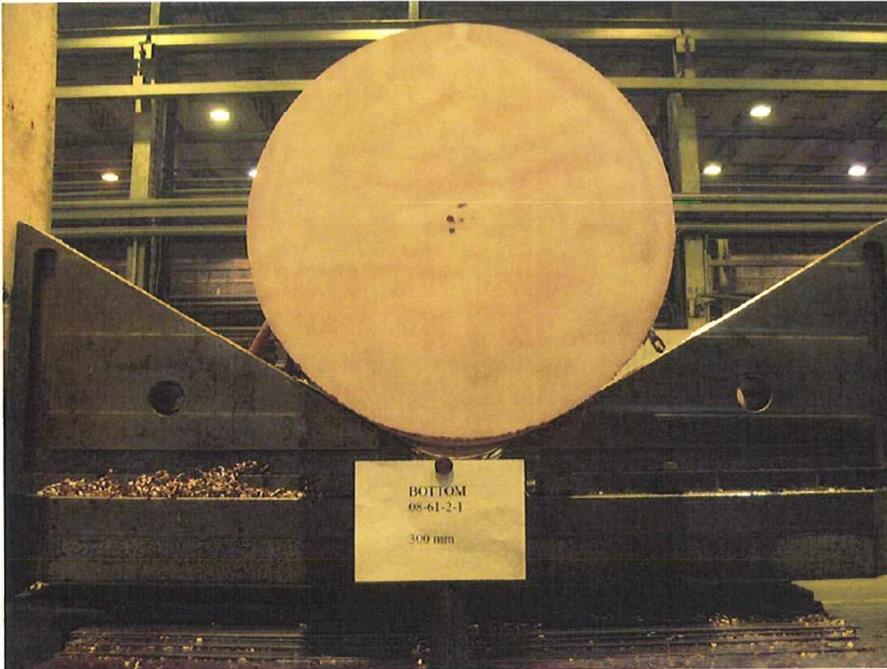
According to Bowyer (2000) “Large ingot size leads to slow cooling which limits cracking due to shrinkage stresses. Large star cracks at the top of ingots arise from primary pipe and will be oxidised”. Referring to Luvata the ingots contain discontinuities in the centre and are located in the starting end and in the top end of the cast ingot. These discontinuities are referred to by Luvata as Spider Cracks. According to Luvata these Spider Cracks are located in positions where they are removed more or less when the ingot is cold sawn to a shorter length. Both ends of the cast ingot are visually inspected and dye penetrant tested after cutting. If discontinuities can be detected after each dye-penetrant test more material will be cut away and a new dye penetrant inspection will be done until no discontinuities can be detected. The cast weight is typical 16 tonnes and the shipped weight for extrusion is 12.4 tonnes  $\pm$  0.1 tonnes. If the specified weight is not within specified limits the ingot will be rejected.

*Figure 4-2. Photo showing an example of the appearance of spider cracks in the centre after 300 mm machining. Luvata.*

Referring to the ingot supplier the ingots may contain discontinuities in the center region, typically in the starting end and in the top end of the cast ingot. These discontinuities are called Spider Cracks. The Spider Cracks are located in positions in the ingot where they are removed more or less when the ingot is cold sawn to a shorter length. The Spider Cracks can be discontinuous which means that the end surface can be defect free after cutting. The crack can appear again in a deeper position if the end surface is cut a second time.

The recent FE simulations that were performed by Swerea MEFOS “Main study - Copper tube extrusion” (SKBdoc 1377246) indicate that remaining centrally located Spider Cracks will be removed during the piercing operation before extrusion.
