September 2020

# Corrosion of copper after 20 years exposure in the bentonite field tests LOT S2 and A3

**SKB TR-20-14**

Adam Johannes Johansson, Daniel Svensson  
Svensk Kärnbränslehantering AB

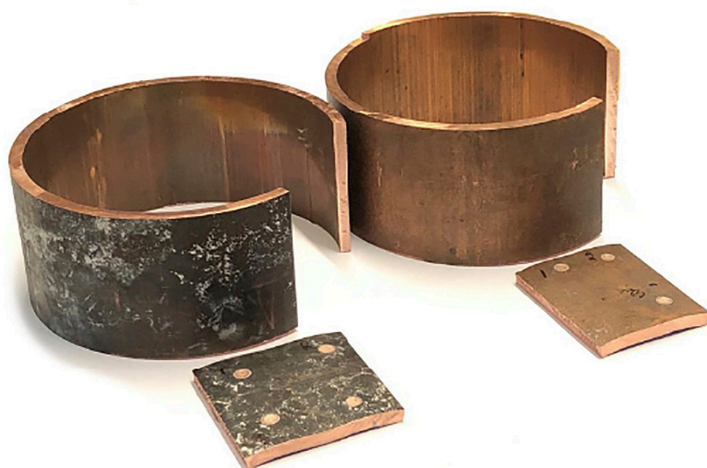
**Figure 2-1.** Sections of pipe A3 (left) and S2 (right) for GDOES analysis. The small circles visible on the surfaces are the spots of analysis.

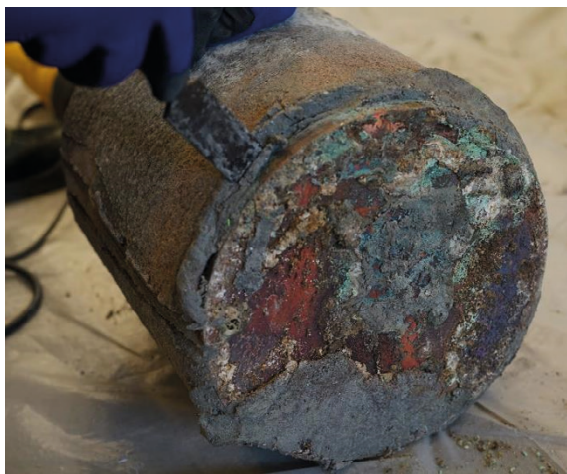
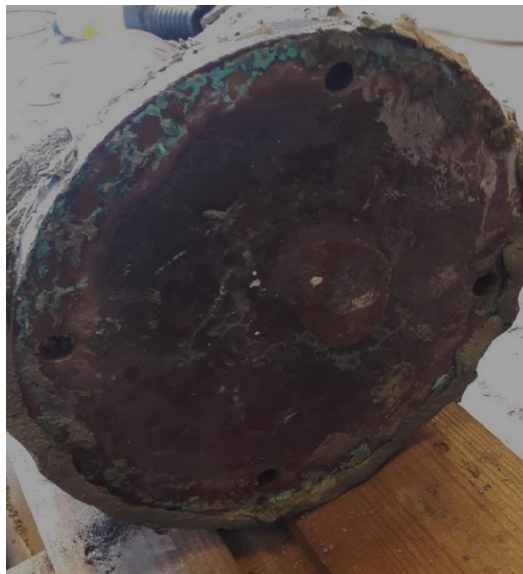
**LOT A3 bottom plate**

The first copper surfaces that became visible during the retrieval were the bottom plates welded to the central copper pipes (Figure 3-1). As indicated in Figure 1-2, the bore holes below the experimental test parcels were filled with sand, i.e. there was no bentonite clay in contact with the bottom plates. The upper left photo in Figure 3-1 shows the bottom plate of A3 when the test parcel was still surrounded by rock. Some of the sand which filled up the hole below the test parcel is still present and some bentonite is visible on the side of the bottom plate. It may be noted in Figures 3-1 and 3-2 that blue-green deposits had formed under the bottom plates in both test parcels, as well as on the side of the bottom plate in A3. Although not apparent in the photographs, the mid part of the S2 bottom plate also had a slightly blue-green appearance. A sample of the blue-green deposit was later analysed with SEM-EDS and XRD (Appendix I). The EDS analysis indicated high levels of chlorine and the XRD showed good agreement with the diffraction pattern of  $\text{Cu}_2(\text{OH})_3\text{Cl}$ , an expected corrosion product of copper in the presence of  $\text{O}_2$  and chloride (Karnland et al. 2009).

**Figure 3-1.** Appearance of the bottom plates immediately after retrieval. Note the blue-green deposits. Upper left: Bottom plate of A3 when it was still surrounded by rock. Lower left: Bottom plate of A3 when the pipe was still embedded in the bentonite. Right: Bottom plate of S2.

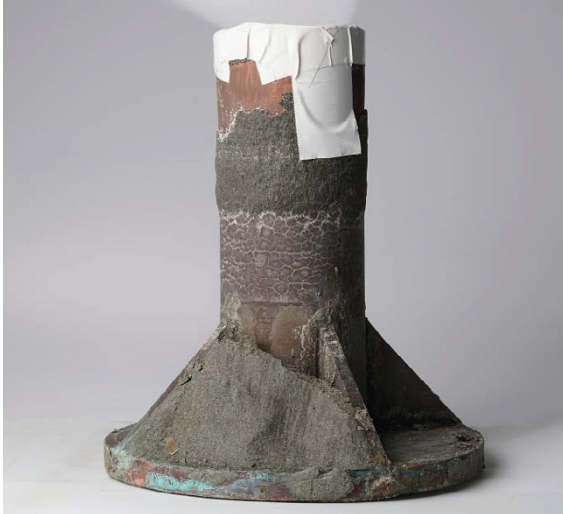
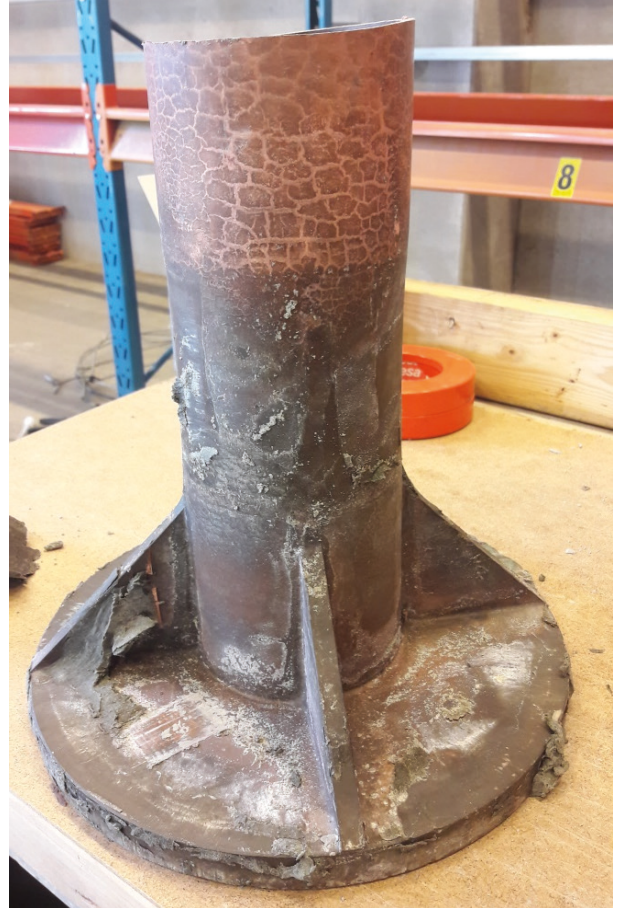
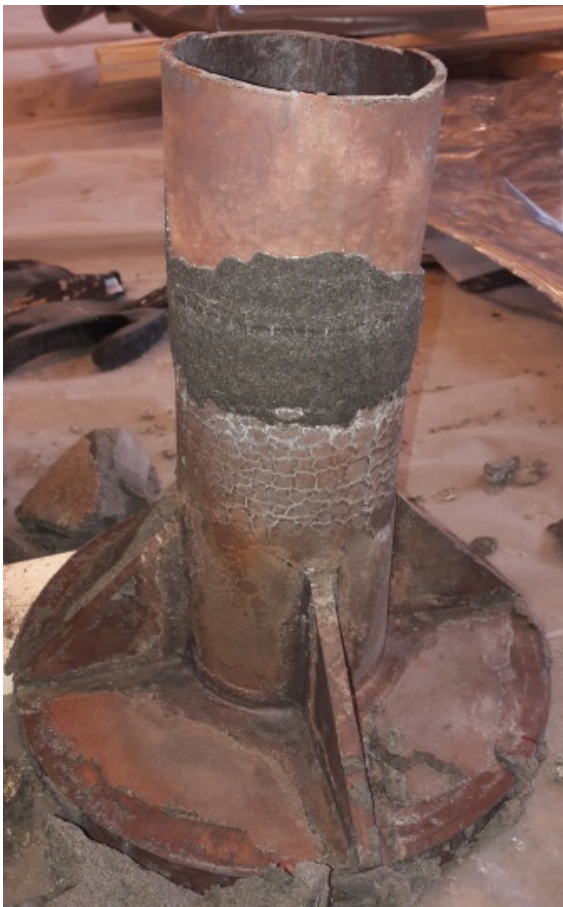
**Figure 3-2.** *Appearance of the lower part of the copper pipes immediately after retrieval.*

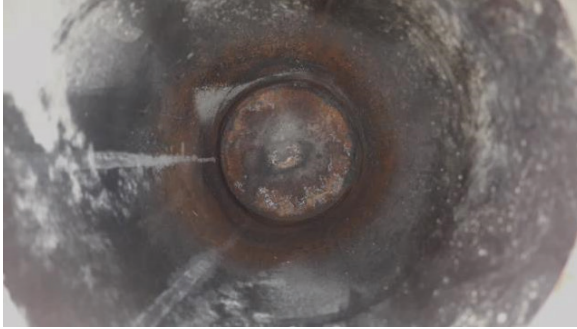
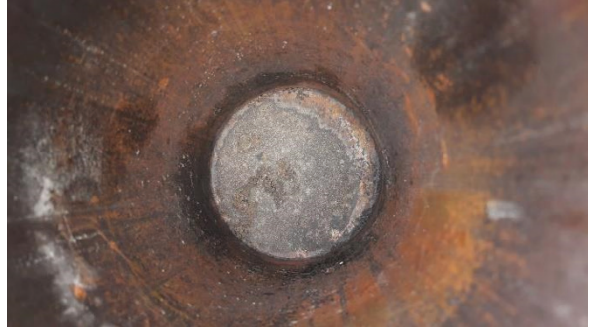
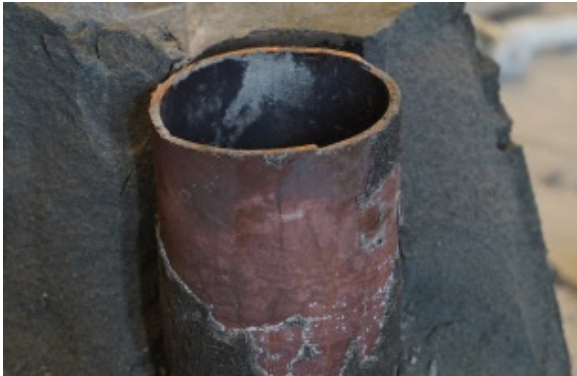
As discussed in the introduction, the copper pipes were open to the Äspö tunnel during the whole experiment. The exposure of the inner pipe surface to air and humidity was clearly visible on some parts and especially the lower parts of the pipe showed signs of corrosion (Figure 3-4). Further examination of cross-sectioned samples of the copper pipes inner surfaces in SEM revealed a thin corrosion film ( $< 1 \mu\text{m}$  thick), and pits of about a few  $\mu\text{m}$  deep (Appendix F).

**Figure 3-4.** *Appearance of the interior of the copper pipes in LOT A3 and S2 immediately after retrieval.*

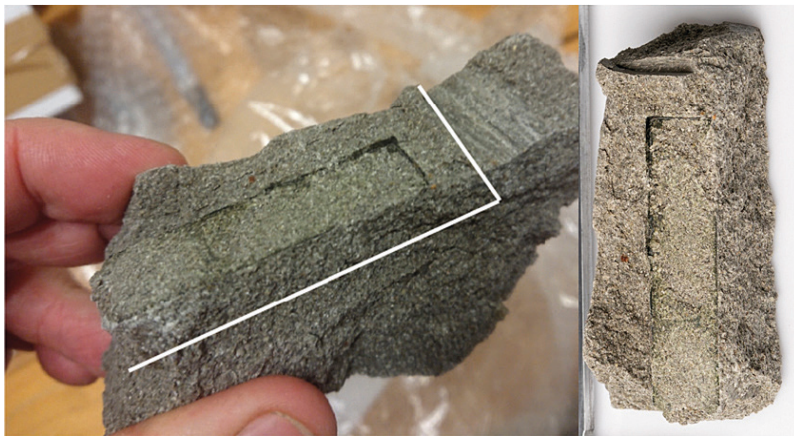
The first sample (Block 30; Cu K N) was sampled using the 0 – 10 mm interval (Figure 3-25). The resulting bulk sample obtained after grinding and compaction of the sample showed a copper concentration below detection limit. Hence it was decided to sample a smaller interval of 0 – 5 mm for the remaining samples (Figure 3-26). This means bulk samples were produced by milling all the bentonite that were within a 5 mm distance from the copper coupon. The 21 – 23 N Cu I sample was trimmed a little bit further after the photo was taken (on its right side).

**Figure 3-25.** Sample “30 Cu K N” from block 30 of LOT A3, before and after trimming. All bentonite at 10 mm distance from the copper coupon was included in the final sample.

The sample “30 Cu K N” from block 30 of LOT A3, included all bentonite within a 10 mm distance from the copper coupon (Figure 3-25), and the resulting “CuO” content was 0.008 wt% (Table 3-8), which is not a reliable quantification due to the very low concentration. This is not considered to be usable. Therefore, the other samples were instead trimmed using a 5 mm distance (Figure 3-26, Table 3-9). This resulted in higher “CuO” levels in the range of 0.03 – 0.05 wt% (Table 3-8). The repeatability of the measurements was rather high (standard deviation SD was low, Table 3-8).

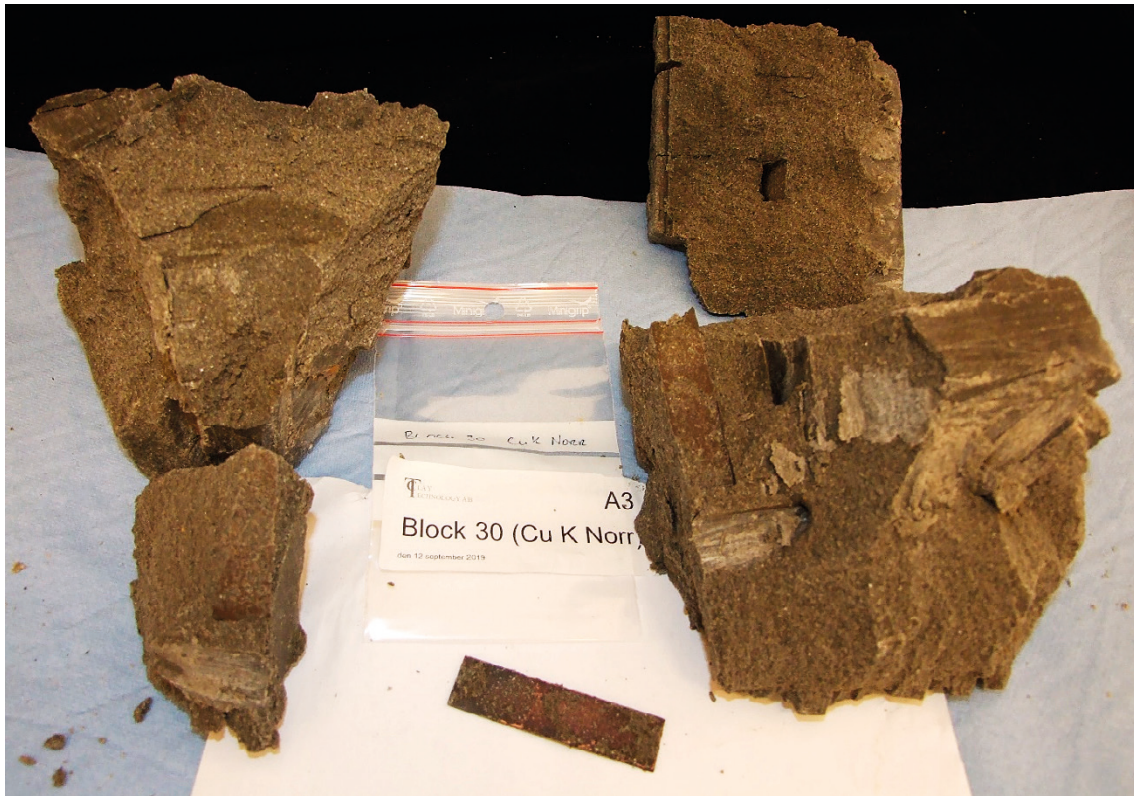
*Figure A-4. Corrosion coupon A3/K with surrounding bentonite clay.*

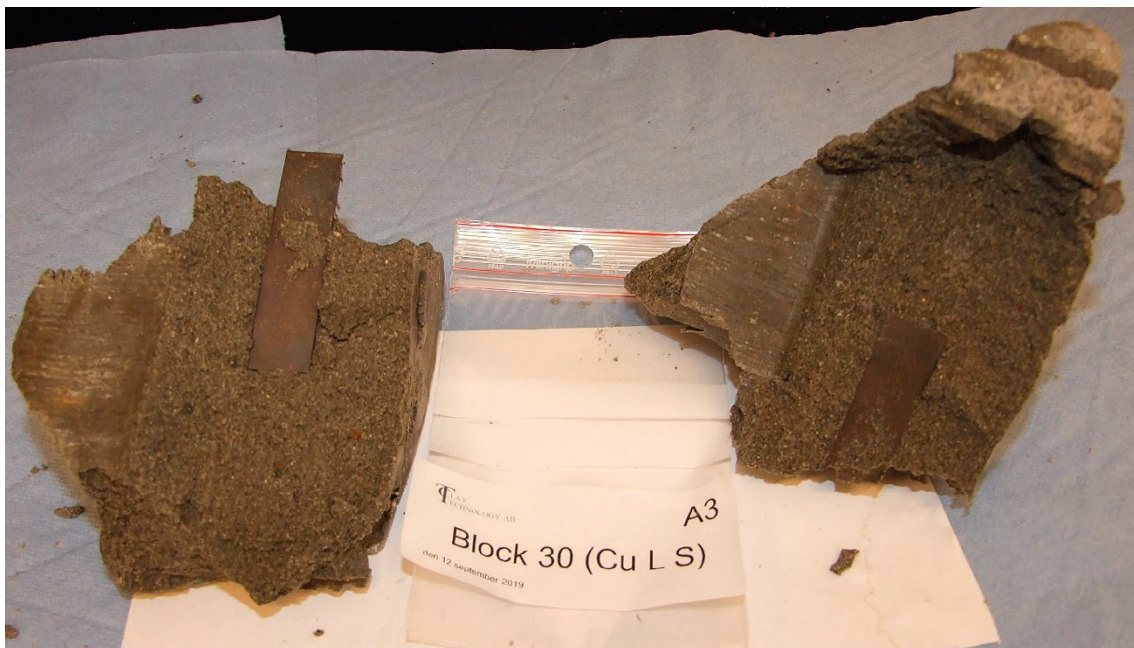
*Figure A-5. Corrosion coupon A3/L with surrounding bentonite clay.*

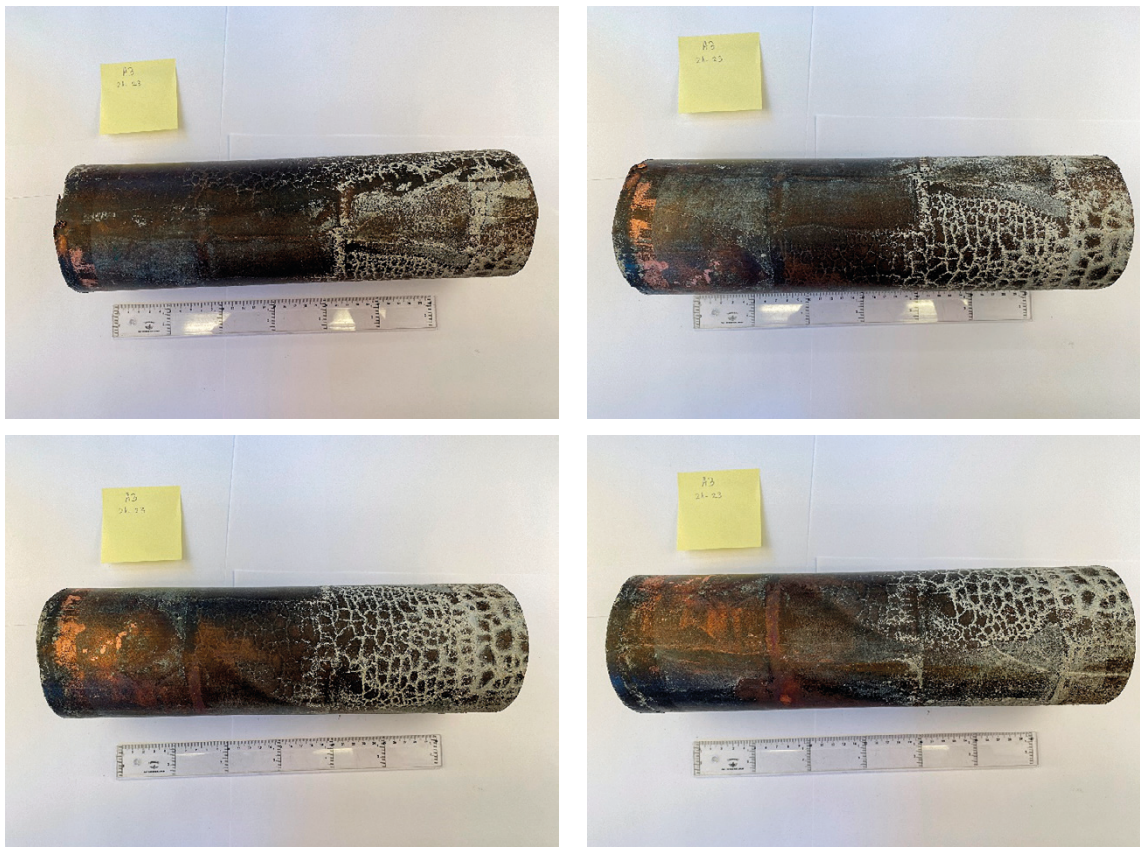
*Figure A-12. Pipe sample A3 as-received, photographed at 0°, 90°, 180°, 270° rotation.*

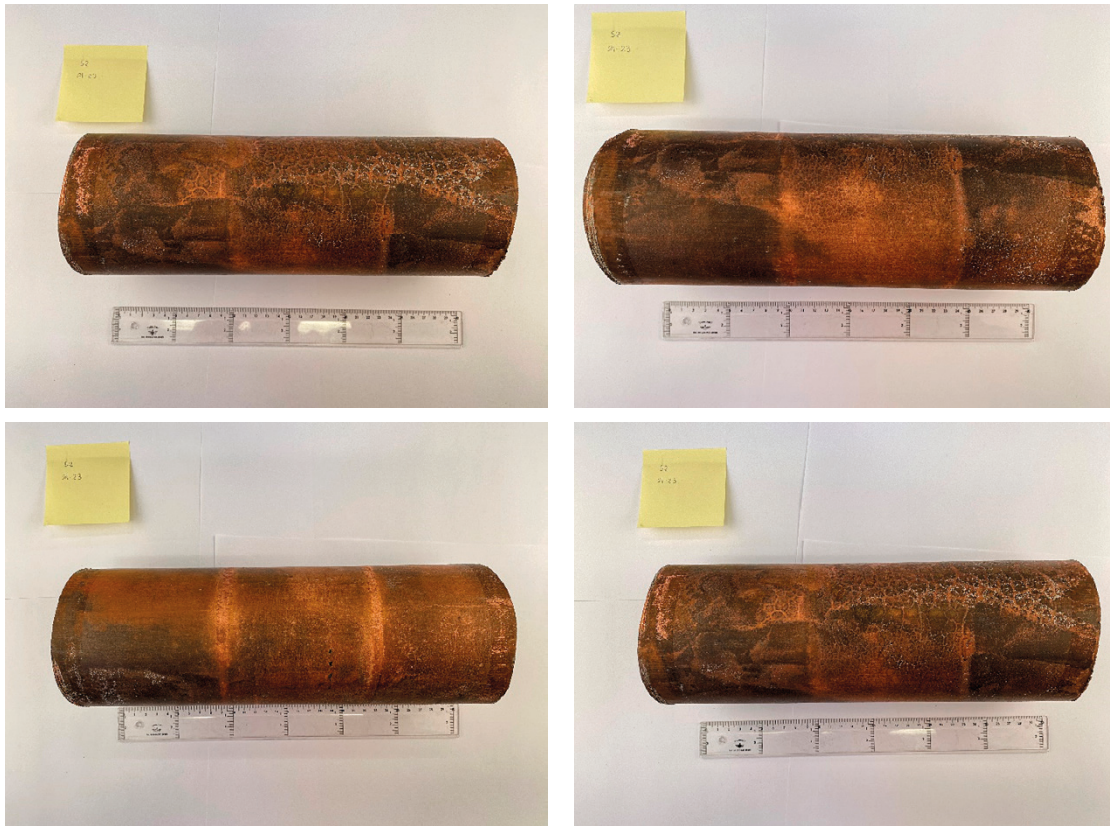
**Figure A-14.** Pipe sample S2 as-received, photographed at 0°, 90°, 180°, 270° rotation.

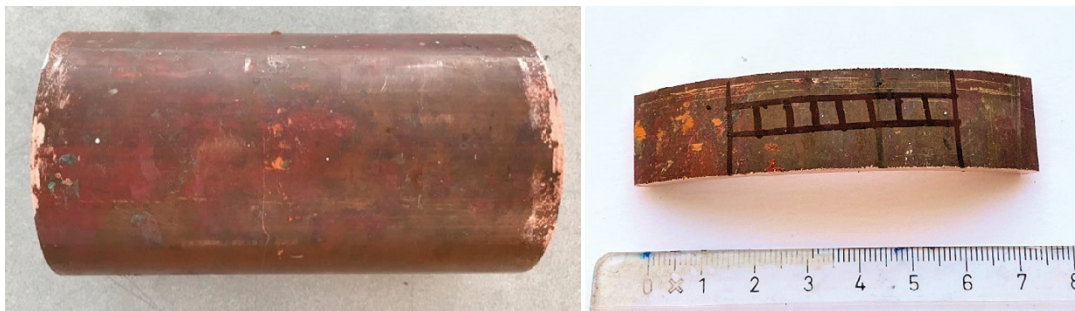
**Figure A-16.** Left: Condition of the reference pipe sample as received. Right: Positions of reference pipe samples that were extracted for H and O analysis.

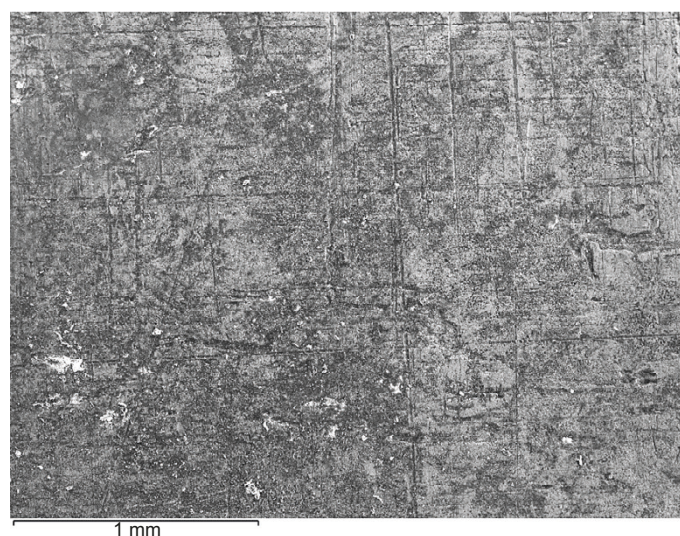
**Figure G-35.** EDS analysis of pipe S23 surface with lighter appearance.

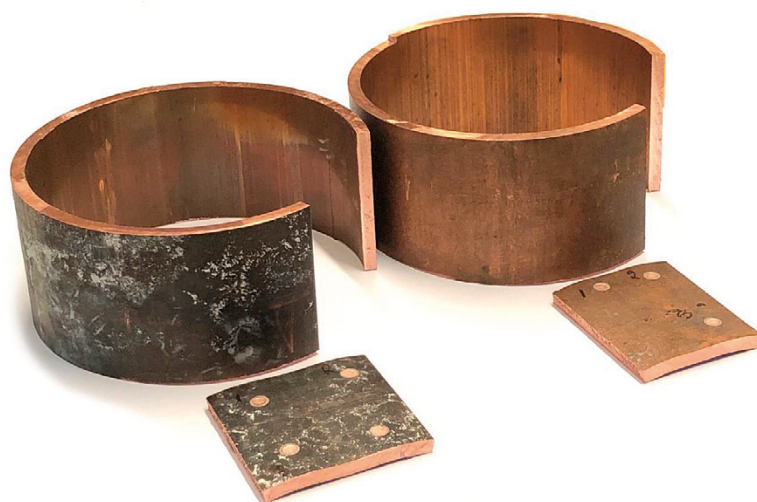
**Figure H-2.** The pipe sections (left: A3, right: S2) and corresponding samples for GDOES analysis.
